Contract #: 04-0120F4Cty: SF/ALA Rte: 80 PM: 13.2/13.9File #: 69.25B**QUALITY ASSURANCE -- NON-CONFORMANCE REPORT****Location:** Changxing Island, Shanghai, P.R. China**Report No:** NCR-000727**Prime Contractor:** American Bridge/Fluor Enterprises, a JV**Date:** 02-May-2010**Submitting Contractor:** Zhenhua Port Machinery Company, Ltd (ZPMC), Changxing Island**NCR #:** ZPMC-0690**Type of problem:****Welding****Concrete****Other****Welding****Curing****Procedural****Bridge No:** 34-0006**Joint fit-up****Coating****Other****Component:** Crossbeam 14 Bottom Panel**Procedural****Procedural****Description:****Reference Description:** Crossbeam 14 Bottom Panel Base Metal Repair without prior Engineer's approval**Description of Non-Conformance:**

**Job Name:** SAS Superstructure  
**Document No:** 05.03.06-000685

**Reference Description:** Crossbeam 14 Bottom Panel Base Metal Repair without prior Engineer's approval

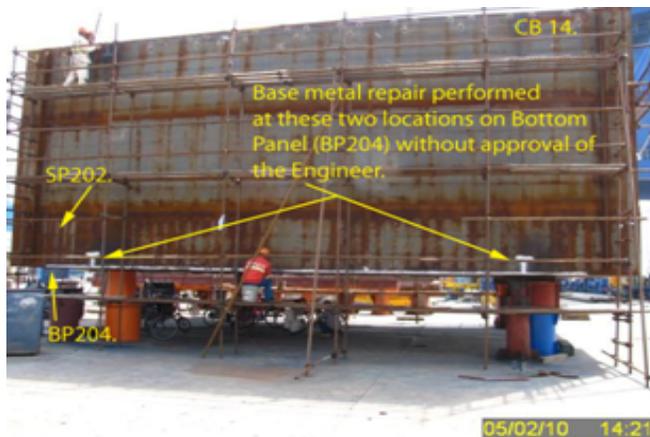
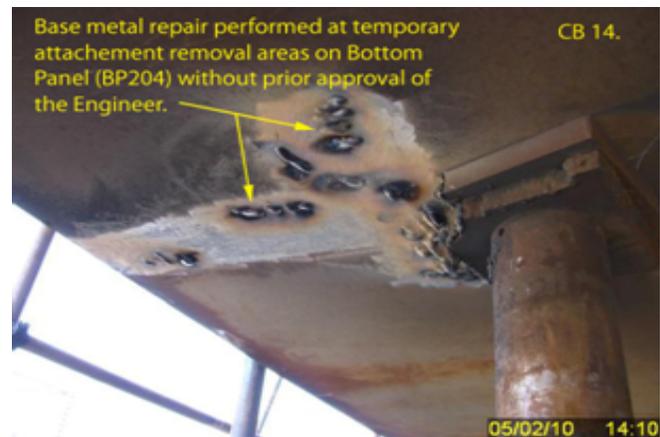
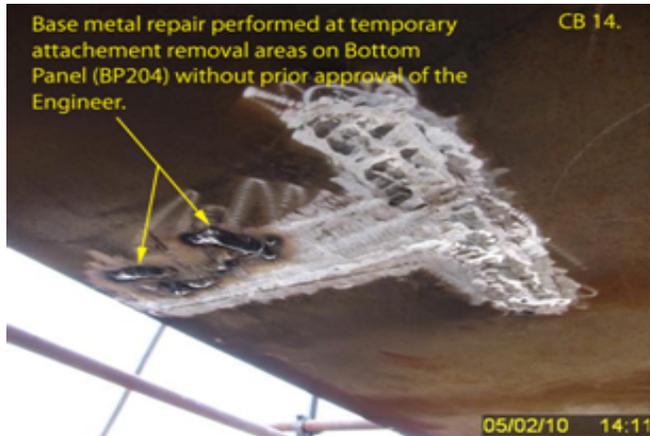
During Quality Assurance (QA) random in-process observations of the fabrication of crossbeam CB14, this QA inspector discovered the following issue:

- Base metal repairs being performed on Seismic Performance Critical Members (SPCM) without prior Engineer's approval or Critical Weld Repair (CWR).
- The repairs were performed at the removal of temporary attachment (lifting lugs) area, locating at the four corners of the bottom panel (BP204) for Crossbeam CB14. The Y locations for the four corners are about 1960mm away from the connection to the OBG Segment, and X locations are near the connection to the CB side panels. (See picture for more details)
- The typical base metal repair has a T-shaped area of approximately 300x400mm.
- The bottom panel of the crossbeam is designated as a Seismic Performance Critical Member (SPCM).
- OBG crossbeam CB14 is located in the Outside Yard.

AWS D1.5 2002, Section 12.17.4: "All critical repairs to base metal and welds shall be approved by the Engineer prior to beginning the repair..."

**Reference Resolution:** ZPMC will provide NDT to show that the base metal repairs are acceptable and the repairs successful. Based on this proposal ZPMC requests that this NCR be approved, with actions pending.

**Reference Resolution:** ZPMC has repaired the base metal in accordance with B-CWR-1485 and is providing the NDT to show that the repairs are acceptable.

ZPMC has repaired the base metal in accordance with B-CWR-1485 and is providing the NDT to show that the repairs are acceptable. ZPMC is working to eliminate this issue through prompt notification to the Department and having a CWR or WWR on hand during repair. Based on this ZPMC requests closure of this NCR.

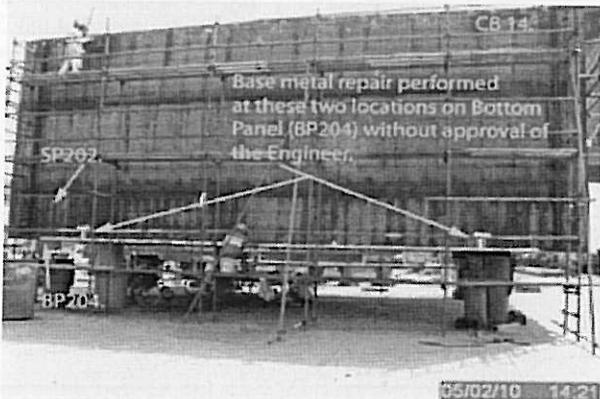
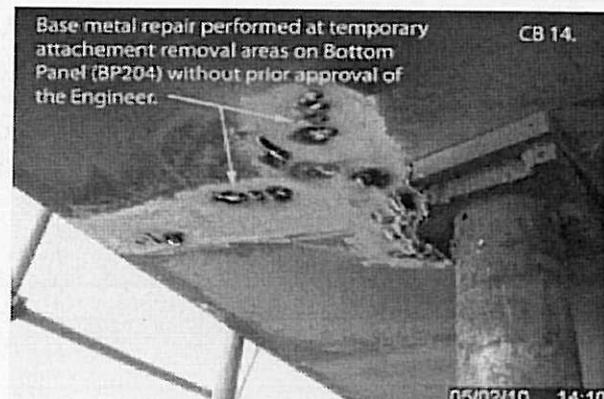
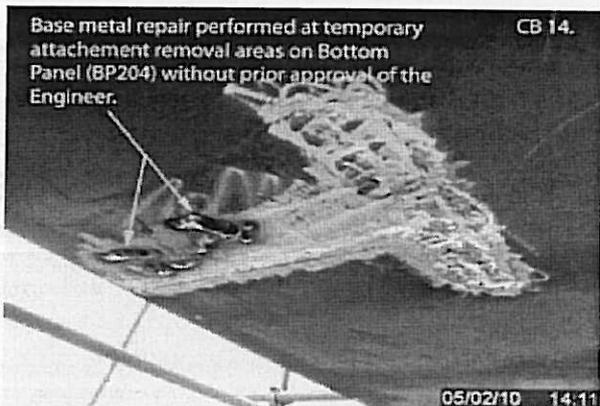
During Quality Assurance (QA) random in-process observations of the fabrication of crossbeam CB14, this QA inspector discovered the following issue:

- Base metal repairs being performed on Seismic Performance Critical Members (SPCM) without prior Engineer's approval or Critical Weld Repair (CWR).
- The repairs were performed at the removal of temporary attachment (lifting lugs) area, locating at the four corners of the bottom panel (BP204) for Crossbeam CB14. The Y locations for the four corners are about 1960mm away from the connection to the OBG Segment, and X locations are near the connection to the CB side panels. (See picture for more details)
- The typical base metal repair has a T-shaped area of approximately 300x400mm.
- The bottom panel of the crossbeam is designated as a Seismic Performance Critical Member (SPCM).
- OBG crossbeam CB14 is located in the Outside Yard.

AWS D1.5 2002, Section 12.17.4: "All critical repairs to base metal and welds shall be approved by the Engineer prior to beginning the repair..."

Submit CWR for tracking purposes and perform NDT required to verify weld quality.

Contractor submitted CWR documenting location of repairs performed along with NDT documentation verifying repairs conform with Contract weld quality requirements.
