Contract #: 04-0120F4  
 Cty: SF/ALA Rte: 80 PM: 13.2/13.9  
 File #: 69.25B

**QUALITY ASSURANCE -- NON-CONFORMANCE REPORT**

**Location:** Changxing Island, Shanghai, P.R. China **Report No:** NCR-000729  
**Prime Contractor:** American Bridge/Fluor Enterprises, a JV **Date:** 05-May-2010  
**Submitting Contractor:** Zhenhua Port Machinery Company, Ltd (ZPMC), Changxing Island **NCR #:** ZPMC-0692

**Reference Description:** Missed MT Indication by QC in OBG Segment 7BW at Longitudinal Diaphragm to FB Weld

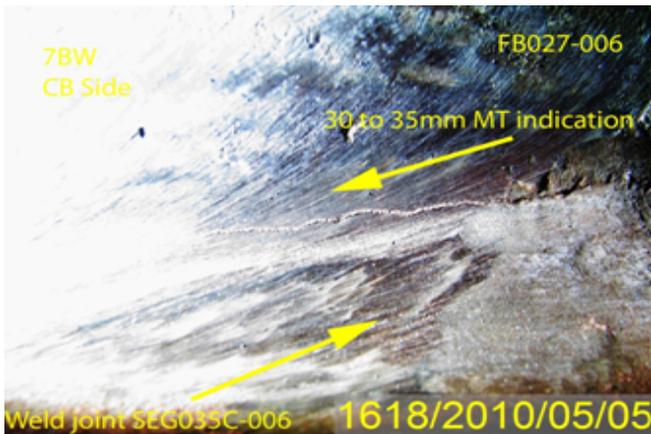
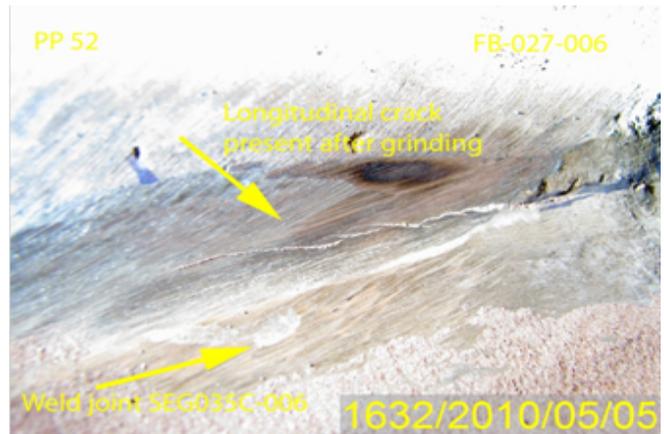
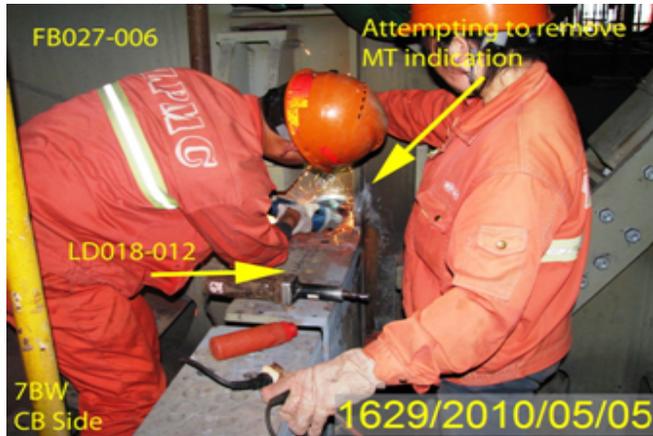
- One (1) longitudinal linear crack measuring approximately 30 to 35mm in length.
- The weld is identified as SEG035C-006.
- The weld is a CJP T-joint joining the longitudinal diaphragm (Piece mark LD018-012) to floor beam web (Piece mark FB027-006).
- Location of this weld joint is at panel point PP52 Cross Beam side of the segment.
- The indication is clearly marked on the material.
- Lift 7 West is located in the OGB Trial Assembly Area.

The Notice of Witness Inspection Number (NWIT) is 005670. The indication is located inside the area that has been previously tested and accepted by ZPMC Quality Control (QC) personnel and ABF QC personnel. According to the contract documents ZPMC Quality Control (QC) is required to perform 100% MT of this weld.

AWS D1.5 (02) Section 6.26.2: "Welds that are subject to MT in addition to visual inspection shall have no cracks.

**Reference Resolution:** ZPMC has repaired the indications referenced in the NCR and is providing the NDT report to show that the weld is now acceptable. Based on this ZPMC requests closure of this NCR.

This proposed resolution is acceptable. The documentation received is sufficient and the Department concurs that Non-Conformance ZPMC-0692 is closed.

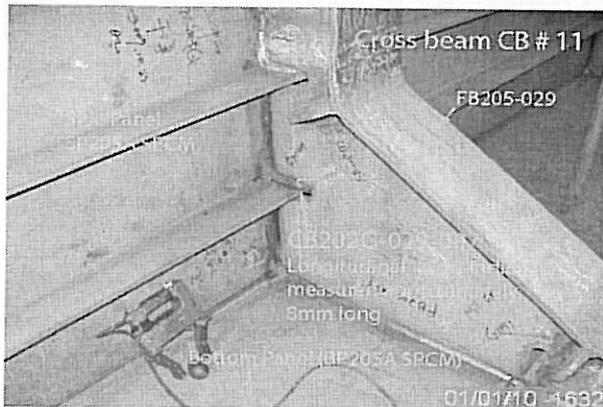
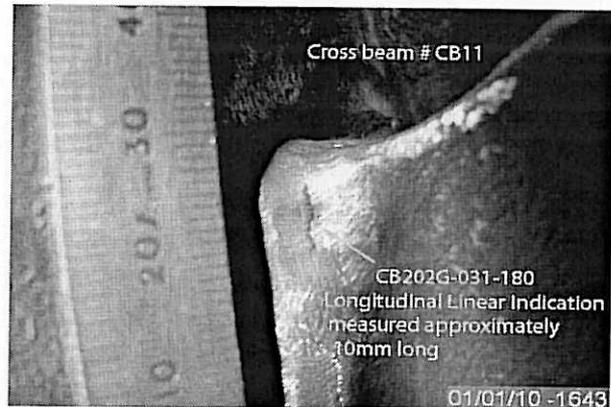
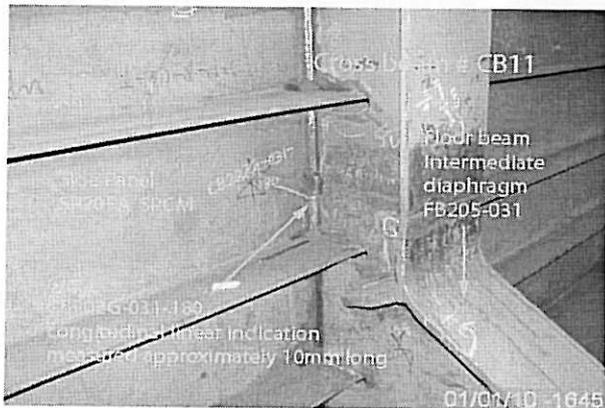
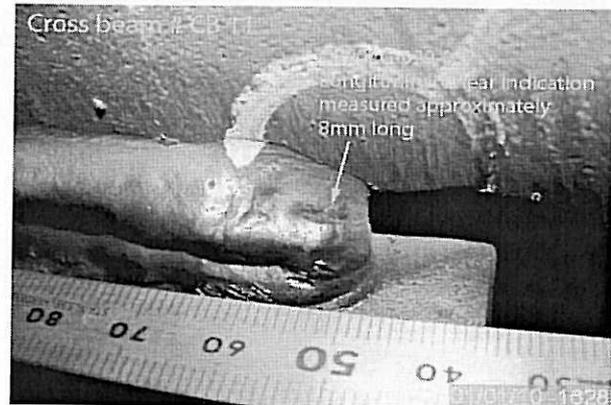
-Two (2) longitudinal linear indications measuring approximately 10mm and 8mm in length.

-The welds are identified as: CB202G-029-087 (8 mm) and CB202G-031-180 (10 mm).

-Weld CB202G-029-087 is a horizontal Fillet Weld joining the Side Panel (SP205A) Seismic Performance Critical Member (SPCM) stiffener connecting to the Floor Beam Intermediate Diaphragm (FB205-029).

-Weld CB202G-031-180 is a vertical Fillet Weld joining the Side Panel (SP205A) SPCM stiffener connecting to the Floor Beam Intermediate Diaphragm (FB205-031).

-The Notice of Witness Inspection Number (NWIT) is 004973. The indications are located inside the area that has been previously tested and accepted by ZPMC Quality Control (QC) personnel. ZPMC's QC personnel are required to perform hundred (100%) percent MT inspection of these welds.

AWS D1.5 (02) Section 6.26.2 – “Welds that are subject to MT in addition to visual inspection shall have no cracks.”

Submit a repair procedure to the engineer for approval. Ensure the MT technician that missed these indications is trained and equipped in a manner so these indications are not missed in the future. A response for the resolution of this issue is expected within 7 days.

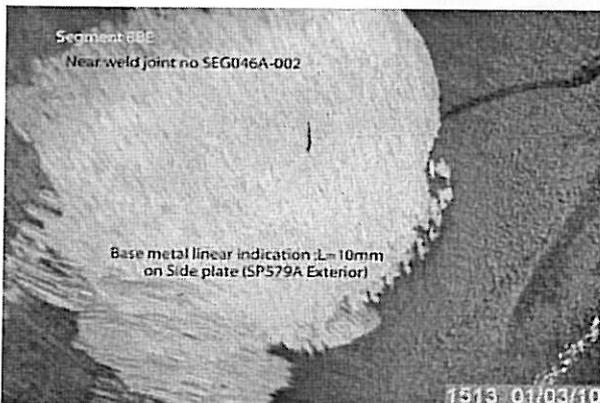
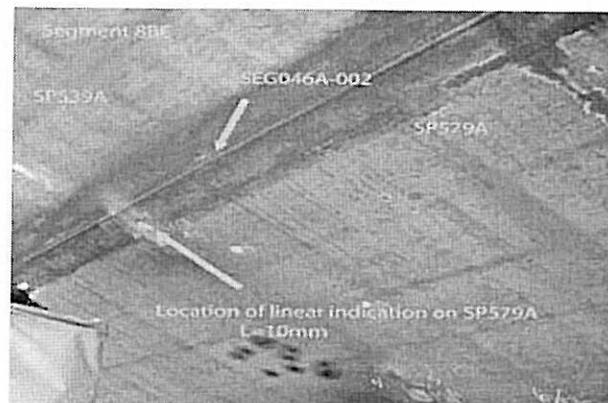
- One (1) linear indication that measured approximately 10mm in length.
- The linear indication was discovered in the base metal at SP579A (PL1043A Exterior).
- The adjacent weld is identified as: SEG046A-002
- This weld joins SP579A (PL1043A) to SP539A (PL1042A).
- This base metal linear indication was located in a temporary attachment removal area.
- The OBG Segment 8BE is located in the outside yard, south side of the Bay14.

The Notice of Witness Inspection Number (NWIT) is 004978. The indication is located inside the area that has been previously tested and accepted by ZPMC Quality Control (QC) personnel. As per the contract documents, ZPMCs QC personnel are required to perform 100% Magnetic particle inspection of this weld.

AWS D1.5 2002 Section 3.3.8: "Temporary Welds, removal of temporary welds shall conform to section 3.3.7.4."

Propose a resolution for the identified non-conformance with revised procedures to prevent future occurrences. Missed MT indications are a chronic issue. Provide the required training and equipment necessary so the ZPMC MT technician does not miss this type of indication in the future. A response for the resolution of this issue is expected within 7 days.

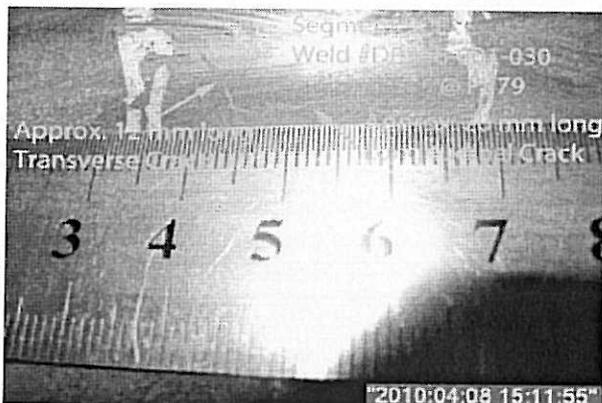
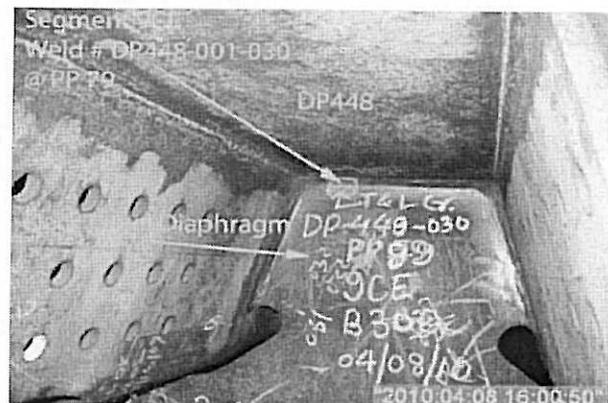
- One (1) Transverse linear indication (crack) measuring approximately 12 mm in length.
- One (1) Longitudinal linear indication (crack) measuring approximately 20 mm in length.
- The weld is identified as: DP448-001-030 @ Panel Point-079.
- The weld is a Fillet Weld type joining DP448 to Deck Panel Diaphragm plate X1C.
- The OBG 9CE segment is located at the back side of Bay # 13.

The Notice of Witness Inspection Number (NWIT) is 005476. The indication is located inside the area that has been previously tested and accepted by ZPMC Quality Control (QC) personnel. ZPMC's QC personnel are required to perform twenty five (25%) percent MT inspection of this weld.

-AWS D1.5 (02) Section 6.26.2 – “Welds that are subject to MT in addition to visual inspection shall have no cracks.

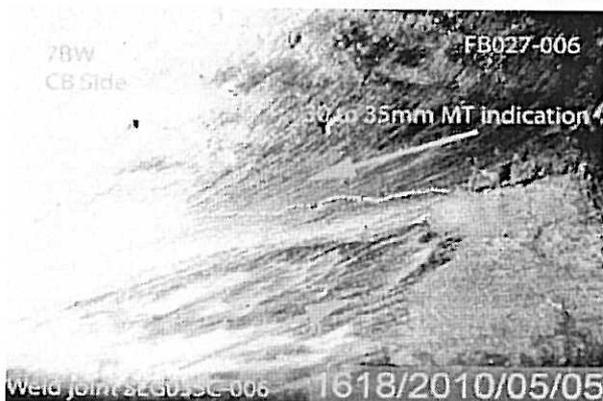
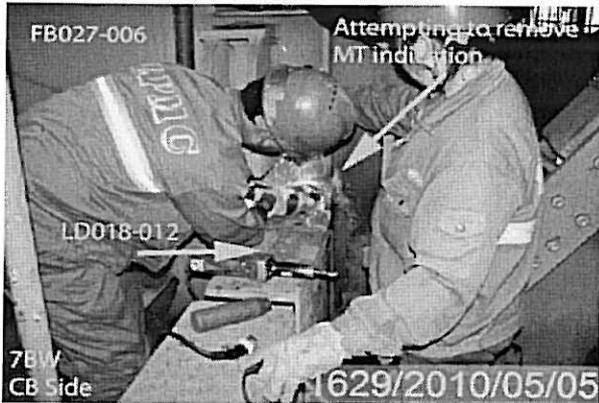
- One (1) longitudinal linear crack measuring approximately 30 to 35mm in length.
- The weld is identified as SEG035C-006.
- The weld is a CJP T-joint joining the longitudinal diaphragm (Piece mark LD018-012) to floor beam web (Piece mark FB027-006).
- Location of this weld joint is at panel point PP52 Cross Beam side of the segment.
- The indication is clearly marked on the material.
- Lift 7 West is located in the OGB Trial Assembly Area.

The Notice of Witness Inspection Number (NWIT) is 005670. The indication is located inside the area that has been previously tested and accepted by ZPMC Quality Control (QC) personnel and ABF QC personnel.

According to the contract documents ZPMC Quality Control (QC) is required to perform 100% MT of this weld.

AWS D1.5 (02) Section 6.26.2: "Welds that are subject to MT in addition to visual inspection shall have no cracks."

Repair said indication and perform NDT required to verify weld quality.

Contractor submitted post weld repair NDT documentation verifying the weld is in conformance with Contract weld quality requirements.
