**QUALITY ASSURANCE -- NON-CONFORMANCE REPORT**

**Location:** Changxing Island, Shanghai, P.R. China**Report No:** NCR-000731**Prime Contractor:** American Bridge/Fluor Enterprises, a JV**Date:** 06-May-2010**Submitting Contractor:** Zhenhua Port Machinery Company, Ltd (ZPMC), Changxing Island**NCR #:** ZPMC-0694**Type of problem:**

**Reference Description:** Missed UT indication by QC on Segment 10AE Side Plate to Side Plate Weld**Description of Non-Conformance:**

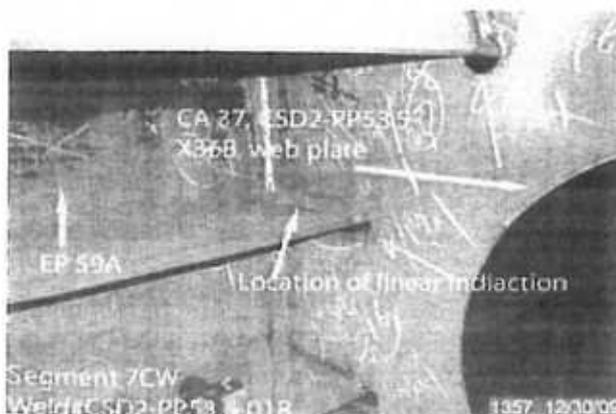
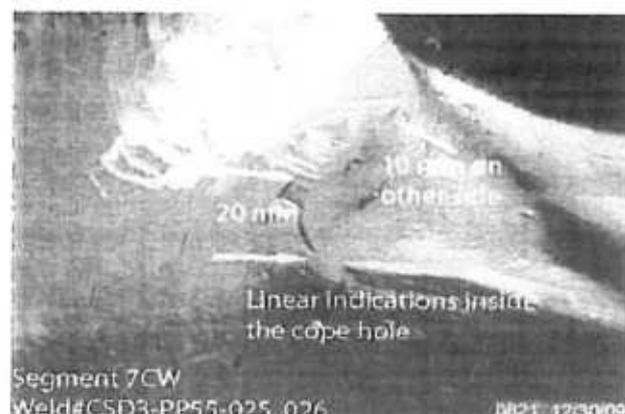
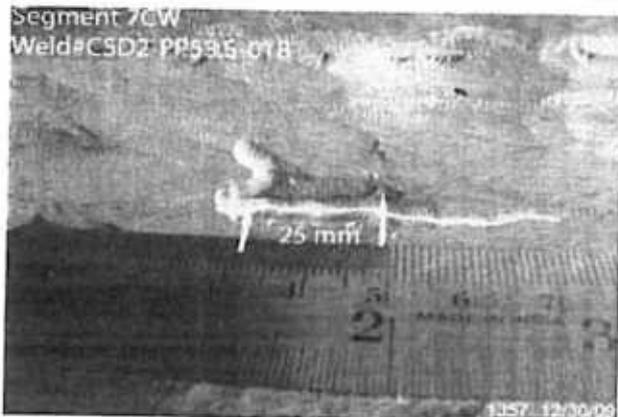
During the Quality Assurance Magnetic Particle Testing (MT) review of welds located on Segment 7CW, this Quality Assurance Inspector (QA) discovered the following issues:

- Two (2) Longitudinal linear indication measuring approximately 20mm and 25mm in length.
- The welds are identified as: CSD3-PP55-025, 026 (30 mm) and CSD2-PP53.5-018 (25 mm).
- The welds are a Fillet Weld type joining the Edge Plate (EP59A) stiffeners to Corner Assembly (CA37A) web plates.
- The OBG 7CW segment is located at in front of Blast Shop.

The Notice of Witness Inspection Number (NWIT) is 004947. The indication is located inside the area that has been previously tested and accepted by ZPMC Quality Control (QC) personnel. ZPMC's QC personnel are required to perform twenty five (25%) percent MT inspection of this weld.

AWS D1.5 (02) Section 6.26.2 – “Welds that are subject to MT in addition to visual inspection shall have no cracks.

Submit a repair procedure to the engineer for approval. Provide the ZPMC MT technician additional training and equipment to ensure these types of indications are identified in the future.

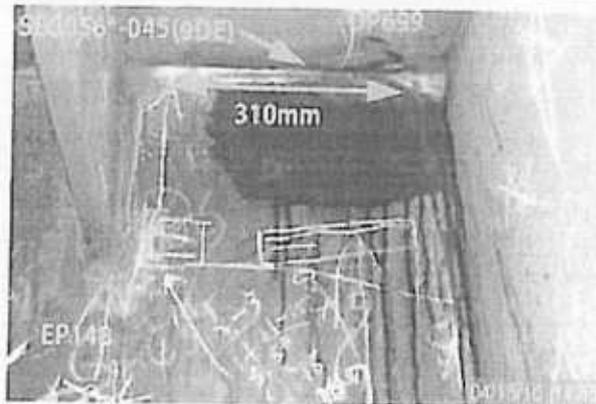
During the Quality Assurance (QA) Ultrasonic Testing (UT) review of welds located on Orthotropic Box Girder (OBG) Segment 9DE, this QA Inspector discovered the following issues:

- Two (2) longitudinal linear indications measuring approximately 310mm and 30mm in length.
- The indications dBs rating are +6 and +4.
- Material thickness is 18mm.
- The depth of the indications is approximately 11mm and 13mm.
- The welds are identified as SEG056\*-045 at Panel Point (PP) PP81.5 and EP148-022 at PP 81.
- The welds are designated as Seismic Performance Critical Material (SPCM).
- The indications are clearly marked on or near the weld.
- The Y distance for the indications are 50 mm from PP81.5 and 0 mm from EP148A.
- Weld SEG056\*-045 is a Complete Joint Penetration (CJP) Corner joint, joining the Edge Plate PL1336C(SPCM) to Deck Plate PL1314A (Non SPCM).
- Weld EP148-022 is a Complete Joint Penetration (CJP) "T" joint, joining the Edge Plate stiffener RS89F (Non SPCM) to FB24A plate PLX24D (SPCM).
- Segment 9DE is located outside of Paint shop.

AWS D1.5-02 Section 6; Table 6.3 specifies a class "A" indication as having a rating of 10dBs and under for material thicknesses 8mm through 20mm.

Propose a resolution for the identified non-conformance to prevent future occurrences. A response for the resolution of this issue is expected within 7 days.

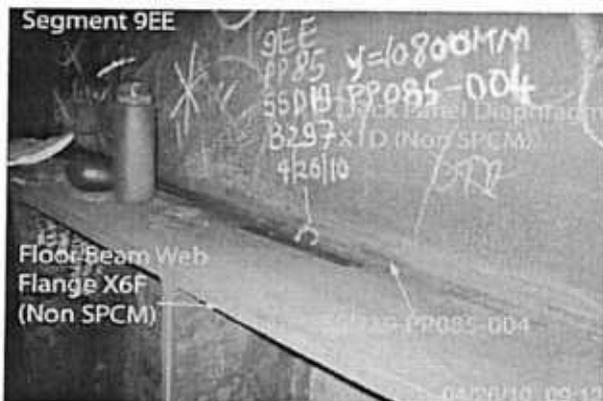
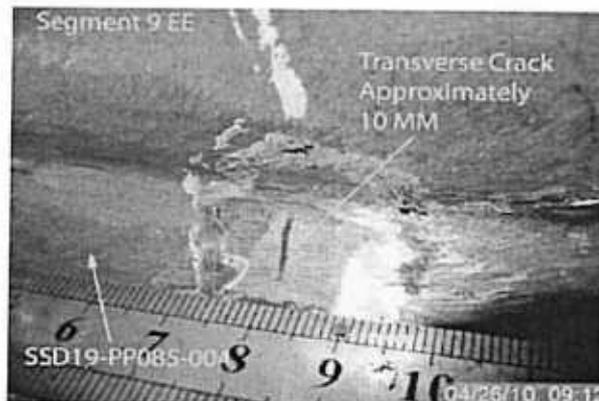
During the Quality Assurance (QA) Magnetic Particle Testing (MT) review of welds located on Segment 9EE, this QA Inspector discovered the following issues:

- One (1) transverse crack measuring approximately 10mm in length in the fillet weld joining the Deck Panel Diaphragm (X1D) to Floor Beam Web Flange (X6F) at panel point 85.
- The Y location is 10800mm from the termination of the weld on the crossbeam side.
- The indication is clearly marked near the weld.
- The weld is identified as: SSD19-PP085-004.
- OBG segment 9EE is located north of the blast shop.
- The Notice of Witness Inspection Number (NWIT) is 005583. The indication is located within the area that has been previously tested and accepted by ZPMC Quality Control (QC) personnel.

AWS D1.5 (02) Section 6.26.2 – “Welds that are subject to MT in addition to visual inspection shall have no cracks.

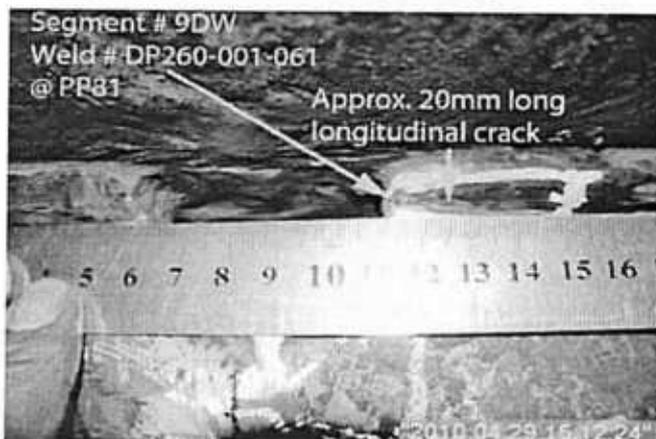
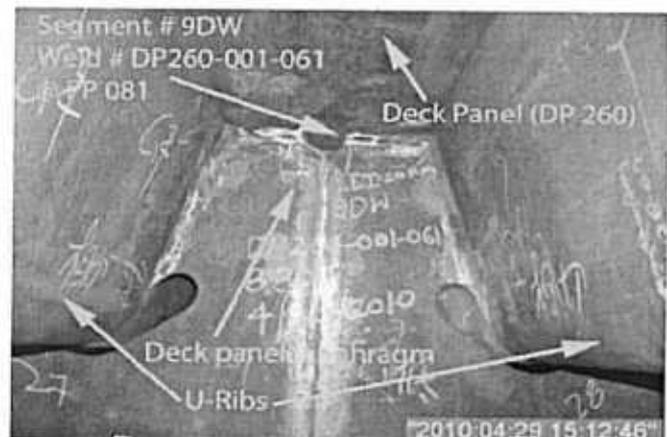
During the Quality Assurance (QA) Magnetic Particle Testing (MT) review of welds located on Segment 9DW, this QA Inspector discovered the following issue:

- One (1) Longitudinal linear crack like indication measuring approximately 20 mm in length.
- The weld is identified as DP260-001-061 @ Panel Point 081.
- The weld is a Fillet Weld T-joint joining the Deck Plate to Deck Panel Diaphragm plate.
- The plate number for Deck Plate is identified as PL307A (Non SPCM).
- Deck panel diaphragm plate is identified as X1E (Non SPCM).
- The indication is clearly marked on the material near the weld.
- OBG Segment 9DW is located at the back side of OBG Bay #14.
- The Notice of Witness Inspection Number (NWIT) is 005616. The indication is located inside the area that has been previously tested and accepted by ZPMC Quality Control (QC) personnel. Per the contract documents ZPMC's QC personnel are required to perform 100% MT inspection of this weld.

AWS D1.5 (02) Section 6.26.2 – “Welds that are subject to MT in addition to visual inspection shall have no cracks.

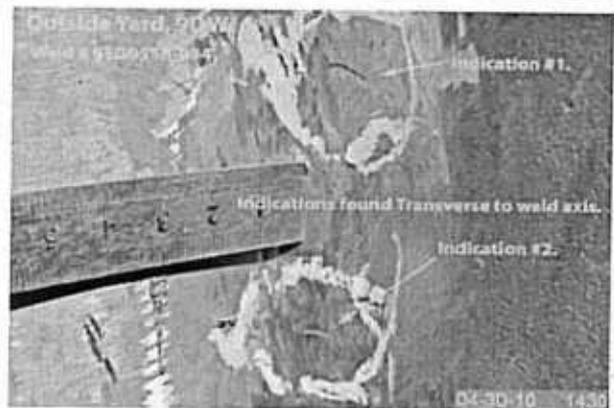
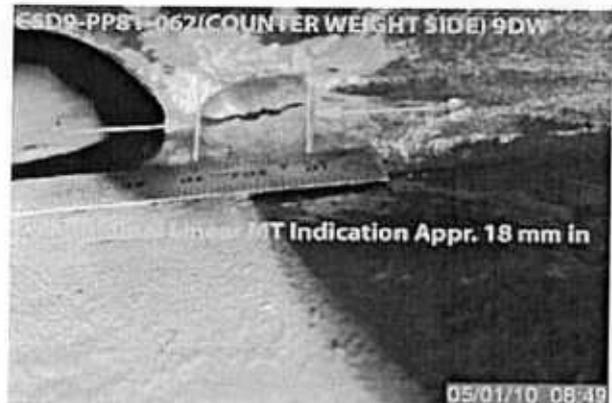
- Three transverse linear indications, one measuring approximately 9mm and two indications measuring approximately 5mm in length at Longitudinal Diaphragm (LD) LD3A to Floor beam (FB) FB11A.
- Weld is identified as SEG055B-034 and designated as a Fracture Critical Weld (FCW).
- The weld is a 14mm Complete Joint Penetration (CJP) T-joint joining LD 3A shear plate identified as X39B to FB web plate identified as X47C (Seismic Performance Critical Material SPCM).
- The indications are clearly marked on the material.

AWS D1.5 (02) Section 6.26.2 – "Welds that are subject to MT in addition to visual inspection shall have no cracks."
