Contract #: 04-0120F4
 Cty: SF/ALA Rte: 80 PM: 13.2/13.9
 File #: 69.25B

QUALITY ASSURANCE -- NON-CONFORMANCE REPORT

Report No: NCR-000745

Reference Description: Gap Between Mill-to-Bear Surfaces, West Shaft, Lift 1

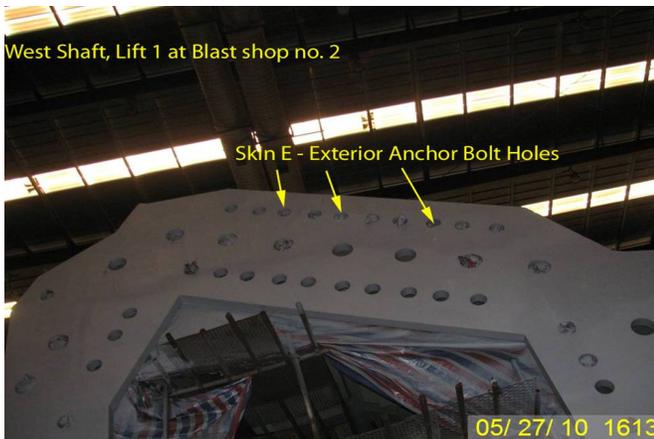
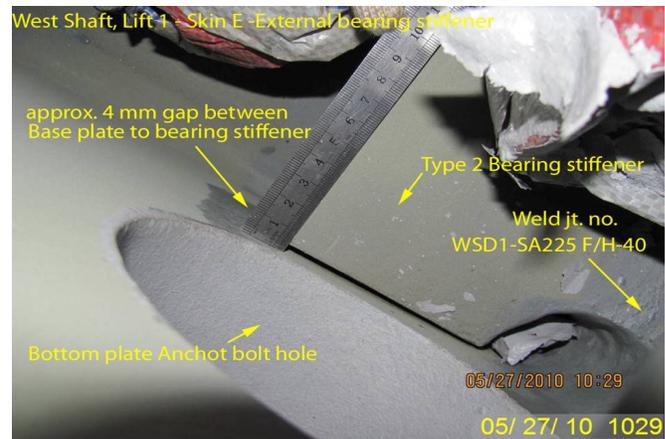
During the Quality Assurance (QA) Inspection of Anchor Bolt to Bearing stiffener distance measurement at West shaft Skin E, external side, Caltrans QA discovered the following issue:

- Approx. 4 mm gap found between Type 2 Bearing stiffener and Base plate.
- This Type 2 bearing stiffener weld joint with Type 1 stiffener is identified as WSD1-SA225F/H-40

Drawing no.- 180R2 – Tower Anchorage Details no. 5

Note no. 10 –Bearing stiffener PL#2 shall be milled to bear against tower Base plate

AWS D1.5 Section: 3.5.1.9: “The bearing ends of bearing stiffeners shall be flush and square with the web and shall have at least 75 percent of this area in contact with the flanges. When bearing against a steel base or seat,

all steel components shall fit within 1 mm [1/32 in.] for 75 percent of the projected area of the web and stiffeners”

ZPMC has corrected this issue using shims. This gap has been inspected by the Department and found to be acceptable. ZPMC is providing the notifications numbers and dates so that this acceptance by the Department's inspectors can be verified. Based on this ZPMC requests closure of this NCR.

As soon as get this information, ZPMC made investigation and realized this problem. In order to remedy this issue, ZPMC discussed with ABF and CT. At last the final conclusion and agreement was made that shim shall be applied to the over-gap. Now, all the over-gap had been shimmed, also they were checked and accepted by CT inspector.

Contractor proposes to install shim plates to fill the gaps, sealed by caulking. The retrofit will be re-inspected after the arrival in the United States.

Contractor installed the shim plates, and caulked the gaps and the retrofit works accepted by QA prior to shipment. Re-inspection on arrival in the States for all four Tower Shafts took place and found satisfactory.

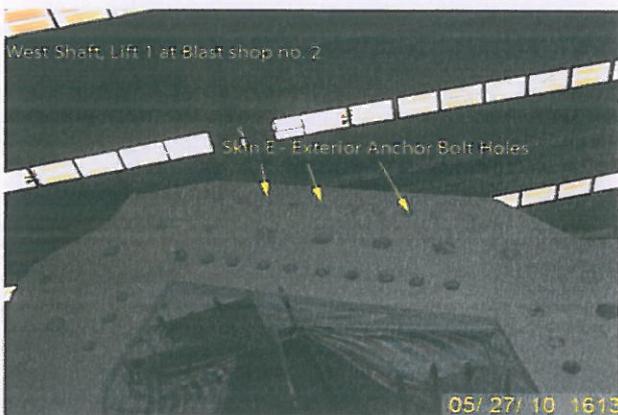
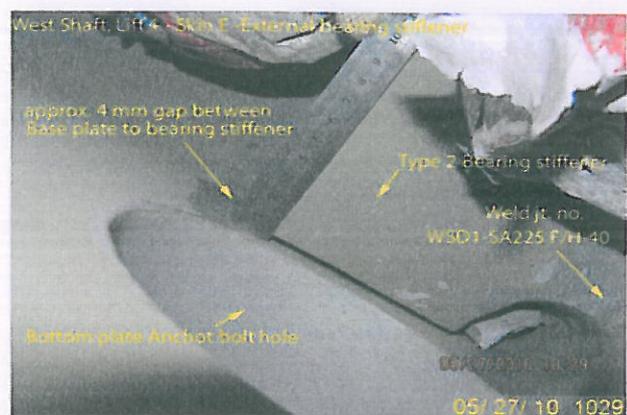
During the Quality Assurance (QA) Inspection of Anchor Bolt to Bearing stiffener distance measurement at West shaft Skin E, external side, Caltrans QA discovered the following issue:

- Approx. 4 mm gap found between Type 2 Bearing stiffener and Base plate.
- This Type 2 bearing stiffener weld joint with Type 1 stiffener is identified as WSD1-SA225F/H-40

Drawing no.- 180R2 – Tower Anchorage Details no. 5

Note no. 10 –Bearing stiffener PL#2 shall be milled to bear against tower Base plate

AWS D1.5 Section: 3.5.1.9: “The bearing ends of bearing stiffeners shall be flush and square with the web and shall have at least 75 percent of this area in contact with the flanges. When bearing against a steel base or seat,

all steel components shall fit within 1 mm [1/32 in.] for 75 percent of the projected area of the web and stiffeners”
