Contract #: 04-0120F4Cty: SF/ALA Rte: 80 PM: 13.2/13.9File #: 69.25B**QUALITY ASSURANCE -- NON-CONFORMANCE REPORT****Location:** Changxing Island, Shanghai, P.R. China**Report No:** NCR-000753**Prime Contractor:** American Bridge/Fluor Enterprises, a JV**Date:** 31-May-2010**Submitting Contractor:** Zhenhua Port Machinery Company, Ltd (ZPMC), Changxing Island**NCR #:** ZPMC-0716**Type of problem:**

Reference Description: 4 Missed UT indications found by QA after ZPMC QC has previously tested and accepted these welds in Segment 10CW

Dear: Mr. Charles Kanapicki
Job Name: SAS Superstructure

Subject: NCR No. ZPMC-0716

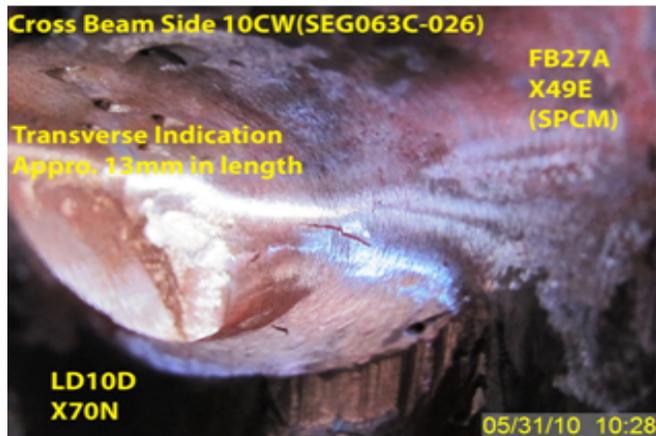
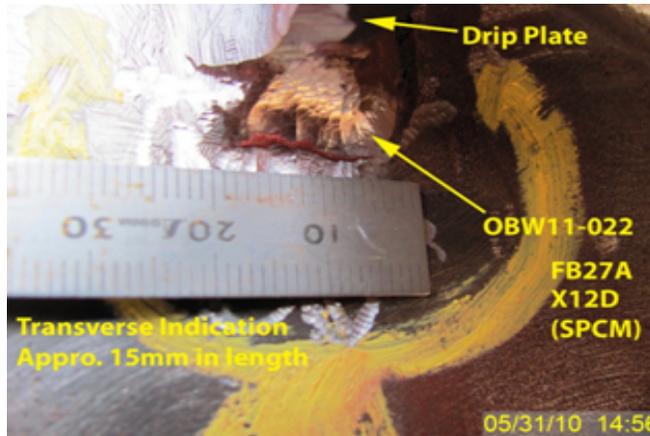
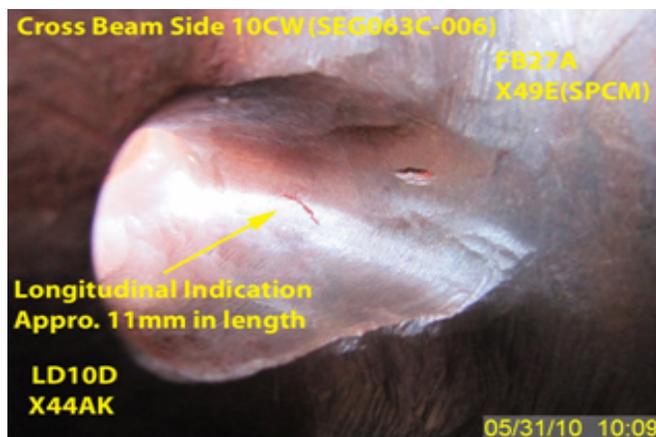
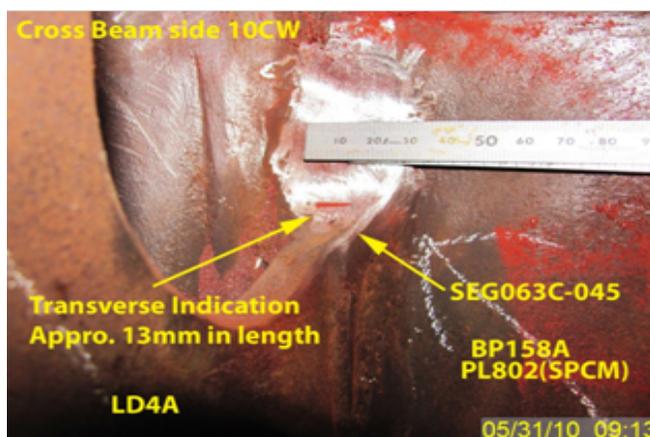
During the Quality Assurance (QA) Magnetic Particle Testing (MT) review of welds located on Segment 10CW, this QA Inspector discovered four (4) linear indications on the following welds:

- Weld #SEG063C-045: One (1) Transverse linear indication measuring approximately 13 mm in length.
- Weld #OBW11-022: One (1) Transverse linear indication measuring approximately 15 mm in length.

- Weld #SEG063C-026: One (1) Transverse linear indication measuring approximately 13 mm in length.
- Weld #SEG063C-006: One (1) Longitudinal linear indication measuring approximately 11 mm in length.

- All indications are clearly marked on the material near the weld.
- All welds are designated as Seismic Performance Critical Material (SPCM).
- Weld SEG063C-045 is a Complete Joint Penetration (CJP) joint joining between LD4A (X68B) Non SPCM to BP158A (PL802A) SPCM at Cross Beam Side.

- Weld OBW11-022 is a fillet weld joint joining between Drip plate to Floor Beam FB27A(X12D) SPCM at Panel Point PP94 (Cross Beam Side).
- The weld SEG063C-026 is a CJP weld joint joining between FB27A (X49E) SPCM to LD10D (X70N) Non SPCM.

- The weld SEG063C-006 is a CJP weld joint joining between FB27A (X49E) SPCM to LD10D (X44AK) Non SPCM.
- OBG segment 10CW is located outside west of Bay#16.

The Notice of Witness Inspection Number (NWIT) is 005839. The indications are located within the area that has been previously tested by ZPMC Quality Control (QC) personnel.

AWS D1.5 (02) Section 6.26.2 – “Welds that are subject to MT in addition to visual inspection shall have no cracks.

ZPMC acknowledges the four indications were missed and is providing the NDT records show these indications have been removed, repaired and are now acceptable. Please be noticed one indication on OBW11-022 was removed after grinding. Based on this, please consider closure of this NCR.

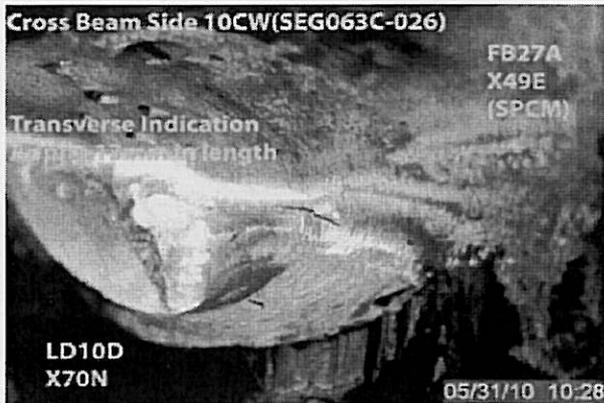
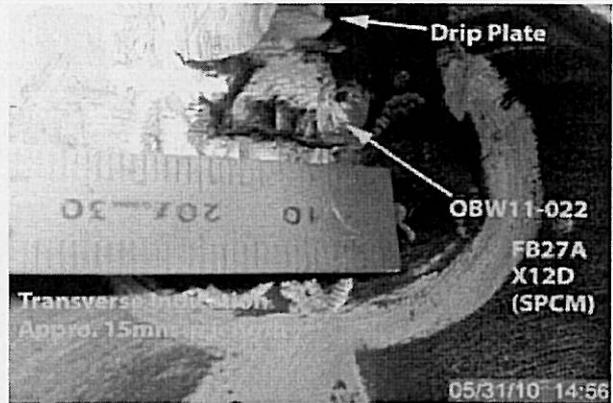
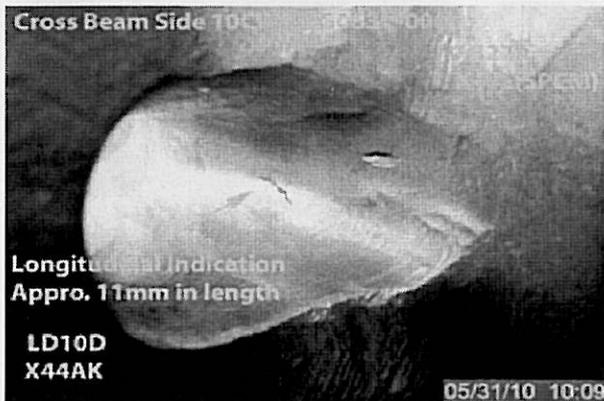
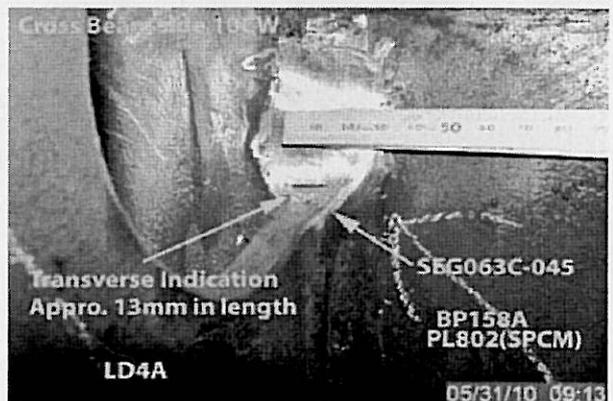
During the Quality Assurance (QA) Magnetic Particle Testing (MT) review of welds located on Segment 10CW, this QA Inspector discovered four (4) linear indications on the following welds:

-Weld #SEG063C-045: One (1) Transverse linear indication measuring approximately 13 mm in length.

-Weld #OBW11-022: One (1) Transverse linear indication measuring approximately 15 mm in length.

-Weld #SEG063C-026: One (1) Transverse linear indication measuring approximately 13 mm in length.

-Weld #SEG063C-006: One (1) Longitudinal linear indication measuring approximately 11 mm in length.

The Notice of Witness Inspection Number (NWIT) is 005839. The indications are located within the area that has been previously tested by ZPMC Quality Control (QC) personnel.

ZPMC acknowledges the four indications were missed and is providing the NDT records show these indications have been removed, repaired and are now acceptable. Please be noticed one indication on OBW11-022 was removed after grinding. ZPMC QA personnel have talked with the head of NDT department to address this issue. Based on this, please consider closure of this NCR.

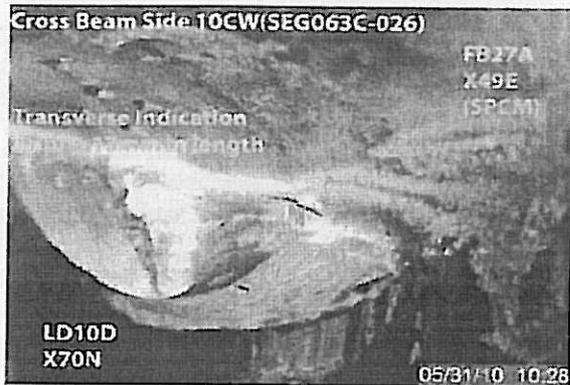
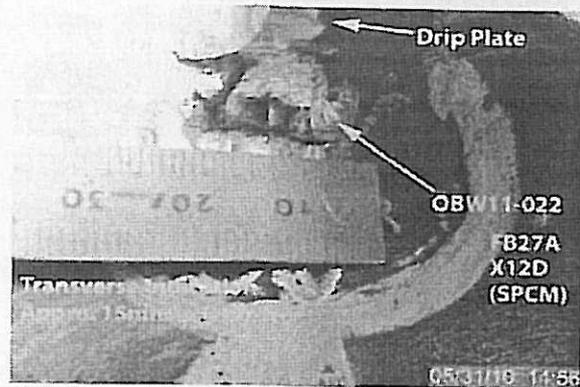
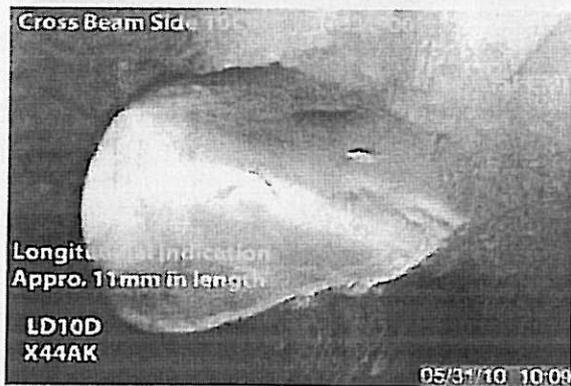
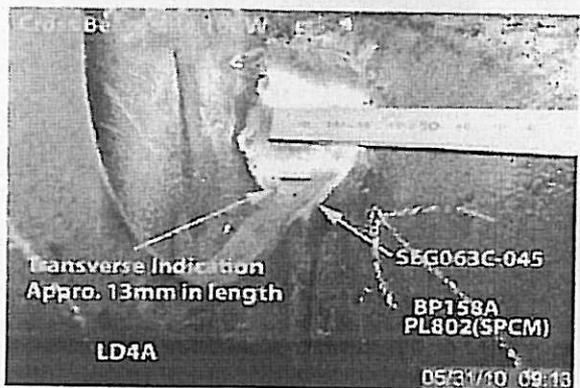
AWS D1.5 (02) Section 6.26.2 – “Welds that are subject to MT in addition to visual inspection shall have no cracks.

Repair said indication and perform NDT required to verify weld quality.

Contractor supplied post repair NDT documentation verifying weld conforms with Contract weld quality requirements.
