Contract #: 04-0120F4Cty: SF/ALA Rte: 80 PM: 13.2/13.9File #: 69.25B**QUALITY ASSURANCE -- NON-CONFORMANCE REPORT****Location:** Changxing Island, Shanghai, P.R. China**Report No:** NCR-000764**Prime Contractor:** American Bridge/Fluor Enterprises, a JV**Date:** 13-Jun-2010**Submitting Contractor:** Zhenhua Port Machinery Company, Ltd (ZPMC), Changxing Island**NCR #:** ZPMC-0726**Type of problem:**

Bridge No: 34-0006**Component:** OBG Segment 7BW FL3 Bottom Panel Stiffeners

Reference Description: ZPMC performed welding without conforming to the approved WPS and ZPMC's Welding Repair Report

Job Name: SAS Superstructure

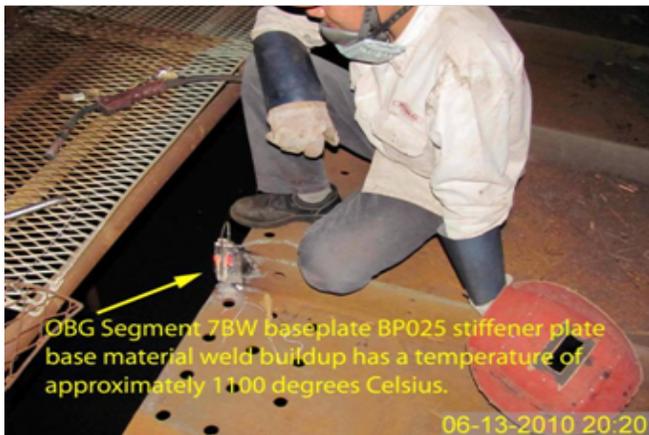
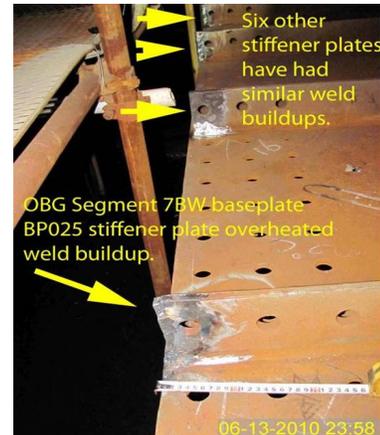
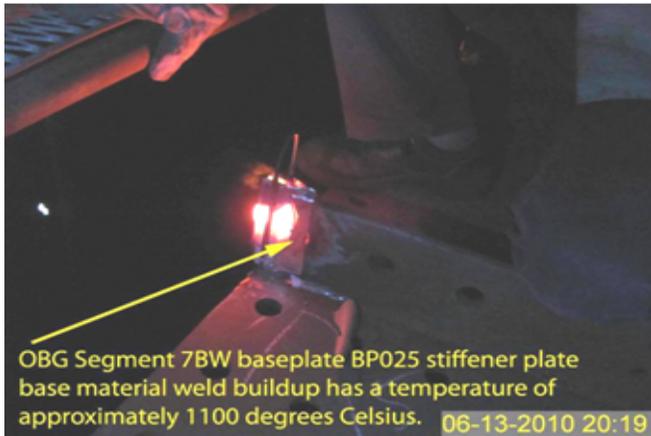
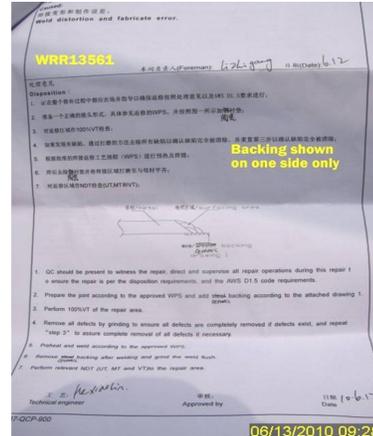
-ZPMC personnel performed weld buildup (buttering) on the ends of the bottom panel stiffeners using weld repair document B-WR13561.

-The welder used two ceramic backing bars, one on each side of the stiffener.

-Multiple weld passes were deposited in the vertical position.

-This QA measured the interpass temperature and observed the weld and adjacent base metal melted an 1100°C Temp stick. Maximum interpass temperature allowed is 230°C.

-This QA noted that the bottom panel and fillet welds joining the stiffeners to the bottom panel are designated on the approved shop drawings as Seismic Performance Critical Material (SPCM).

The additional weld metal added needs to be replaced as the material was superheated and ceramic backing was used to perform buttering.

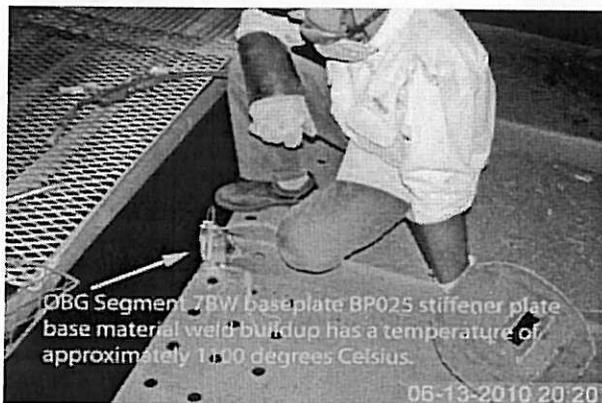
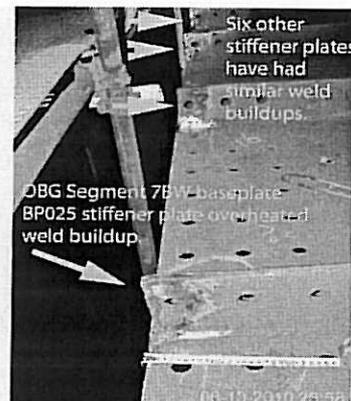
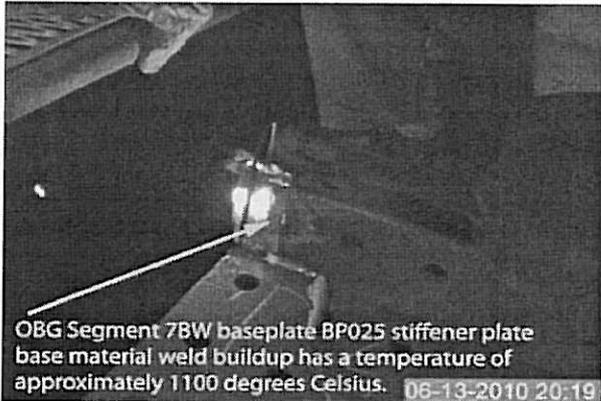
-ZPMC personnel performed weld buildup (buttering) on the ends of the bottom panel stiffeners using weld repair document B-WR13561.

-This QA measured the interpass temperature and observed the weld and adjacent base metal melted an 1100°C Temp stick. Maximum interpass temperature allowed is 230°C.

-This QA noted that the bottom panel and fillet welds joining the stiffeners to the bottom panel are designated on the approved shop drawings as Seismic Performance Critical Material (SPCM).

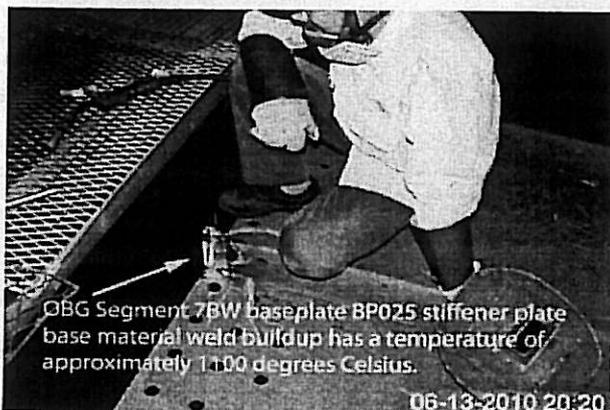
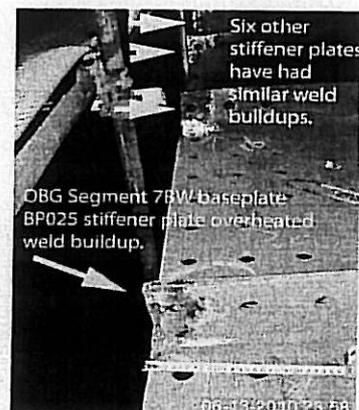
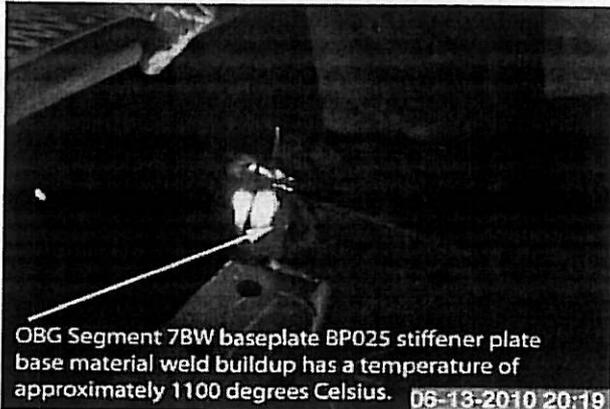
-ZPMC personnel performed weld buildup (buttering) on the ends of the bottom panel stiffeners using weld repair document B-WR13561.

-This QA measured the interpass temperature and observed the weld and adjacent base metal melted an 1100°C Temp stick. Maximum interpass temperature allowed is 230°C.

-This QA noted that the bottom panel and fillet welds joining the stiffeners to the bottom panel are designated on the approved shop drawings as Seismic Performance Critical Material (SPCM).

Remove weld metal and replace in accordance with the approved welding repair procedure.

Welds were removed and replaced. Contractor has submitted subsequent NDT documentation verifying welds are in conformance with Contract weld quality requirements. An internal NCR was also issued by the Contractor in regards to this issue.
