Contract #: 04-0120F4Cty: SF/ALA Rte: 80 PM: 13.2/13.9File #: 69.25B**QUALITY ASSURANCE -- NON-CONFORMANCE REPORT****Location:** Changxing Island, Shanghai, China**Report No:** NCR-000779**Prime Contractor:** American Bridge/Fluor Enterprises, a JV**Date:** 28-Jun-2010**Submitting Contractor:** Zhenhua Port Machinery Company, Ltd (ZPMC), Changxing Island**NCR #:** ZPMC-0741**Type of problem:**

Reference Description: UT Missed indication by QA**Description of Non-Conformance:**

Job Name: SAS Superstructure
Document No: 05.03.06-000737

Welding Repair Report

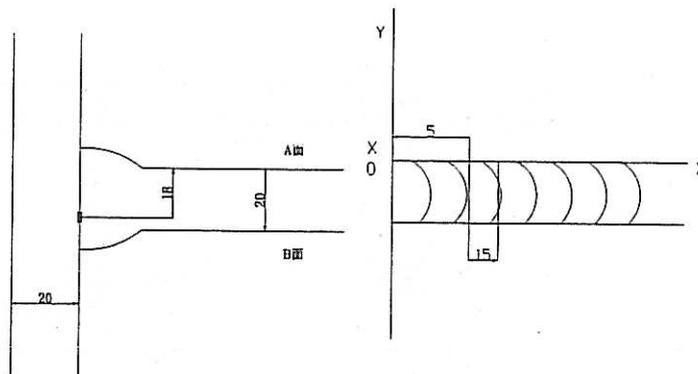
WELD NUMBER: 21TR4-003-005

Rejected indication found by ultrasonic inspection is less than the maximum allowance aggregate length.

(UT探伤发现的缺陷总长度小于最大允许长度。) 21TR4-003-005

1. Did not clear the weld pass completely in time.

1. Gouge or grind from nearer side from metal edge ($D \leq 0.65T$, "D" is depth of defects, "T" is thickness of metal) to remove all defects;
2. Follow repair WPS for joint preparation, preheat, and weld deposit;
3. Verify with VT no defects remain in the weld joint prior to welding;
4. Grind the repaired area flush with base metal or the adjacent weld;
5. Check the welds according to the working drawings.

1. Improve monitoring of welding and interpass cleaning.
