QUALITY ASSURANCE -- NON-CONFORMANCE REPORT

Report No: NCR-000788

Component: West Shaft: Lift 2 Gusset Plate

Reference Description: Missed MT indication

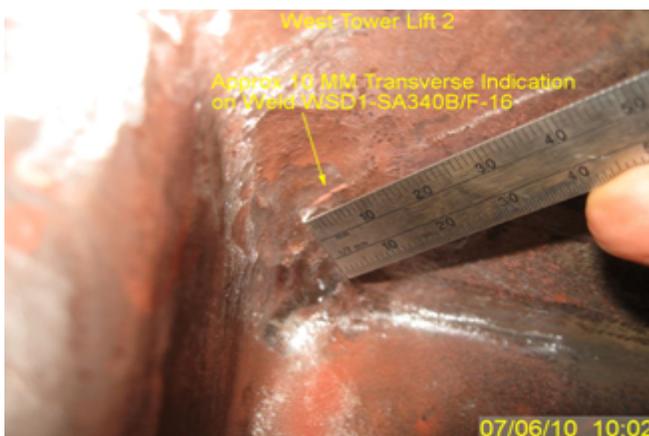
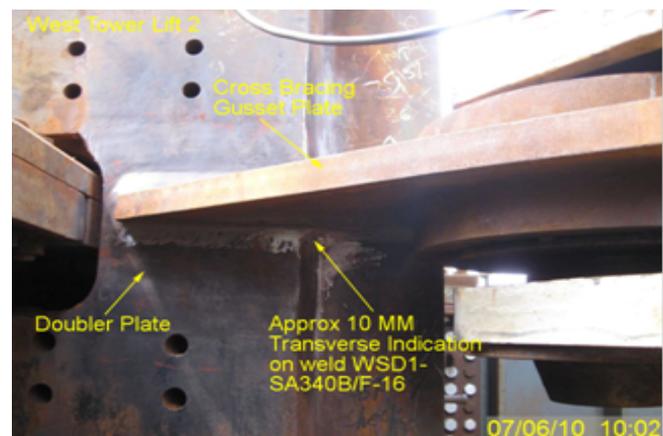
During Magnetic Particle Testing (MT) review of welds on West Tower Lift 2, Caltrans Quality Assurance Inspector (QA) discovered the following issues:

-One transverse indication (crack) measuring approximately 10mm in length in PJP weld between gusset plate and doubler plate

-The weld is identified as WSD1-SA340B/F-16.

The Notice of Witness Inspection Number (NWIT) is #06134. The indication is located within the area that has been previously tested and accepted by ZPMC Quality Control (QC) personnel. As per Contract, 100% MT inspection is required for this weld.

Reference Resolution: ZPMC has repaired the indications missed and is submitting the CWR and NDT used at the time.

ZPMC has repaired the indications missed and is submitting the CWR and NDT used at the time. ZPMC has discussed this issue with both their inspectors and productions staff to eliminate the indications during production and also after during inspection. Based on this ZPMC requests closure of this NCR.
