Contract #: 04-0120F4
 Cty: SF/ALA Rte: 80 PM: 13.2/13.9
 File #: 69.25B

QUALITY ASSURANCE -- NON-CONFORMANCE REPORT

Report No: NCR-000791

Reference Description: Lift 4 Strut (ND1-STSA4-6-127M-1): Missed UT Indication

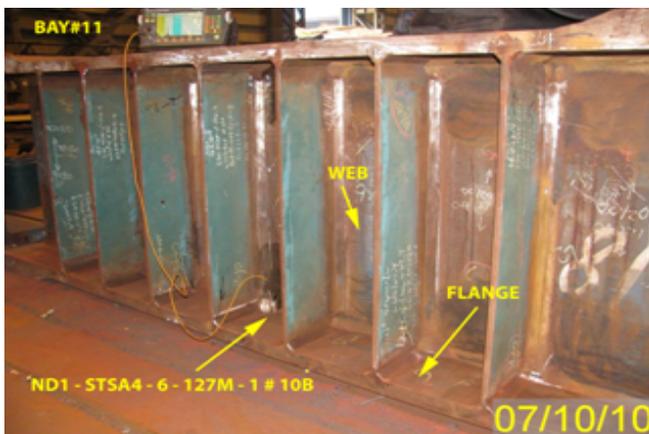
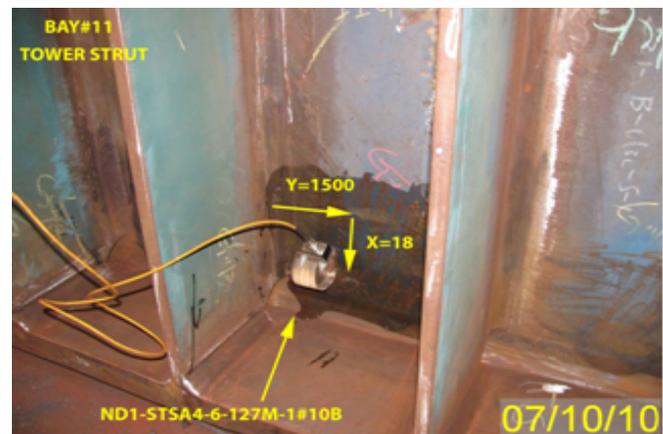
One (1) Class "A" non conforming longitudinal indication measuring approximately 15 mm in length. The weld is a complete joint penetration (CJP) corner joint, joining Web to Flange and is identified as ND1-STSA4-6-127M-1.

The discontinuity rating is +9, Class "A" and reject.

Depth of the discontinuity from face B is approximately 15 mm, and Y location was 1500mm.

The indication is in an area previously tested and accepted by ZPMC QC UT technicians.

Reference Resolution: ZPMC has repaired the missed indication and is providing the WRR and NDT performed after the repair to show the weld is acceptable.

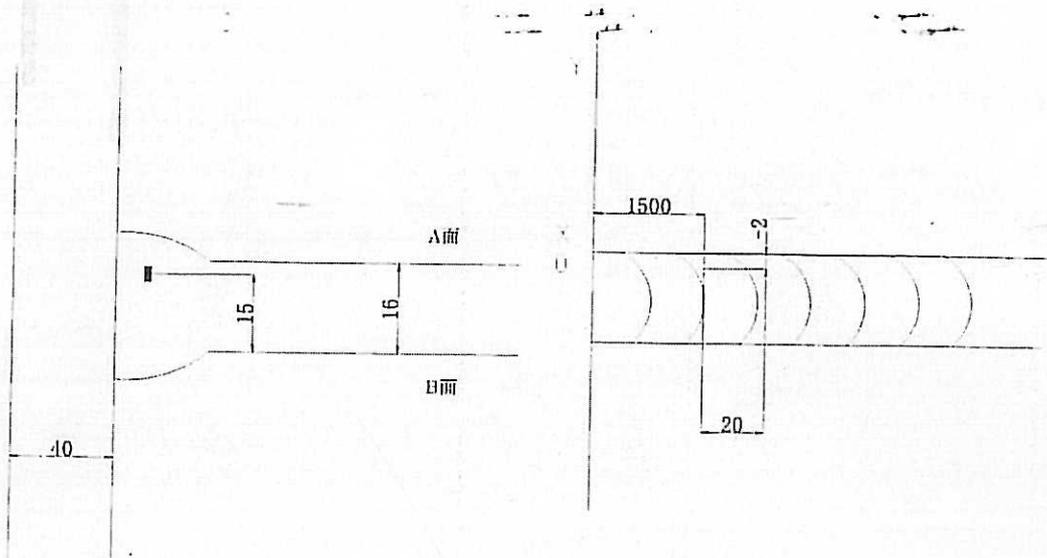
WELD NUMBER: ND1-STSA4-6-127M-1-10A/B

Rejected indication found by ultrasonic inspection is less than the maximum allowance aggregate length.

- 1、 碳刨后,焊接接头没有有效打磨;
 - 2、 起弧和收弧没有交错布置,以将焊渣减少到最少;
 - 3、 焊道间没有有效的清理.
- 1.The weld joint was not ground sufficiently after arc-gouging.
 2. The arc starts and stops were not staggered to minimize slag entrapment.
 3. Interpass cleaning was not performed properly.

- 1、碳刨后的接头位置打磨圆滑过渡，保证每道焊缝的接头可以交错布置；
 - 2、认真仔细检查每道焊缝和加强焊道的清理；
 - 3、焊缝中所有的焊渣全部去除后，表面的缺陷全部打磨干净。
1. The joint shall be ground to a smooth transition to ensure that arc starts and stops are in a staggered Arrangement.
 2. QC shall inspect the weld passes more carefully and enforcing interpass cleaning.
 3. All weld slag shall be removed and surface defects ground during interpass cleaning.
