QUALITY ASSURANCE -- NON-CONFORMANCE REPORT

Report No: NCR-000796

Welding	Concrete	Other	
Welding	Curing	Procedural	Bridge No: 34-0006
Joint fit-up	Coating	Other	Component: Longitudinal Diaphragm LD3030-001
Procedural	Procedural	Description:

Reference Description: Heat Straightening without Prior Approval from the Engineer

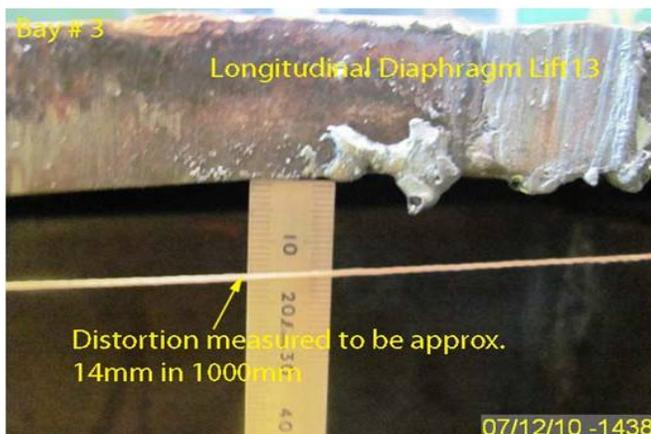
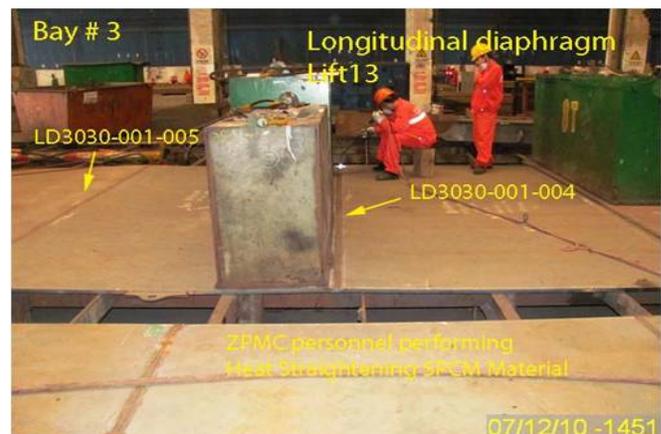
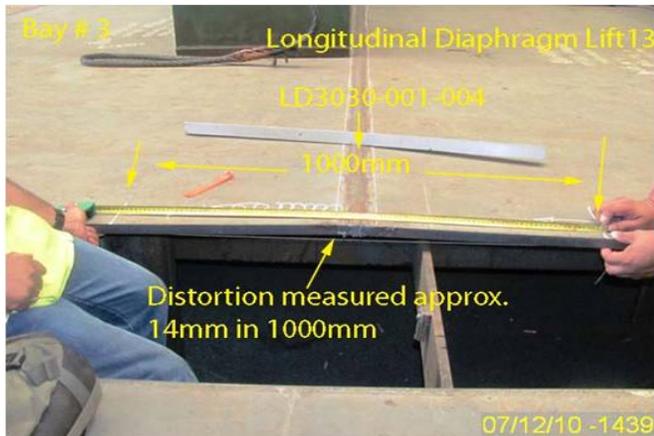
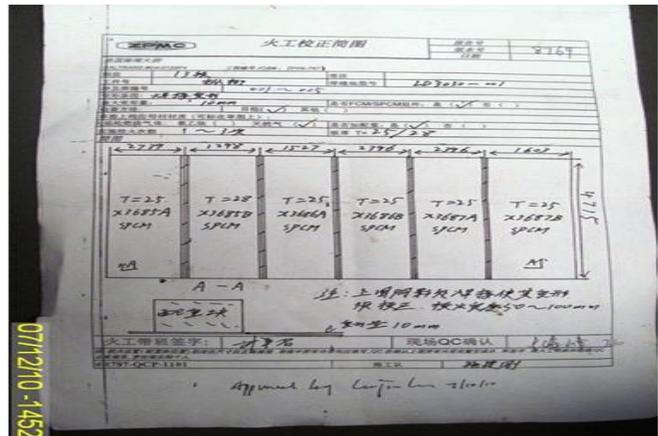
During Quality Assurance (QA) in-process observations of the fabrication of Longitudinal diaphragm LD3030-001, QA discovered the following issue:

- ZPMC personnel performing heat straightening on distorted member without prior Engineer's approval.
- The Longitudinal Diaphragm is identified as LD3030-001.
- The plates are identified as X3685A (SPCM), X3685B (SPCM), X3686A (SPCM), X3686B (SPCM), X3687A (SPCM), and X3687B (SPCM).
- The deviation from flat as measured by QA was 14mm in 1000mm.
- The Material thickness is 25 mm and 28 mm.
- This Longitudinal Diaphragm is located in Sub assembly Bay#3.

For further information, please see the attached pictures below.

AWS D1.5/2002 Section 3.7.3: "Members distorted by welding shall be heat straightened by mechanical means or by carefully supervised application of a limited amount of localized heat as approved by the Engineer".

Caltrans Special Provisions Section 8-3: "For material more than 16 mm, the Contractor shall not heat straighten members more than 3 in 1000 without prior approval of the Engineer".

Reference Resolution: The length of the plate is 12 meters long, so the plate would have to be out of flatness greater than 36mm before Engineer approval is needed.

Measuring determining flatness using 1 meter is not sufficient to determine the if the flatness is out of tolerance, see Item 11.2.2.b from Letter 05.03.01-000419. The tolerance referenced in Section 8-3, Special Provisions (3 over 1000mm) should be used as a ratio when the length of the plate is longer than 1 meter. In this case the length of the plate is 12 meters long, so the plate would have to be out of flatness greater than 36mm before Engineer approval is needed. Based on this clarification and that ZPMC had a valid HSR1 in hand at the time, ZPMC requests this NCR be closed.

The proposed resolution is acceptable. This NCR is considered closed.

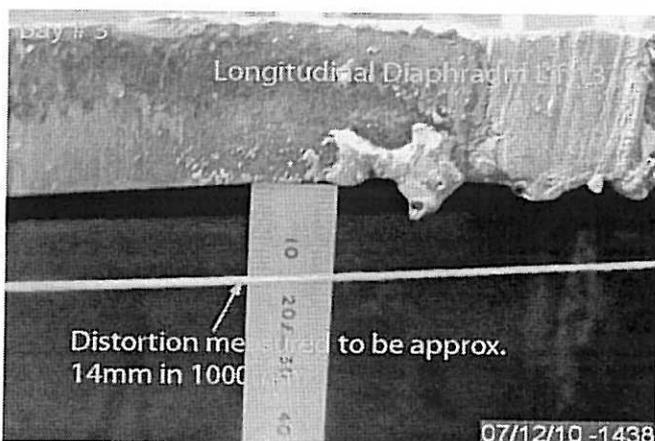
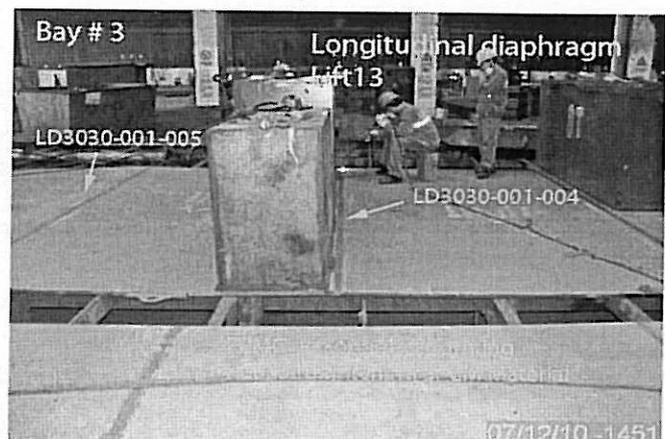
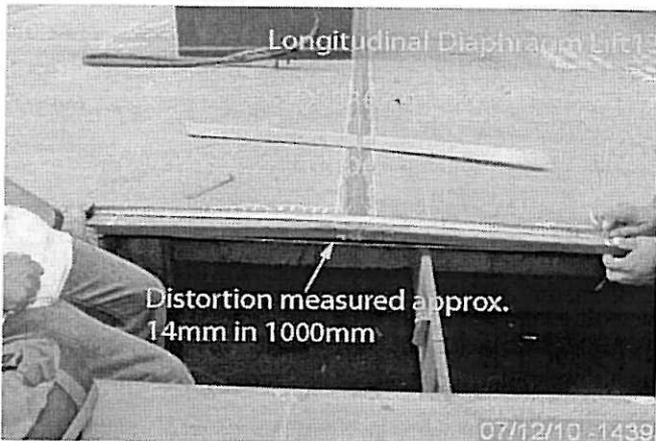
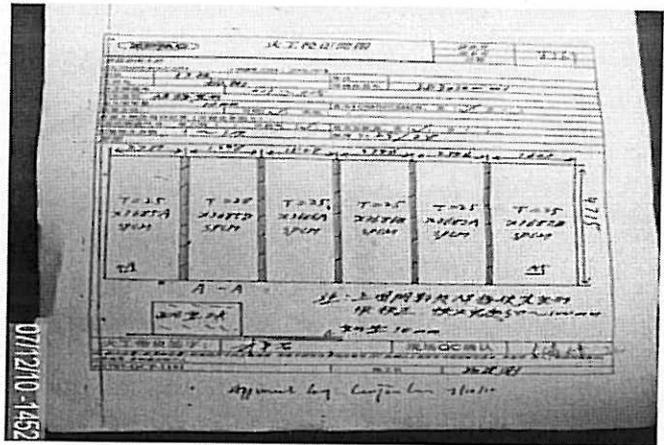
During Quality Assurance (QA) in-process observations of the fabrication of Longitudinal diaphragm LD3030-001, QA discovered the following issue:

- ZPMC personnel performing heat straightening on distorted member without prior Engineer's approval.
- The Longitudinal Diaphragm is identified as LD3030-001.
- The plates are identified as X3685A (SPCM), X3685B (SPCM), X3686A (SPCM), X3686B (SPCM), X3687A (SPCM), and X3687B (SPCM).
- The deviation from flat as measured by QA was 14mm in 1000mm.
- The Material thickness is 25 mm and 28 mm.
- This Longitudinal Diaphragm is located in Sub assembly Bay#3.

For further information, please see the attached pictures below.

AWS D1.5/2002 Section 3.7.3: "Members distorted by welding shall be heat straightened by mechanical means or by carefully supervised application of a limited amount of localized heat as approved by the Engineer".

Caltrans Special Provisions Section 8-3: "For material more than 16 mm, the Contractor shall not heat straighten members more than 3 in 1000 without prior approval of the Engineer".

After review, it has been determined that this NCR was issued in error and will be rescinded.
