QUALITY ASSURANCE -- NON-CONFORMANCE REPORT

Location: Changxing Island, Shanghai, P.R. China**Report No:** NCR-000807**Prime Contractor:** American Bridge/Fluor Enterprises, a JV**Date:** 19-Jul-2010**Submitting Contractor:** Zhenhua Port Machinery Company, Ltd (ZPMC), Changxing Island**NCR #:** ZPMC-0769**Type of problem:**

Reference Description: Lift 8 East was loaded onto the ship without final paint acceptance. Some areas requiring paint inspection are no longer accessible for inspection.

Contract #: 04-0120F4Cty: SF/ALA Rte: 80 PM: 13.2/13.9File #: xx.25A**QUALITY ASSURANCE -- NON-CONFORMANCE RESOLUTION****Location:** Changxing Island, Shanghai, P.R. China**Report No:** NCS-000740**Prime Contractor:** American Bridge/Fluor Enterprises, a JV**Date:** 27-Sep-2010**Submitting Contractor:** Zhenhua Port Machinery Company, Ltd (ZPMC), Changxing Island **NCR #:** ZPMC-0769**Type of problem:**

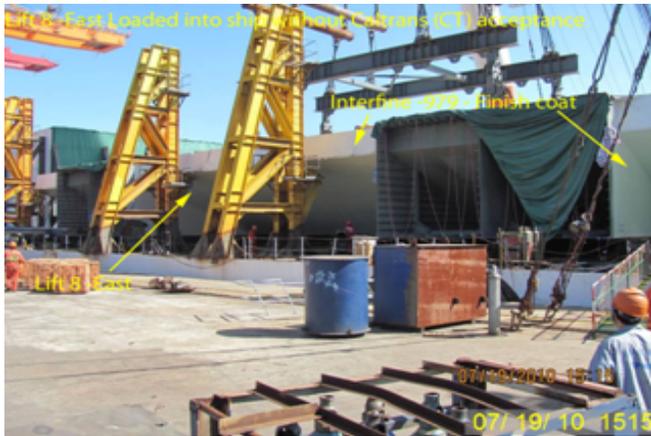
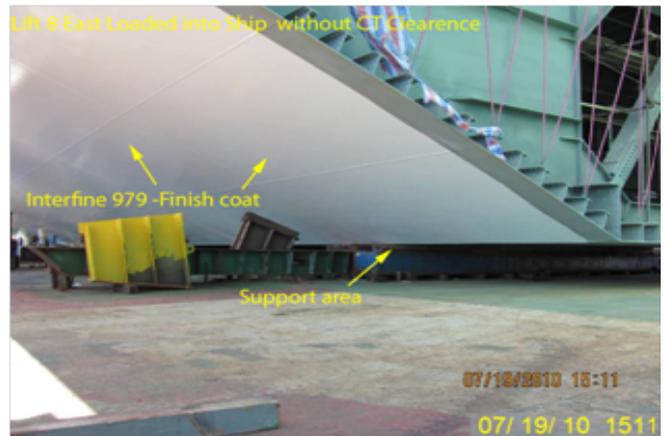
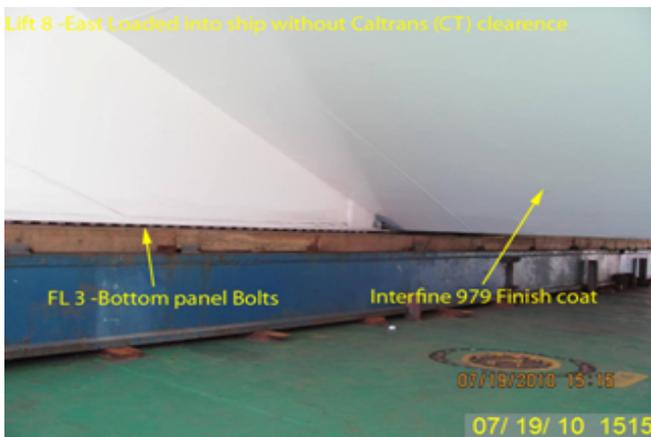
- Lift 8 East was loaded onto the ship without final paint acceptance.
- Before its lifting onto the ship, the record shows that the external Interfine 979 Finish coat was rejected 3 times due to not meeting the dry-film thickness (DFT) requirement, grit contamination, orange peeling and issues with dry spray.
- ZPMC did not notify Caltrans or ABF for final inspection acceptance of the previously rejected areas.

- The final coating on the bolt heads at the FL3 bottom panels (PP 62, 63, 64, 68, 69, and 70) were not inspected by Caltrans or ABF prior to loading.
- High DFT at the edges of the two repaired touch-up areas (approximately 200mmx250mm and 300mmx150mm) were not inspected prior to loading. They are located at the FL3 bottom panel between PP 68 to 69 and PP 69 to 70.
- High DFT observed at the edges of the repaired touch-up area (approximately 250mmx300mm) was not inspected prior to loading. It is located at the bottom panel near PP 70.

- After loading, access was limited to a clearance of approximately 600mm (ship deck to bottom plate).
- No inspection access at the supported areas (Section of the Bottom Panel and the FL3 Bottom Panel).

The areas referenced in the NCR were sanded and repainted prior to the shipment leaving. Attached is the QA Approval form for painting which verifies that Lift 8 East was acceptable. ZPMC requests closure based on these documents.

Contractor completed the required repairs and re-painted area prior to the shipment. QA approval form was submitted verifying paint was in conformance with Contract specifications prior to shipping.
