Contract #: 04-0120F4Cty: SF/ALA Rte: 80 PM: 13.2/13.9File #: 69.25B

QUALITY ASSURANCE -- NON-CONFORMANCE REPORT

Location: Changxing Island, Shanghai, China**Report No:** NCR-000814**Prime Contractor:** American Bridge/Fluor Enterprises, a JV**Date:** 25-Jul-2010**Submitting Contractor:** Zhenhua Port Machinery Company, Ltd (ZPMC), Changxing Island**NCR #:** ZPMC-0776**Type of problem:**

Subject: NCR No. ZPMC-0776

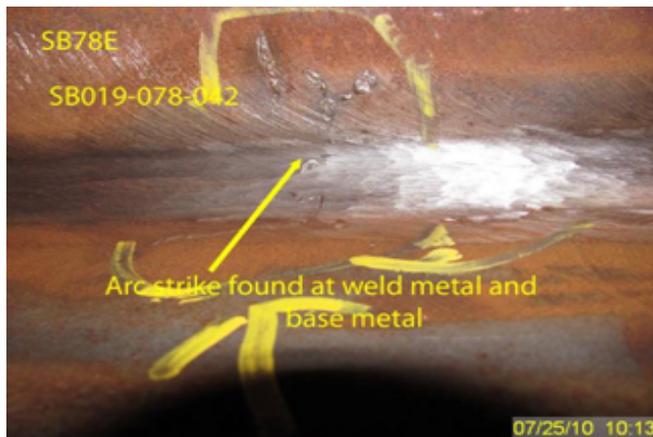
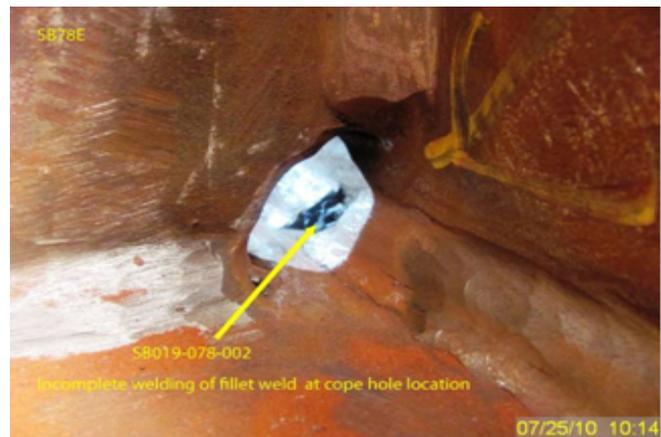
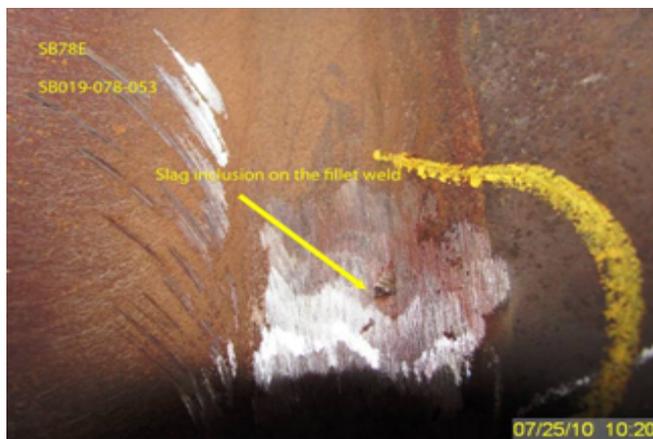
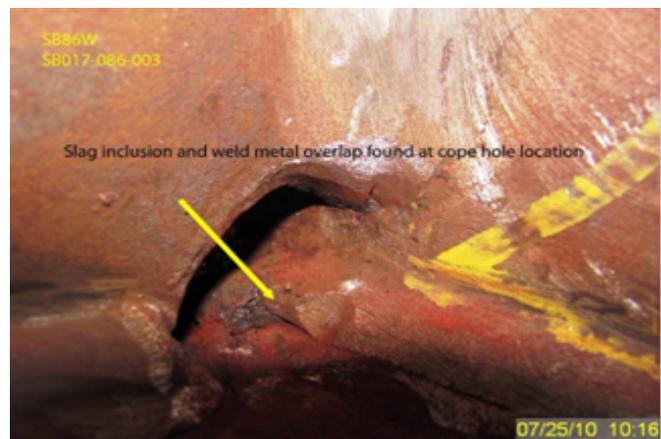
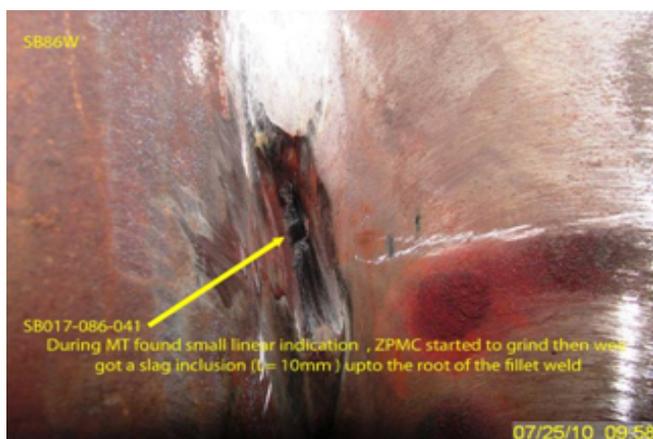
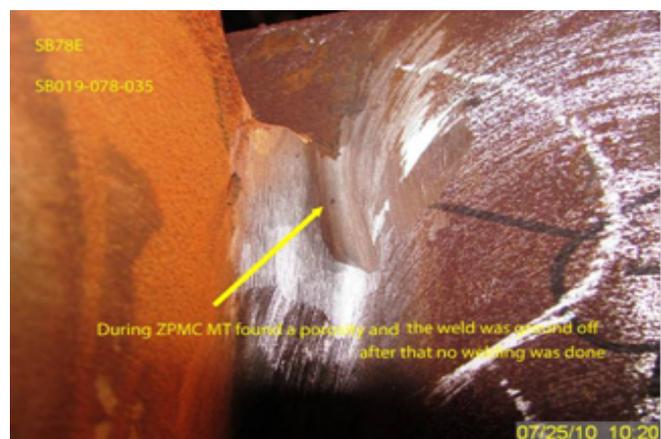
During Visual Testing (VT) and Magnetic Particle Testing (MT) verification of Suspender Brackets SB86W (for Segment 10AW) and SB78E (for Segment 9CE), this Caltrans Quality Assurance (QA) Inspector discovered the following issues:

SB86W

- During MT of the fillet weld, this QA observed 1 linear indication on weld identified as SB017-086-041.
- The indication was ground by ZPMC personnel and a 10mm long slag inclusion was observed near the root of the fillet weld.
- During QA VT of Cope holes, this QA observed slag inclusion, underfill and overlap at weld identified as SB017-086-003.

SB78E

- During VT of this weld, QA observed an incomplete weld near the cope hole location. The fillet weld is identified as SB019-078-002.
- Arc strike was observed on the weld and base metal. This fillet weld is identified as SB019-078-042.
- An approximately 5mm deep grinding mark observed on a fillet weld identified as SB019-078-035.
- Slag inclusion was observed on a fillet weld identified as SB019-078-053.
- Welds mentioned above are fillet welds connecting the suspender bracket center web plate to the vertical stiffeners.
- The Notice of Witness Inspection Number (NWIT) is 006276.
- The indications and VT issues are clearly marked on the material near the weld.
- The indications and VT issues are located within the area that has been previously tested and accepted by ZPMC Quality Control (QC) personnel.

-The OBG Suspender brackets are located inside Fabrication Bay 19.

AWS D1.5 (02) - 3.7.2.3: Excessive Weld Porosity, Excessive Slag Inclusions, Incomplete Fusion. Unacceptable portions shall be removed and re-welded.

AWS D1.5 (02) - 3.10: Arc Strikes: Care shall be taken to avoid arc strikes outside the area of permanent welds on any base metal. Cracks or blemishes caused by arc strikes shall be ground to remove all of the defect.

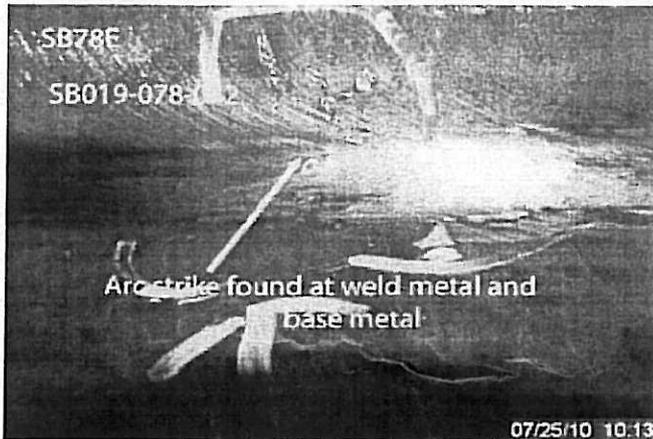
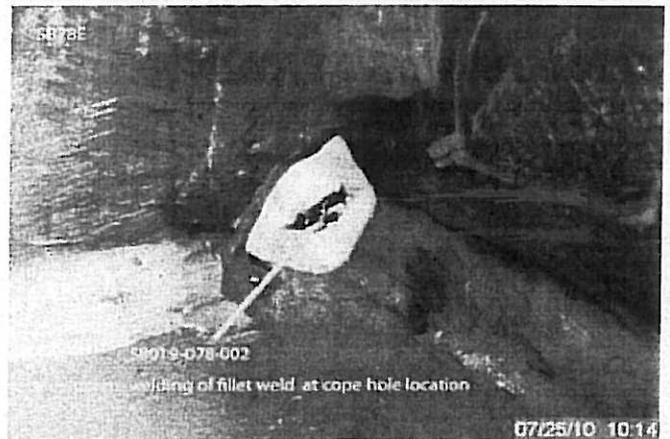
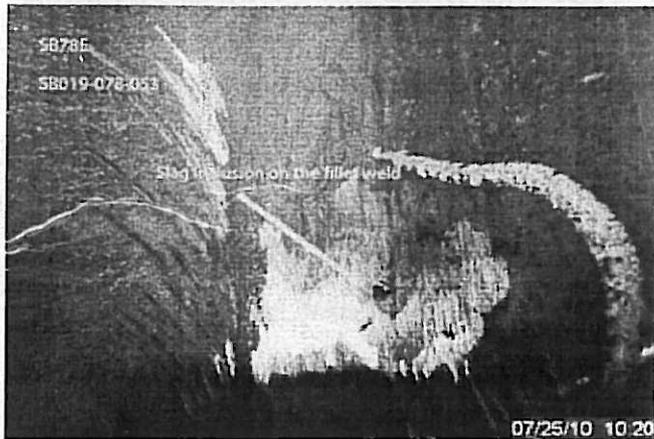
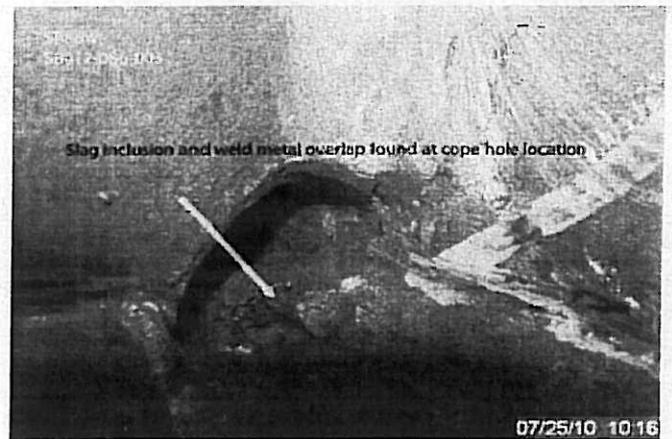
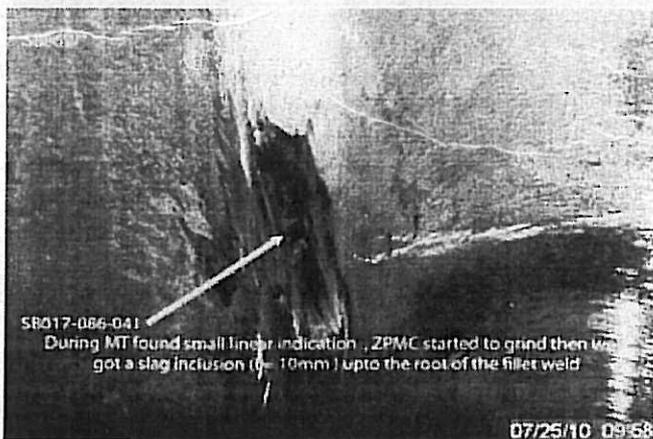
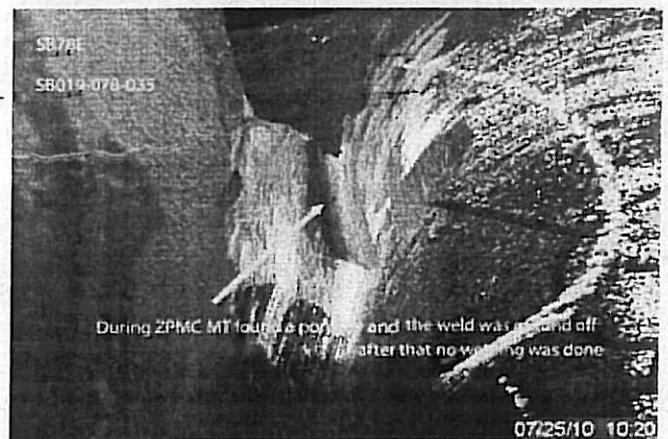
During Visual Testing (VT) and Magnetic Particle Testing (MT) verification of Suspender Brackets SB86W (for Segment 10AW) and SB78E (for Segment 9CE), this Caltrans Quality Assurance (QA) Inspector discovered the following issues:

-During MT of the fillet weld, this QA observed 1 linear indication on weld identified as SB017-086-041.

-The indication was ground by ZPMC personnel and a 10mm long slag inclusion was observed near the root of the fillet weld.

-During QA VT of Cope holes, this QA observed slag inclusion, underfill and overlap at weld identified as SB017-086-003.

-During VT of this weld, QA observed an incomplete weld near the cope hole location. The fillet weld is identified as SB019-078-002.

-Arc strike was observed on the weld and base metal. This fillet weld is identified as SB019-078-042.

-An approximately 5mm deep grinding mark observed on a fillet weld identified as SB019-078-035.

-Slag inclusion was observed on a fillet weld identified as SB019-078-053.

-The OBG Suspender brackets are located inside Fabrication Bay 19.

AWS D1.5 (02) - 3.7.2.3: Excessive Weld Porosity, Excessive Slag Inclusions, Incomplete Fusion. Unacceptable portions shall be removed and re-welded.

AWS D1.5 (02) - 3.10: Arc Strikes: Care shall be taken to avoid arc strikes outside the area of permanent welds on any base metal. Cracks or blemishes caused by arc strikes shall be ground to remove all of the defect.

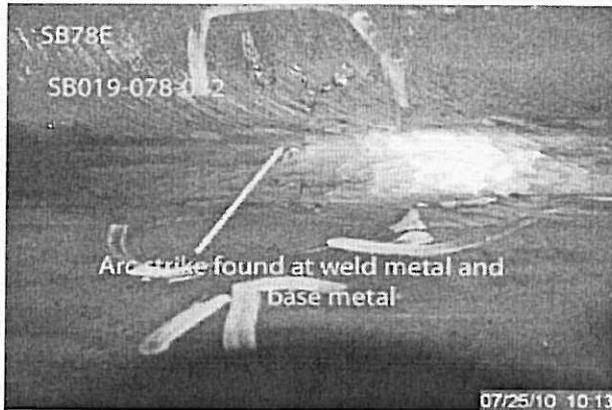
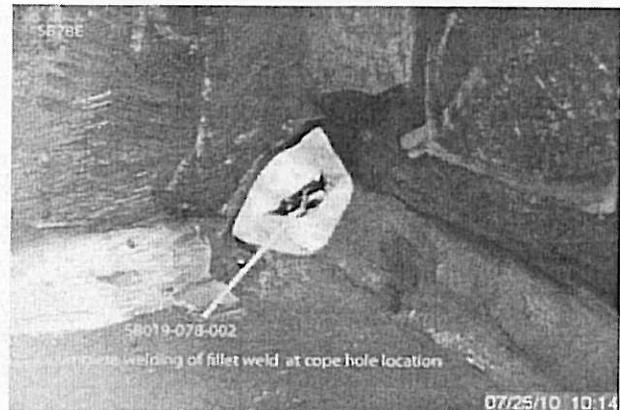
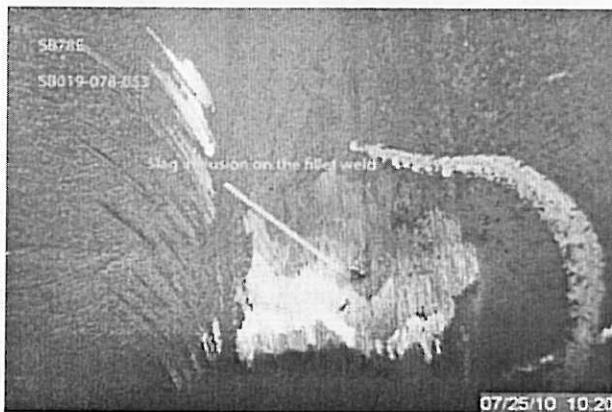
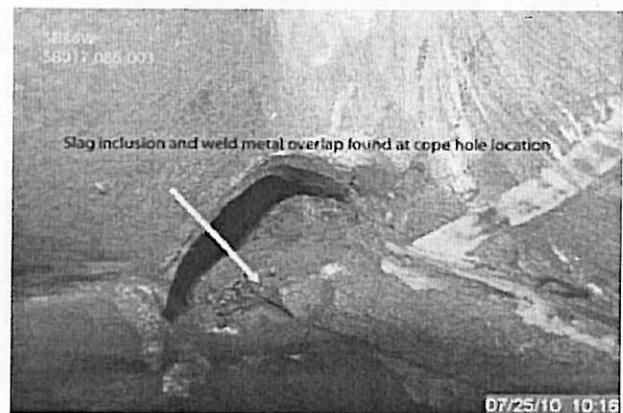
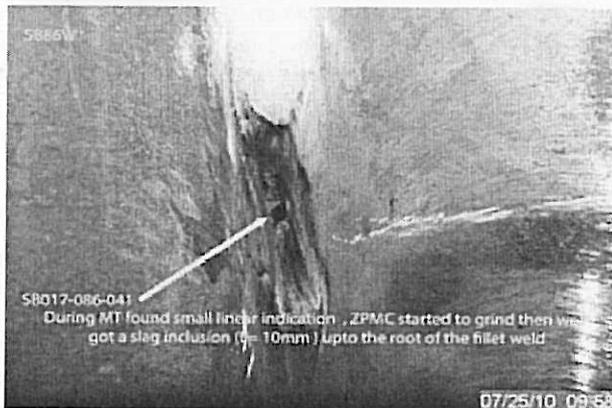
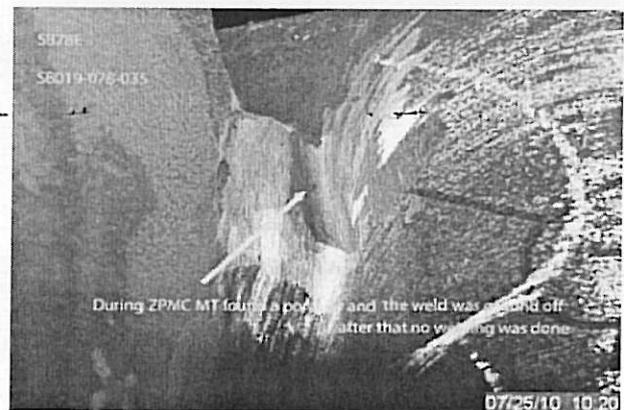
- During MT of the fillet weld, this QA observed 1 linear indication on weld identified as SB017-086-041.
- The indication was ground by ZPMC personnel and a 10mm long slag inclusion was observed near the root of the fillet weld.
- During QA VT of Cope holes, this QA observed slag inclusion, underfill and overlap at weld identified as SB017-086-003.

- During VT of this weld, QA observed an incomplete weld near the cope hole location. The fillet weld is identified as SB019-078-002.
- Arc strike was observed on the weld and base metal. This fillet weld is identified as SB019-078-042.
- An approximately 5mm deep grinding mark observed on a fillet weld identified as SB019-078-035.
- Slag inclusion was observed on a fillet weld identified as SB019-078-053.
- Welds mentioned above are fillet welds connecting the suspender bracket center web plate to the vertical stiffeners.
- The Notice of Witness Inspection Number (NWIT) is 006276.
- The indications and VT issues are clearly marked on the material near the weld.
- The indications and VT issues are located within the area that has been previously tested and accepted by ZPMC Quality Control (QC) personnel.

-The OBG Suspender brackets are located inside Fabrication Bay 19.

- Perform necessary repairs with NDT verification.
- Address the issue with the CWI on the shop floor.

- The welds were repaired with VT and MT records for verification.
- ZPMC QA personnel talked with the CWI on the shop floor to prevent future occurrence.
