Contract #: 04-0120F4
 Cty: SF/ALA Rte: 80 PM: 13.2/13.9
 File #: 69.25B

QUALITY ASSURANCE -- NON-CONFORMANCE REPORT

Location: Changxing Island, Shanghai, China **Report No:** NCR-000823
Prime Contractor: American Bridge/Fluor Enterprises, a JV **Date:** 02-Aug-2010
Submitting Contractor: Zhenhua Port Machinery Company, Ltd (ZPMC), Changxing Island **NCR #:** ZPMC-0785

Reference Description: Backing bar not continuous for Lift 13 member FB3217A

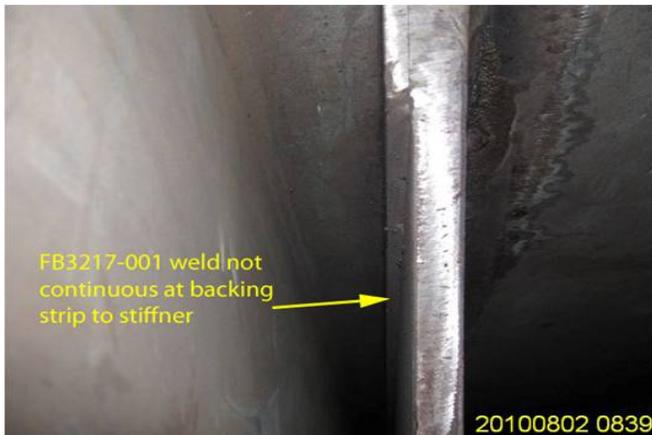
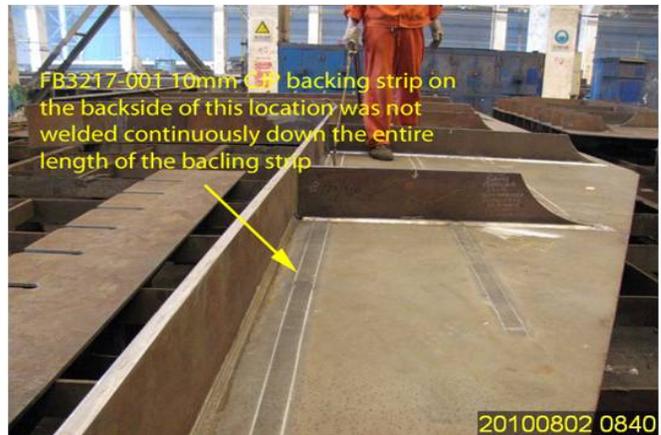
- Backing bar attached with intermittent tack welds.
- AWS requires the backing to be welded continuously for its entire length.
- The weld is identified as FB3217-100-136.
- The weld is a Complete Joint Penetration (CJP) T-joint, joining stiffener plate identified as X4495J to floor beam web plate identified as X4243A.
- The OBG Floor Beam FB3217-001 is located in Bay 2.

The NDT Inspection Notification Sheet is Document No. 06305. The backing strip is located within an area that has been previously tested and accepted by ZPMC Quality Control (QC) personnel. ZPMC's QC personnel are required to perform 100% VT inspection of this weld.

AWS D1.5 (02) Section 3.13.3.2 – “Where the steel backing of longitudinal welds is externally attached to the base metal by welding, such welding shall be continuous for the length of the backing.”

Reference Resolution: ZPMC has completely welded the backing bar to the floorbeam and is providing the VT to show that it is complete. Also included it the UT report for the completed weld.

The backing has been attached to the base material by a continuous weld as required by Contract specifications and AWS D1.5 Section 3.13.4. NDT reports have been submitted verifying the weld in question meets Contract weld quality requirements. An internal NCR was issued in regards to this matter and the welder responsible was counseled on his work practices.

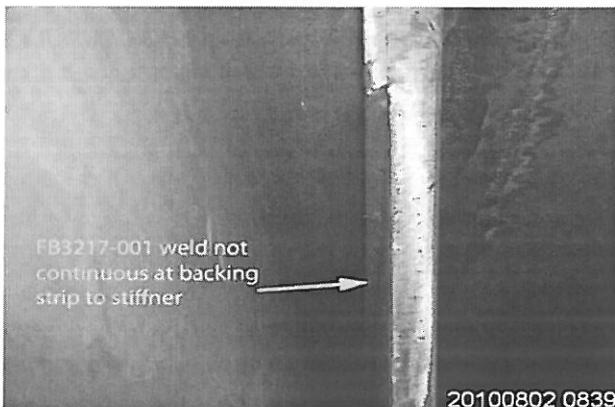
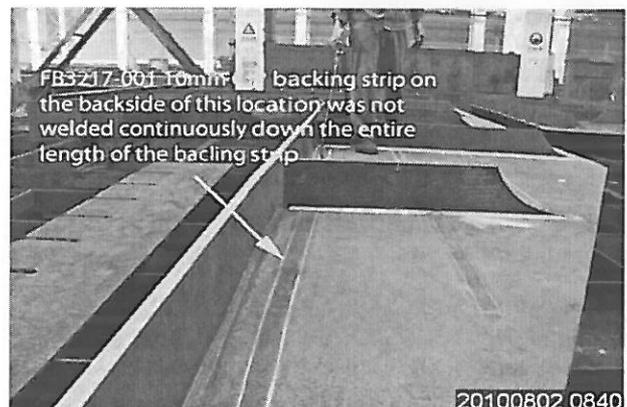
-Backing bar attached with intermittent tack welds.

-The weld is identified as FB3217-100-136.

-The weld is a Complete Joint Penetration (CJP) T-joint, joining stiffener plate identified as X4495J to floor beam web plate identified as X4243A.

The NDT Inspection Notification Sheet is Document No. 06305. The backing strip is located within an area that has been previously tested and accepted by ZPMC Quality Control (QC) personnel. ZPMC's QC personnel are required to perform 100% VT inspection of this weld.

AWS D1.5 (02) Section 3.13.3.2 – “Where the steel backing of longitudinal welds is externally attached to the base metal by welding, such welding shall be continuous for the length of the backing.”
