Contract #: 04-0120F4
 Cty: SF/ALA Rte: 80 PM: 13.2/13.9
 File #: 69.25B

QUALITY ASSURANCE -- NON-CONFORMANCE REPORT

Report No: NCR-000828

Reference Description: West Tower Lift 2: Missed MT Crack on Skin B

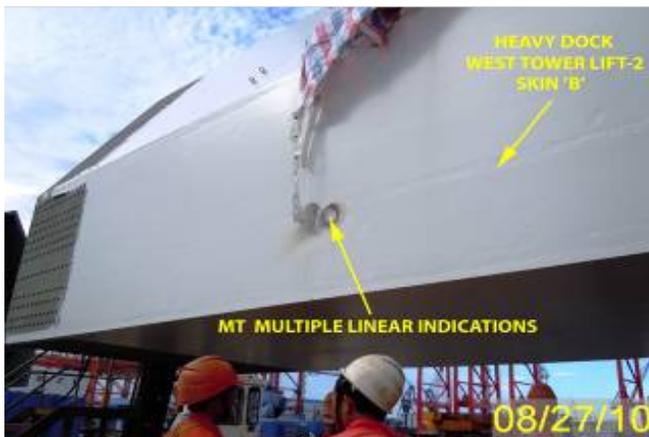
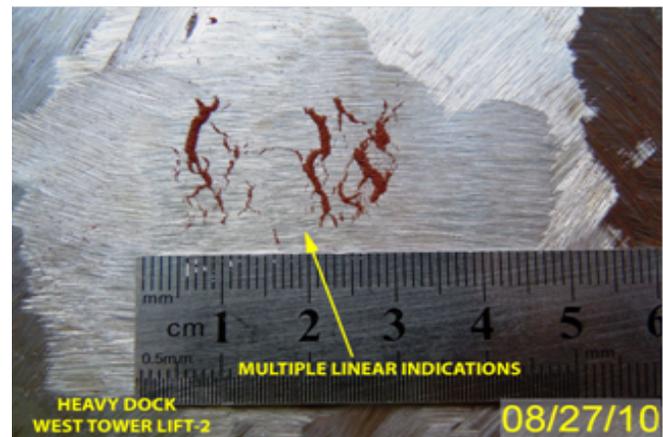
- Cracks found on base material of Skin 'B' external side.
- Location: West Tower Lift-2 Skin 'B', 4380 mm from top of the tower and 560 mm from Skin B/C corner.
- This member is Non-Seismic Performance Critical Member (non SPCM).
- This member is located at the Heavy Dock area.

The Notice of Witness Inspection Number (NWIT) is 006494. These cracks are located inside the area that has been previously tested and accepted by ZPMC Quality Control (QC) personnel. ZPMC's QC personnel performed 100% MT inspection of these welds.

For further information, please see the attached photos and applicable reference below.

ZPMC has repaired the indications and is providing the repair report and NDT performed after to show it is acceptable. To address the missed indications in the tower, ZPMC and ABFJV have combined resources to ensure inspections are performed in a timely but complete way. This merger is underway and the change should decrease the number of missed indications along with the refresher training that ZPMC conducts. Based on this ZPMC requests closure of this NCR.

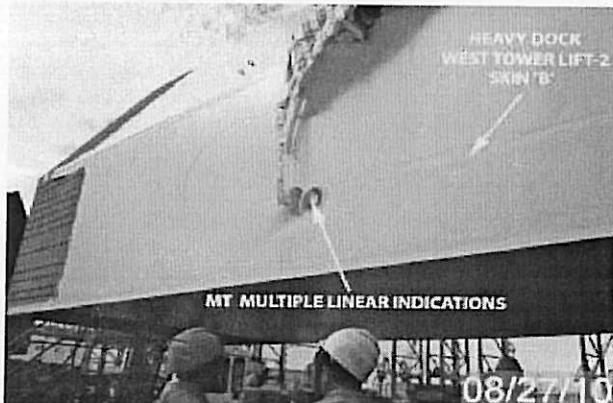
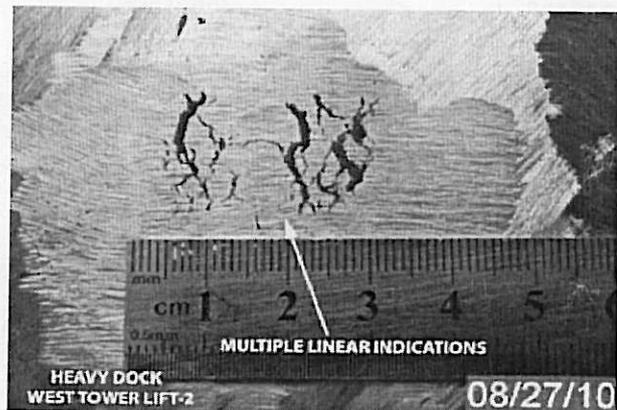
-Cracks found on base material of Skin 'B' external side.

-Location: West Tower Lift-2 Skin 'B', 4380 mm from top of the tower and 560 mm from Skin B/C corner.

The Notice of Witness Inspection Number (NWIT) is 006494. These cracks are located inside the area that has been previously tested and accepted by ZPMC Quality Control (QC) personnel. ZPMC's QC personnel performed 100% MT inspection of these welds.

For further information, please see the attached photos and applicable reference below.

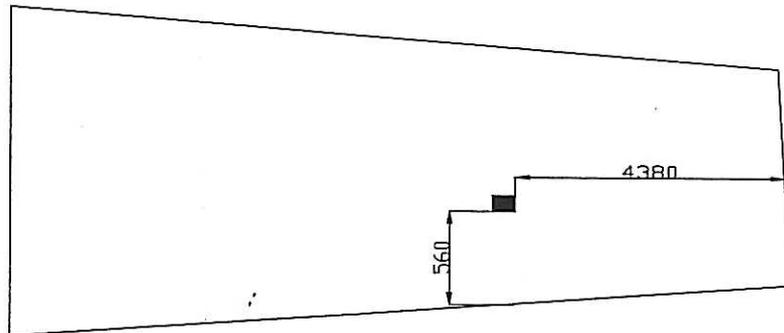
Draft of welding discontinuity:

西塔二吊B面板在报加州冲砂后的返修点时发现一裂纹，长30mm宽10mm深5mm具体如图：
West tower 2nd lifting Skin B, the crack was found after sanding; 30mm in length, 10mm in wide, 5mm in depth, and the details sees the following draft.

Remark: repair area in shadow.

1. 火焰加热时, 水汽没有完全的去掉或者这个区域预热不够;
1. Moisture wasn't completely removed during drying operation (preheating) or the area wasn't preheated sufficiently.

- 1、 Grind smoothly the defect area
- 2、 If User's request ,check with VT or other NDT method to make sure the defect remove completely;
- 3、 Preheat and weld passes temperature according to the approved WPS, it should be 2-3mm than the theory size;
- 4、 Grind the weld area smoothly;
- 5、 Perform NDT of the repair area.

1. QC shall verify sufficient preheat has been applied, to remove moisture, prior to welding.
