QUALITY ASSURANCE -- NON-CONFORMANCE REPORT

Location: Changxing Island, Shanghai, P.R. China**Report No:** NCR-000832**Prime Contractor:** American Bridge/Fluor Enterprises, a JV**Date:** 02-Sep-2010**Submitting Contractor:** Zhenhua Port Machinery Company, Ltd (ZPMC), Changxing Island**NCR #:** ZPMC-0794**Type of problem:**

Reference Description: QA found some missed UT indications and a MT crack after ZPMC had tested and accepted these weld in Segment 11DE

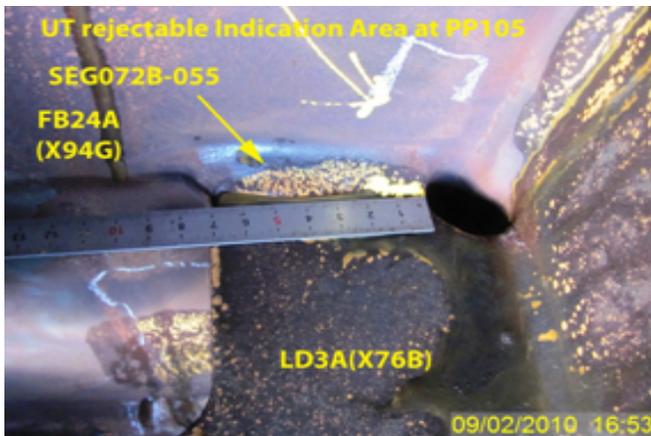
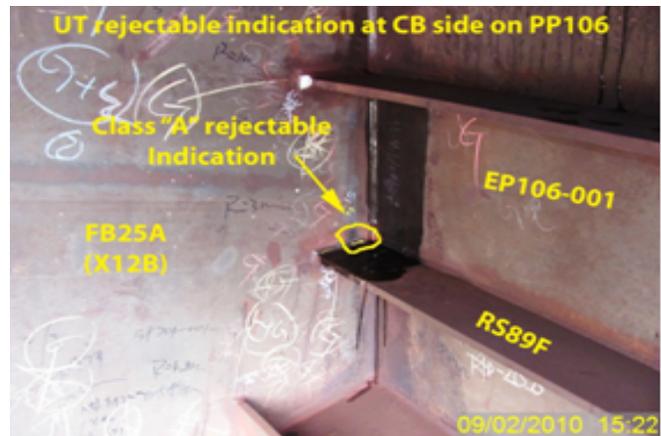
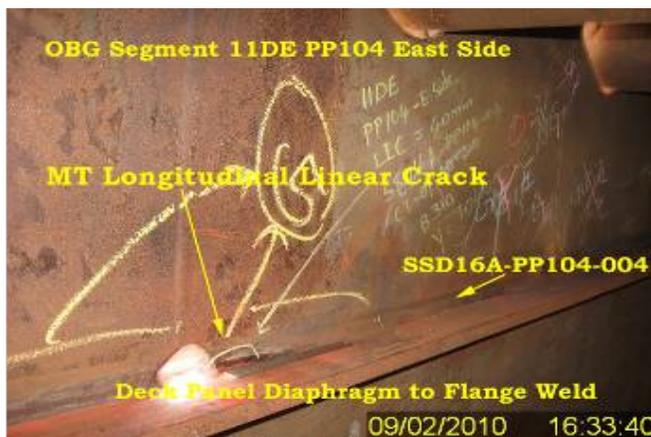
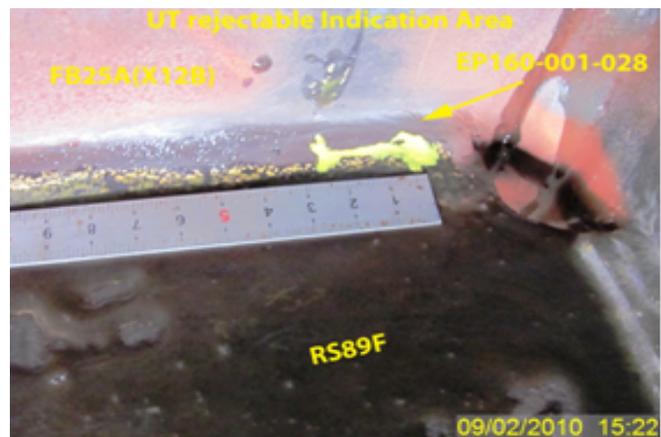
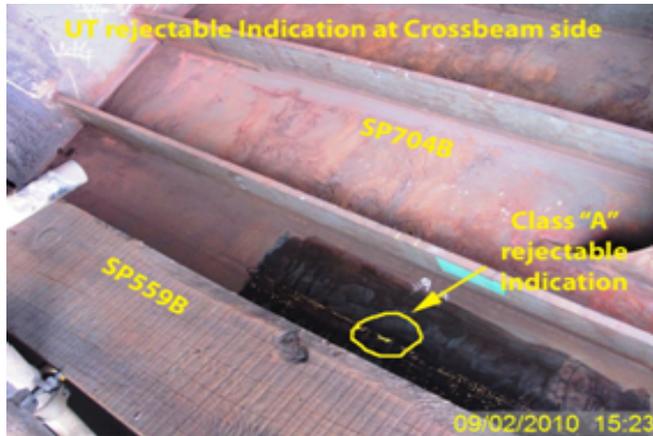
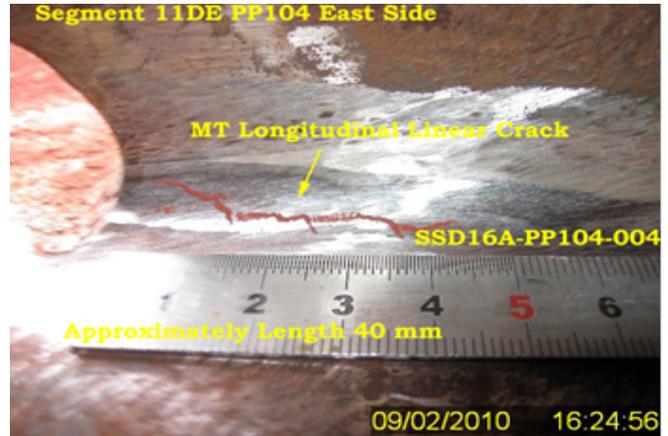
During the Quality Assurance (QA) Ultrasonic Testing (UT) review of welds located on Orthotropic Box Girder (OBG) segment 11DE, this QA Inspector discovered the following issues:

- A total of four (4) longitudinal class "A" rejectable indications measuring approximately 15mm~25mm in length.
- The welds are identified as SEG072A-002, SEG072A-008, SEG072B-055 and EP160-001-028.

- The indication dB rating for joint SEG072A-002 is a +9 and for joint SEG072A-008 is a +4.
- The indication dB rating for joint SEG072B-055 is +9.
- The indication dB rating for joint EP160-001-028 is +3.

- The depth of the indications are approximately 9mm~15mm.
- Welds SEG072A-002, SEG072A-008 are joining Side Plate to Side plate and EP160-001-028 is at PP106, joining Edge Plate stiffener to corner assembly Diaphragm.

- One (1) MT Longitudinal Linear Crack measuring approximately 40 mm in length.
- The weld is identified as SSD16A-PP104-004 and is located at panel point (PP) 104 East side.
- This weld is a fillet weld that joins the Deck Panel Diaphragm to the Web flange.
- Y location is 7040mm measured from the termination of the weld on the Cross Beam side.
- The Linear Crack is clearly marked on the material near the weld.
- The Deck Panel Diaphragm and Flange weld are identified as Non Seismic Performance Critical Members (Non-SPCM).
- OBG segment 11DE is located outside at the north end of Bay 14.

The Notice of Witness Inspection Number (NWIT) is 006556. This Linear Crack is located within an area that has been previously tested by ZPMC Quality Control (QC) personnel. As per contract documents ZPMC is required to perform 100% Magnetic Particle Testing (MT) of this weld.

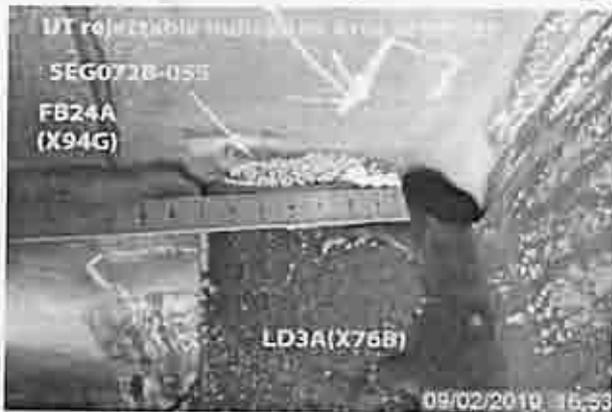
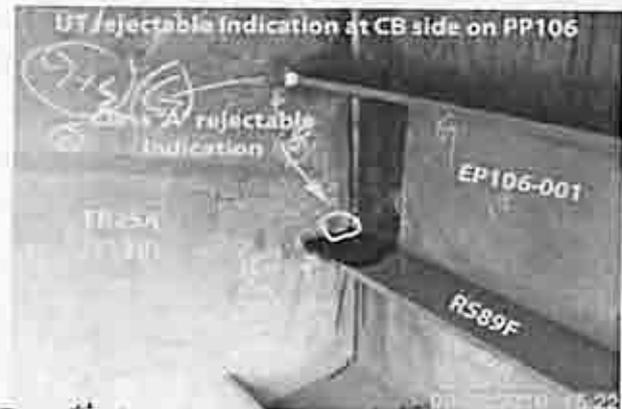
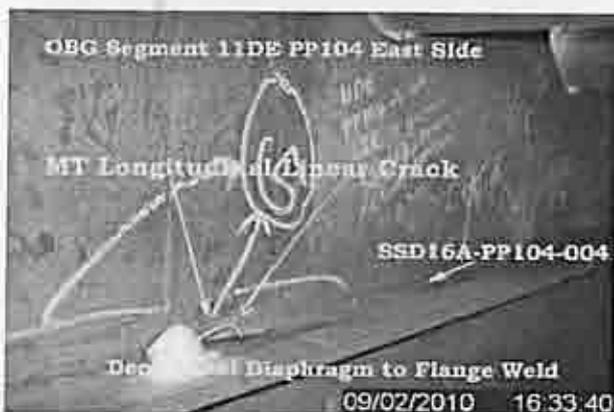
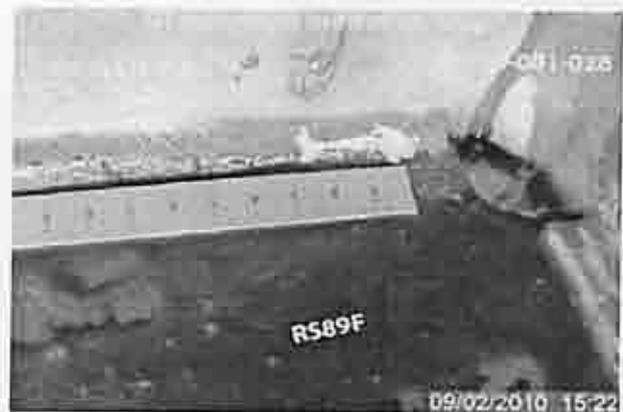
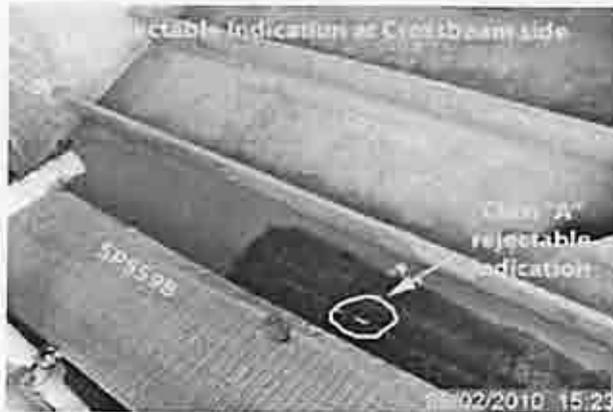
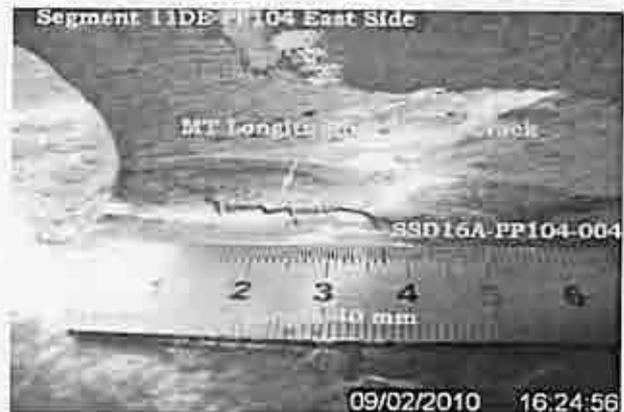
The Notice of Witness Inspection (NWIT) No. is 006556. All indications found are located within an area previously tested and accepted by ZPMC Quality Control (QC) personnel with exception of weld SEG072A-002.

- One (1) MT Longitudinal Linear Crack measuring approximately 40 mm in length.
- The weld is identified as SSD16A-PP104-004 and is located at panel point (PP) 104 East side.
- This weld is a fillet weld that joins the Deck Panel Diaphragm to the Web flange.
- Y location is 7040mm measured from the termination of the weld on the Cross Beam side.
- The Linear Crack is clearly marked on the material near the weld.
- The Deck Panel Diaphragm and Flange weld are identified as Non Seismic Performance Critical Members (Non-SPCM).
- OBG segment 11DE is located outside at the north end of Bay 14.

The Notice of Witness Inspection Number (NWIT) is 006556. This Linear Crack is located within an area that has been previously tested by ZPMC Quality Control (QC) personnel. As per contract documents ZPMC is required to perform 100% Magnetic Particle Testing (MT) of this weld.

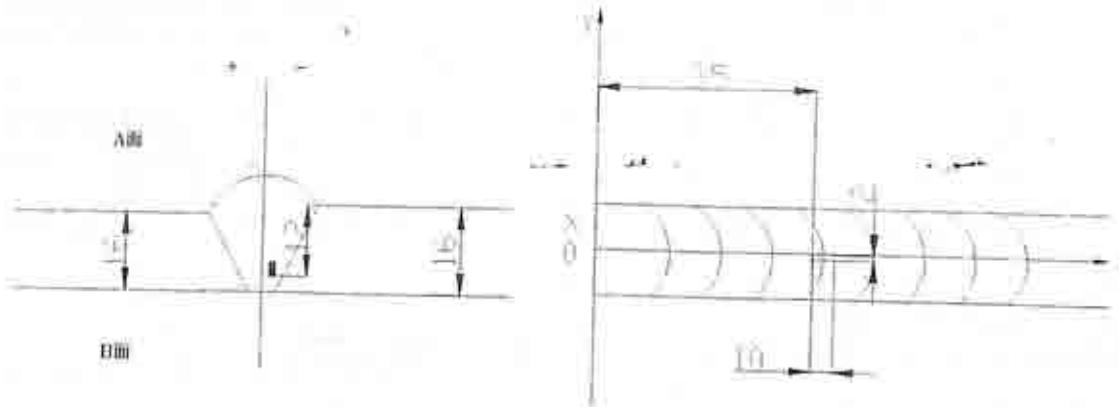
WELD NUMBER: SEG072A-008

(Description of welding discontinuity): Rejected indication found by ultrasonic inspection is less than the maximum allowance aggregate length.

1. 从缺陷距离端面较近一侧 ($D \leq 0.65T$, D 为缺陷深度, T 为板厚) 采用碳刨或打磨的方法去除焊缝缺陷;
 2. 参照返修焊接工艺规程 (WPS) 准备正确的接头型式, 预热和焊接;
 3. 将修补区域打磨到与母材或邻近焊缝平齐;
 4. 根据批准的车间图纸检查焊缝.
-
1. Gouge or grind from nearer side from metal edge. ($D \leq 0.65T$, "D" is depth of defects, "T" is thickness of metal) to remove all defects;
 2. Follow repair WPS for joint preparation, preheat, and weld deposit;
 3. Grind the repaired area flush with base metal or the adjacent weld;
 4. Check the welds according to the working drawings.

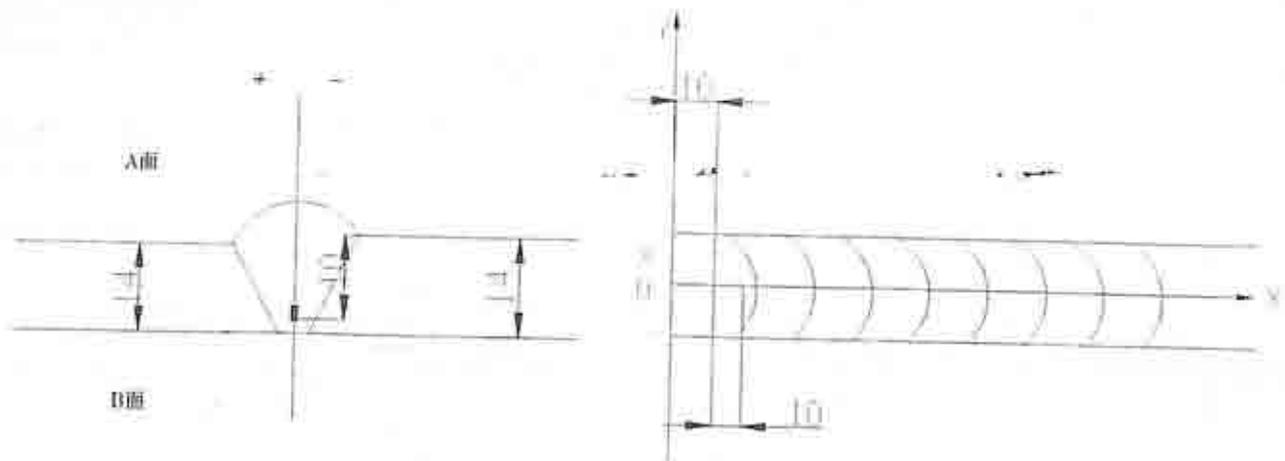
WELD NUMBER: SEG072A-002

(Description of welding discontinuity): Rejected indication found by ultrasonic inspection is less than the maximum allowance aggregate length.

1. Gouge or grind from nearer side from metal edge ($D \leq 0.65T$, "D" is depth of defects, "T" is thickness of metal) to remove all defects;
2. Follow repair WPS for joint preparation, preheat, and weld deposit;
3. Grind the repaired area flush with base metal or the adjacent weld;
4. Check the welds according to the working drawings.

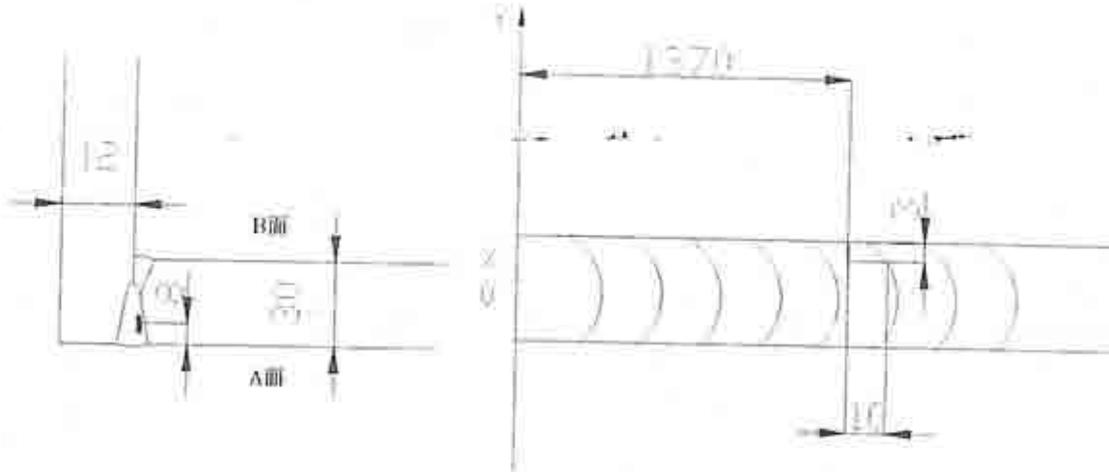
WELD NUMBER: SEG072B-055

(Description of welding discontinuity): Rejected indication found by ultrasonic inspection is less than the maximum allowance aggregate length.

1. 从缺陷距离端面较近一侧 ($D \leq 0.65T$, D 为缺陷深度, T 为板厚) 采用碳刨或打磨的方法去除焊缝缺陷;
 2. 参照返修焊接工艺规程 (WPS) 准备正确的接头型式, 预热和焊接;
 3. 将修补区域打磨到与母材或邻近焊缝平齐;
 4. 根据批准的车间图纸检查焊缝.
-
1. Gouge or grind from nearer side from metal edge ($D \leq 0.65T$; "D" is depth of defects, "T" is thickness of metal) to remove all defects;
 2. Follow repair WPS for joint preparation, preheat, and weld deposit;
 3. Grind the repaired area flush with base metal or the adjacent weld;
 4. Check the welds according to the working drawings.

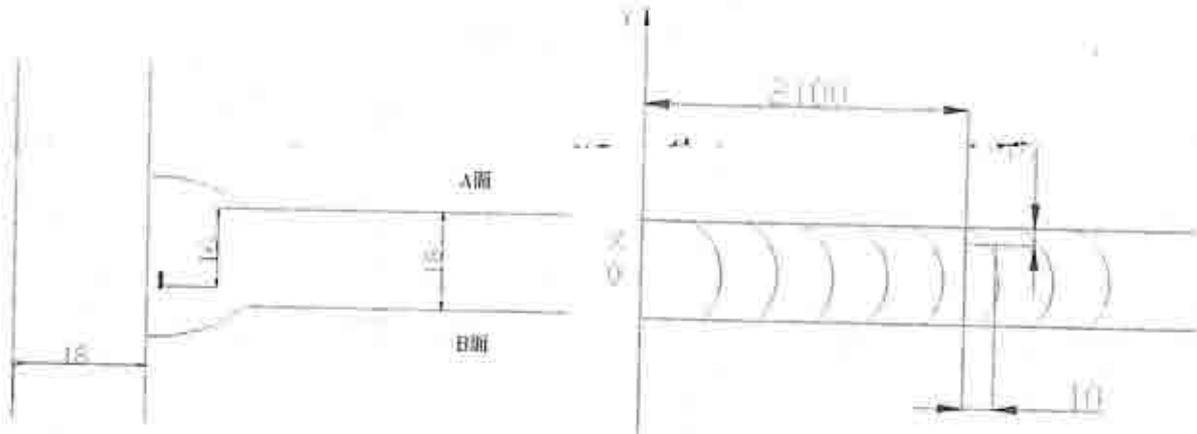
WELD NUMBER: EP160-001-028

(Description of welding discontinuity): Rejected indication found by ultrasonic inspection is less than the maximum allowance aggregate length.

1. Gouge or grind from nearer side from metal edge ($D \leq 0.65T$, "D" is depth of defects, "T" is thickness of metal) to remove all defects;
2. Follow repair WPS for joint preparation, preheat, and weld deposit;
3. Grind the repaired area flush with base metal or the adjacent weld;
4. Check the welds according to the working drawings.
