DIVISION OF ENGINEERING SERVICES

Contract #: 04-0120F4Cty: SF/ALA Rte: 80 PM: 13.2/13.9File #: 69.25B**QUALITY ASSURANCE -- NON-CONFORMANCE REPORT****Location:** Changxing Island, Shanghai, P.R. China**Report No:** NCR-000833**Prime Contractor:** American Bridge/Fluor Enterprises, a JV**Date:** 04-Sep-2010**Submitting Contractor:** Zhenhua Port Machinery Company, Ltd (ZPMC), Changxing Island**NCR #:** ZPMC-0795**Type of problem:**

**Reference Description:** Missed UT Indication located at 99m Cross Bracing Gusset Plate**Description of Non-Conformance:**

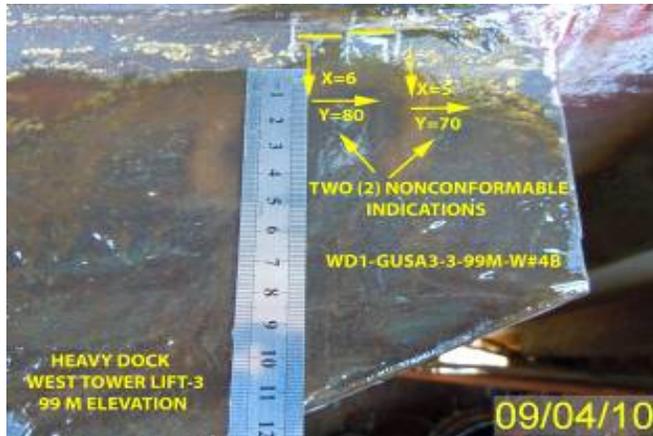
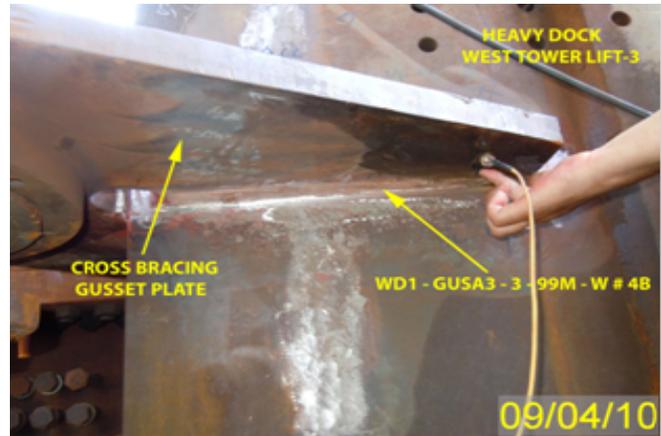
During random 10% verification Ultrasonic Testing (UT) of Cross Bracing Gusset plate, this Quality Assurance Inspector (QA) discovered the following issues:

- Two (2) Class "A" non conforming longitudinal indication's in one weld.
- First UT discontinuity rating was -2 db; Class "A" non-conforming indication.

- Depth of the discontinuity from face "B" is approximately 18mm.

- Length of the discontinuity is approximately 15mm.

location is 70 mm from Skin D/E corner of the weld.

- Second UT discontinuity rating was +0 db; Class "A" non-conforming indication.
- Depth of the discontinuity from face "B" is approximately 24mm.

- Length of the discontinuity is approximately is 10mm.
- Y location is 80 mm from Skin D/E corner of the weld.

- This weld is a T-joint complete joint penetration (CJP), between the West Tower Skin 'E' and the Cross Bracing Gusset plate.

This weld is identified as WD1-GUSA3-3-99M-W#4B.

The Notice of Witness Inspection Number (NWIT) is 006575. These indications are located inside the area that has been previously tested and accepted by ZPMC Quality Control (QC) personnel. ZPMC's QC personnel performed 100% UT inspection of this weld.

**Reference Resolution:** ZPMC has repaired the missed indication and is providing the WRR and NDT performed after the repair to show the weld is acceptable.

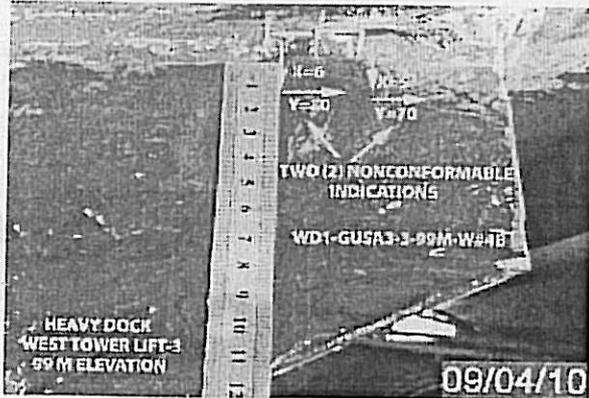
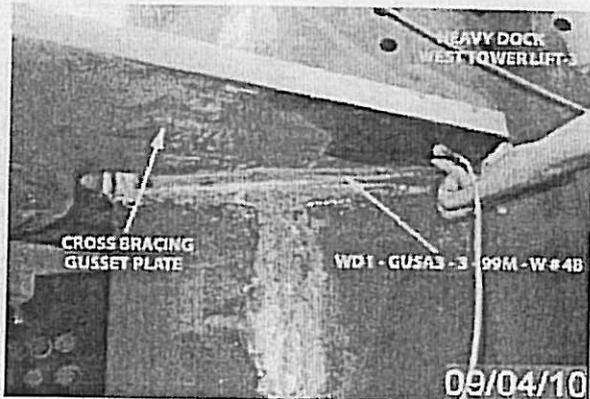
During random 10% verification Ultrasonic Testing (UT) of Cross Bracing Gusset plate, this Quality Assurance Inspector (QA) discovered the following issues:

- Two (2) Class "A" non conforming longitudinal indication's in one weld.
- First UT discontinuity rating was -2 db; Class "A" non-conforming indication.

-Depth of the discontinuity from face "B" is approximately 18mm.

-Length of the discontinuity is approximately 15mm.

location is 70 mm from Skin D/E corner of the weld.

-Second UT discontinuity rating was +0 db; Class "A" non-conforming indication.

-Depth of the discontinuity from face "B" is approximately 24mm.

-Length of the discontinuity is approximately is 10mm.

-Y location is 80 mm from Skin D/E corner of the weld.

-This weld is a T-joint complete joint penetration (CJP), between the West Tower Skin 'E' and the Cross Bracing Gusset plate.

This weld is identified as WD1-GUSA3-3-99M-W#4B.

The Notice of Witness Inspection Number (NWIT) is 006575. These indications are located inside the area that has been previously tested and accepted by ZPMC Quality Control (QC) personnel. ZPMC's QC personnel performed 100% UT inspection of this weld.

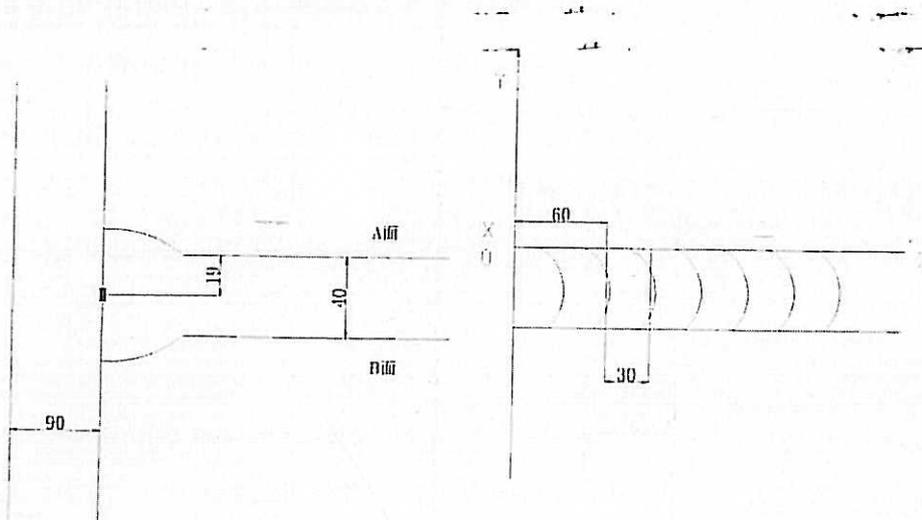
WELD NUMBER: WD1-GUSA3-3-99M-W-3A/B

焊缝编号为：WD1-GUSA3-3-99M-W-4A/B

1. 焊道未及时处理干净。
1. Did not clear the weld pass completely in time.

1. 从缺陷距离端面较近一侧 ( $D \leq 0.65T$ , D为缺陷深度, T为板厚) 采用碳刨或打磨的方法去除焊缝缺陷;
  2. 参照返修焊接工艺规程 (WPS) 准备正确的接头型式, 预热和焊接;
  3. 将修补区域打磨到与母材或邻近焊缝平齐;
  4. 根据批准的车间图纸检查焊缝.
- 
1. Gouge or grind from nearer side from metal edge ( $D \leq 0.65T$ , "D" is depth of defects, "T" is thickness of metal) to remove all defects;
  2. Follow repair WPS for joint preparation, preheat, and weld deposit;
  3. Grind the repaired area flush with base metal or the adjacent weld;
  4. Check the welds according to the working drawings.

1. Improve monitoring of welding and interpass cleaning.
