Contract #: 04-0120F4Cty: SF/ALA Rte: 80 PM: 13.2/13.9File #: 69.25B**QUALITY ASSURANCE -- NON-CONFORMANCE REPORT****Location:** Changxing Island, Shanghai, P.R. China**Report No:** NCR-000835**Prime Contractor:** American Bridge/Fluor Enterprises, a JV**Date:** 07-Sep-2010**Submitting Contractor:** Zhenhua Port Machinery Company, Ltd (ZPMC), Changxing Island**NCR #:** ZPMC-0797**Type of problem:**

Reference Description: ZPMC performed repair on Suspender Bracket 74E at Lift 9E without having an approved CWR

Subject: NCR No. ZPMC-0797

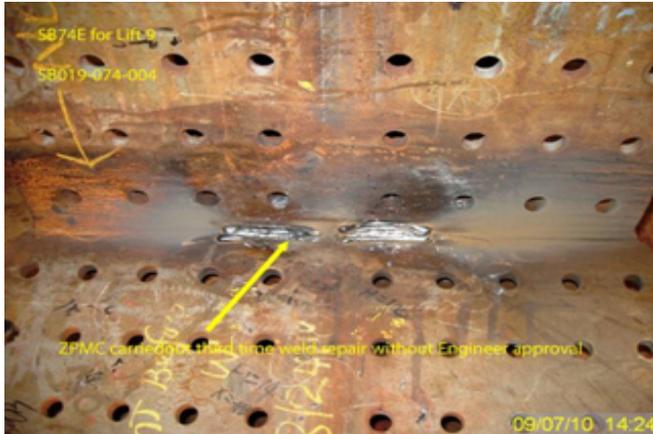
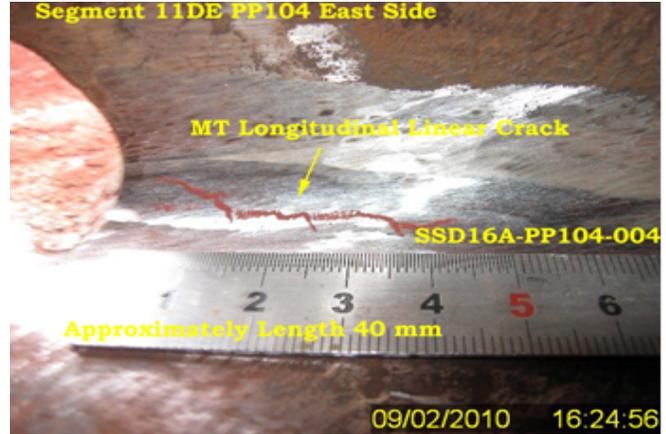
- ZPMC personnel performing weld repair of one (1) transverse crack measuring approximately 10 mm without the prior approval of the Engineer, an approved Critical Weld Repair (CWR), or following the "pre-approved CWR" procedure that was agreed jointly.

- This weld is rejected for the 3rd time by Ultrasonic Testing.
- The transverse crack found in the excavation with Magnetic Particle Testing verification by ZPMC personnel after carbon arc gouging.

- The weld is identified as SB019-074-004 for OBG Lift 9E.
- Y-location of the transverse crack without CWR is at 310mm from the left end of X53B.
- Subsequent to the completion of weld repair, ZPMC sought for a CWR approval from CT for a longitudinal crack repair at a different location on the same weld joint.

- As of September 8, 2010 at 11:00, no CWR or Engineer's approval has been requested from ZPMC for this transverse crack defect.
- This member is located inside the OBG Fabrication shop Bay 19.

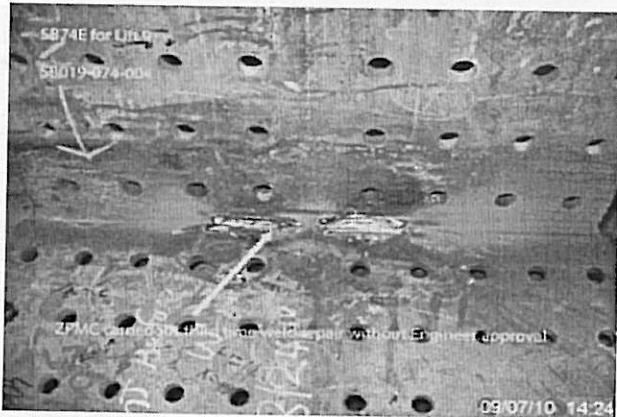
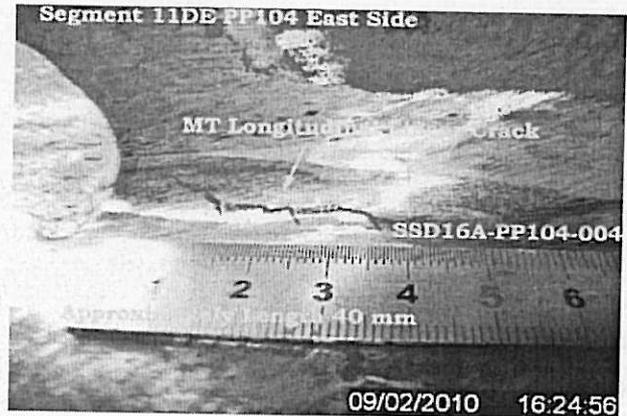
- ZPMC personnel performing weld repair of one (1) transverse crack measuring approximately 10 mm without the prior approval of the Engineer, an approved Critical Weld Repair (CWR), or following the "pre-approved CWR" procedure that was agreed jointly.

- This weld is rejected for the 3rd time by Ultrasonic Testing.
- The transverse crack found in the excavation with Magnetic Particle Testing verification by ZPMC personnel after carbon arc gouging.

- The weld is identified as SB019-074-004 for OBG Lift 9E.
- Y-location of the transverse crack without CWR is at 310mm from the left end of X53B.
- Subsequent to the completion of weld repair, ZPMC sought for a CWR approval from CT for a longitudinal crack repair at a different location on the same weld joint.

- As of September 8, 2010 at 11:00, no CWR or Engineer's approval has been requested from ZPMC for this transverse crack defect.
- This member is located inside the OBG Fabrication shop Bay 19.

Contractor will remove the weld in question, and reweld it with approved CWR. Contractor will provide the NDT report to prove the weld is acceptable. Internal NCR will be issued to address the requirement of CWR prior welding repair.

Contractor removed and rewelded the weld. The NDT report shows the weld in question is acceptable. Internal NCR was issued to the personnel involved.
