Contract #: 04-0120F4  
 Cty: SF/ALA Rte: 80 PM: 13.2/13.9  
 File #: 69.25B

## QUALITY ASSURANCE -- NON-CONFORMANCE REPORT

**Report No:** NCR-000838

**Reference Description:** Missed Transverse UT Indication

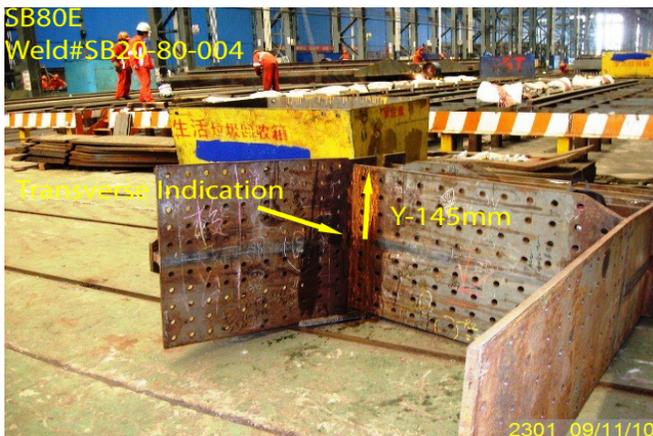
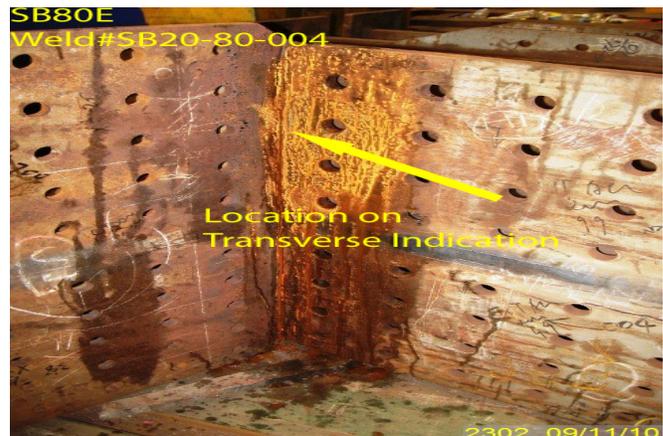
-One (1) Class "A" transverse indication with crack like characteristics measuring approximately 15 mm in length.

-The db rating is +5.

-The weld is identified as SB020-080-004.

-The weld is a Complete Joint Penetration (CJP) Tee Joint joining the suspender bracket vertical connection plate (X57BC) to the top plate (X53B).

-The thickness of the vertical connection plate in way of the weld is 22mm.

-The "Y" location is approximately 145mm measured from the end of the joint (Looking West).

-The indication is clearly marked by QA near the weld.

The Notice of Witness Inspection Number (NWIT) is 006632. The indication is located inside the area that has been previously tested and accepted by ZPMC (QC) personnel. ZPMC's QC personnel performed 100% UT inspection of this weld, due to indications found in the required 25% length of testing.

AWS D1.5-2002, Section 6, Table 6.3. Specifies a class A indication as having a db rating of +8 and lower for weld thicknesses 20mm through 38mm.

ZPMC has repaired the missed indications and is providing the WWR used at the time to repair the weld and the UT report performed after to show that the weld is acceptable. To prevent future occurrences ZPMC has written an internal NCR and the inspector who missed the indications has been identified and his performance will be monitored to ensure that he does not continue a pattern of missed indications. Based on this ZPMC requests closure of this NCR.

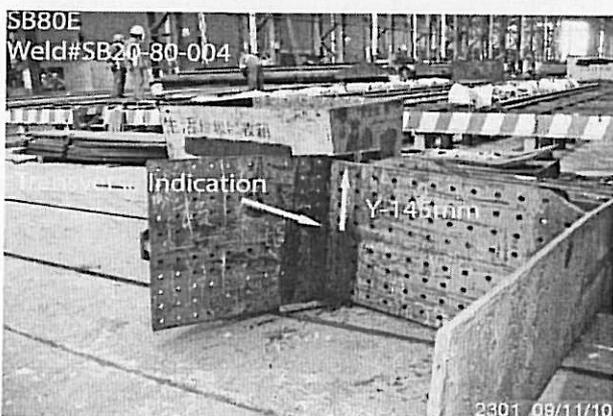
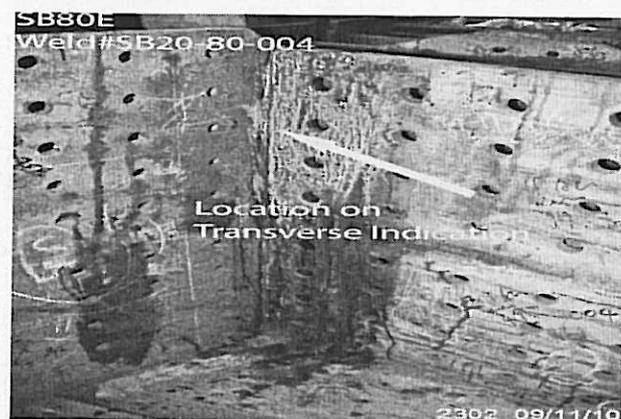
-One (1) Class "A" transverse indication with crack like characteristics measuring approximately 15 mm in length.

-The db rating is +5.

-The weld is identified as SB020-080-004.

-The weld is a Complete Joint Penetration (CJP) Tee Joint joining the suspender bracket vertical connection plate (X57BC) to the top plate (X53B).

-The thickness of the vertical connection plate in way of the weld is 22mm.

-The "Y" location is approximately 145mm measured from the end of the joint (Looking West).

-The indication is clearly marked by QA near the weld.

The Notice of Witness Inspection Number (NWIT) is 006632. The indication is located inside the area that has been previously tested and accepted by ZPMC (QC) personnel. ZPMC's QC personnel performed 100% UT inspection of this weld, due to indications found in the required 25% length of testing.

AWS D1.5-2002, Section 6, Table 6.3. Specifies a class A indication as having a db rating of +8 and lower for weld thicknesses 20mm through 38mm.

Contractor repaired the indications with WWR document support. UT was performed after repaired. UT report showed the weld is acceptable. Contractor also identified the inspector, and issued an internal NCR to him. His performance is monitored.
