Contract #: 04-0120F4Cty: SF/ALA Rte: 80 PM: 13.2/13.9File #: 69.25B**QUALITY ASSURANCE -- NON-CONFORMANCE REPORT****Location:** Changxing Island, Shanghai, P.R. China**Report No:** NCR-000843**Prime Contractor:** American Bridge/Fluor Enterprises, a JV**Date:** 19-Sep-2010**Submitting Contractor:** Zhenhua Port Machinery Company, Ltd (ZPMC), Changxing Island**NCR #:** ZPMC-0805**Type of problem:**

Reference Description: North Tower Lift 3: Missed UT Indication at 89m**Description of Non-Conformance:**

Job Name: SAS Superstructure
Document No: 05.03.06-000800

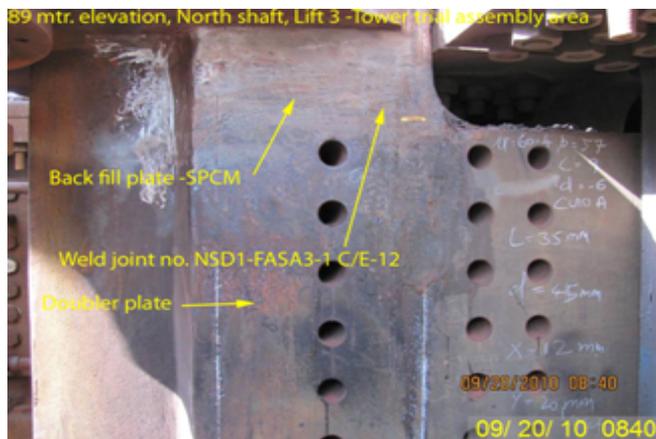
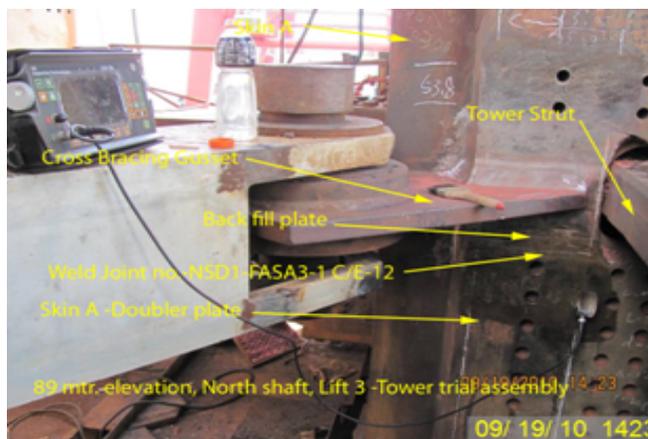
- One Class "A" non conforming longitudinal indication measuring approximately 35 mm in length found in 89 m elevation of North shaft, Lift3, between Doubler plate and Back fill plate.
- The weld is a complete joint penetration (CJP) Butt joint, and is identified as NSD1 – FASA3-1 C/E – 12.
- The discontinuity rating is Class "A" reject (DB rating -5).
- The back fill plate member is identified as Seismic performance critical member (SPCM)
- Depth of the discontinuity from face A is approximately 45 mm, and Y location found to be 18 mm from Tower Strut side.
- The Material thickness is 50 mm.
- The member is located in Tower Trial assembly area, Heavy Dock Jetty.
- The indication was discovered in an area which had been previously tested and accepted by ZPMC QC UT technicians.
- The NDT Inspection notification Number is 06711.

AWS D1.5-02 Section 6; Table 6.4 specifies welds >38mm through 60mm having a dbb rating of -2 and lower being a class A indication. Any indication in this category shall be rejected.

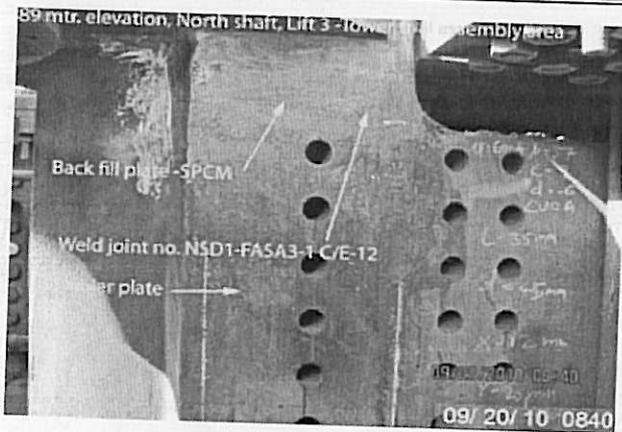
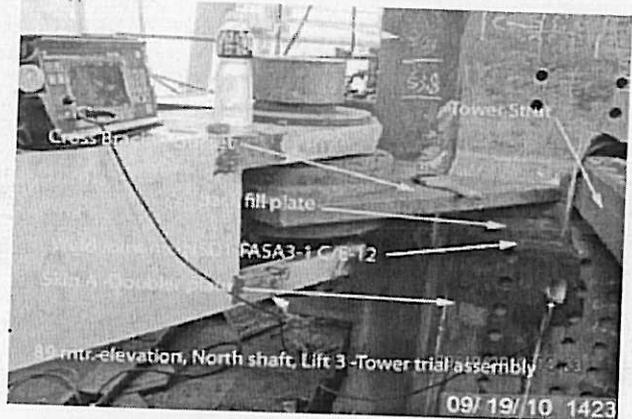
- One Class "A" non conforming longitudinal indication measuring approximately 35 mm in length found in 89 m elevation of North shaft, Lift3, between Doubler plate and Back fill plate.
- The weld is a complete joint penetration (CJP) Butt joint, and is identified as NSD1 - FASA3-1 C/E - 12.
- The discontinuity rating is Class "A" reject (DB rating -5).
- The back fill plate member is identified as Seismic performance critical member (SPCM)
- Depth of the discontinuity from face A is approximately 45 mm, and Y location found to be 18 mm from Tower Strut side.
- The Material thickness is 50 mm.
- The member is located in Tower Trial assembly area, Heavy Dock Jetty.
- The indication was discovered in an area which had been previously tested and accepted by ZPMC QC UT technicians.
- The NDT Inspection notification Number is 06711.

AWS D1.5-02 Section 6; Table 6.4 specifies welds >38mm through 60mm having a dbb rating of -2 and lower being a class A indication. Any indication in this category shall be rejected.

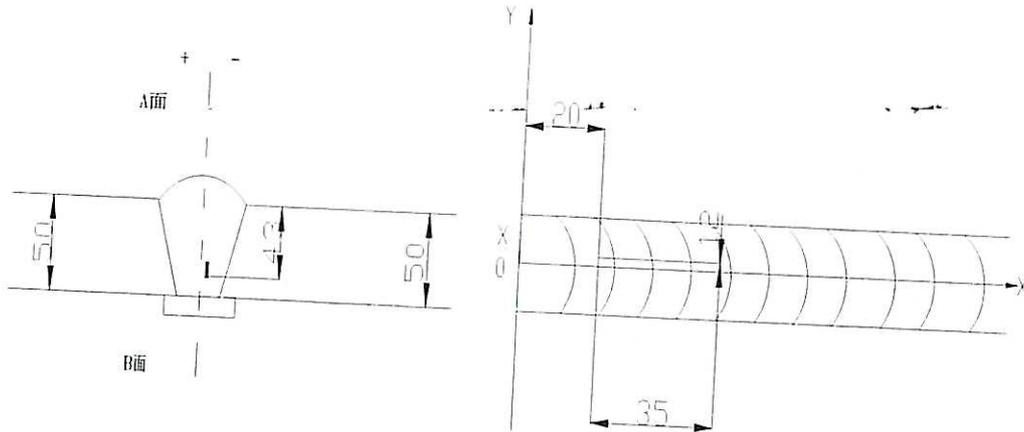
WELD NUMBER: NSD1-FASA3-1C/E-12

焊缝编号为：NSD1-FASA3-1C/E-12

1. Did not clear the weld pass completely in time.

1. Gouge or grind from nearer side from metal edge ($D \leq 0.65T$, "D" is depth of defects, "T" is thickness of metal) to remove all defects;
2. Follow repair WPS for joint preparation, preheat, and weld deposit;
3. Grind the repaired area flush with base metal or the adjacent weld;
4. Check the welds according to the working drawings.
