Contract #: 04-0120F4Cty: SF/ALA Rte: 80 PM: 13.2/13.9File #: 69.25B**QUALITY ASSURANCE -- NON-CONFORMANCE REPORT****Location:** Changxing Island, P.R. China**Report No:** NCR-000844**Prime Contractor:** American Bridge/Fluor Enterprises, a JV**Date:** 20-Sep-2010**Submitting Contractor:** Zhenhua Port Machinery Company, Ltd (ZPMC), Changxing Island**NCR #:** ZPMC-0806**Type of problem:**

Reference Description: Heat straightening without Engineer's approval and exceeding maximum allowable temperature during heat working.

Dear: Mr. Charles Kanapicki
Job Name: SAS Superstructure

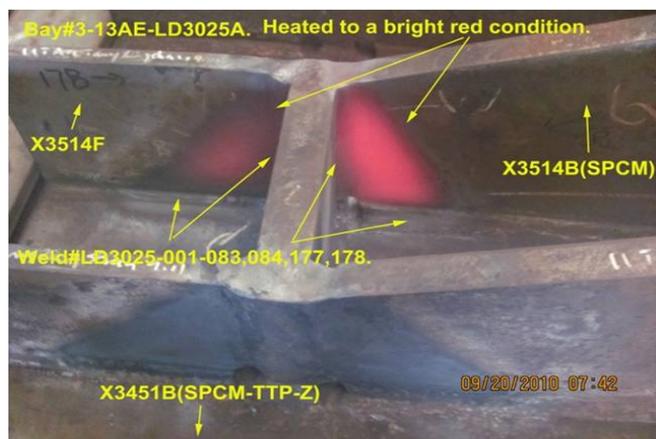
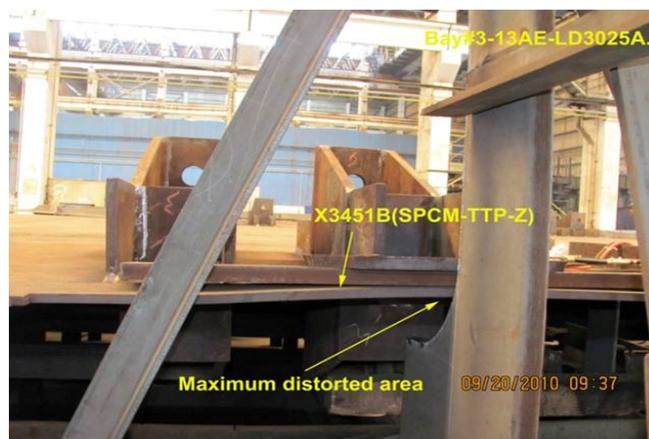
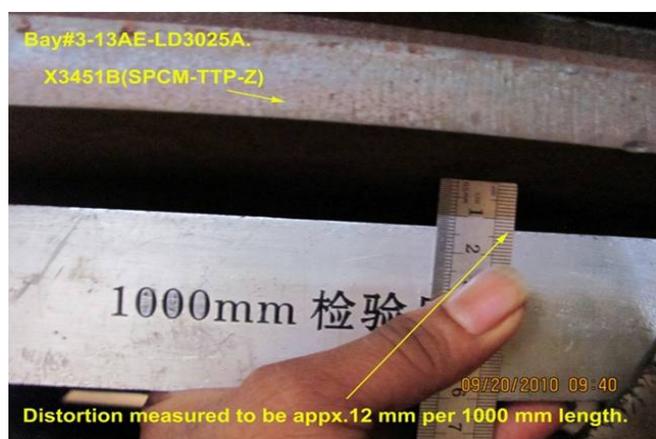
During Caltrans Quality Assurance in-process observations of the Longitudinal Diaphragm, LD3025A, fabrication, this Quality Assurance Inspector (QA) observed ZPMC personnel performing heat straightening work under the guidelines of an HSR1 when an HSR was required. Furthermore, the metal was heated above the maximum allowable temperature during heat straightening. Specific details pertaining to this incident are listed below:

- Material was heated to a bright red condition.
- This QA Inspector observed that a 760°C Tempilstik melted when struck against the heated area of the material. -A temperature indicating crayon, digital temperature measurement gauge, or other similar means of monitoring the temperature was not utilized by ZPMC Quality Control (QC) and the actual maximum attained temperature was not measured.
- The effected welds are identified as LD3025-001-083,084,177 and 178.
- These welds are Complete Joint Penetration (CJP) butt joints, joining Lifting Lug plates X3514F and X3514B (SPCM) to LD web plate X3451B (SPCM and TTP).
- The LD web plate material thickness is 18 mm.
- Distortion was measured to be approximately 12mm over a distance of 1000mm.
- ZPMC QC provided HSR1 identified as HSR1 7375 when asked for the recoding documents.
- The affected member is located in Sub assembly Bay#3.

For further information, please see the pictures below.

Caltrans Special Provisions Section 8-3: "For material more than 16 mm, the Contractor shall not heat straighten members more than 3 in 1000 without prior approval of the Engineer".

AWS 1.5 2002 section 3.7.3 "Members distorted by welding shall be straightened by mechanical means or by carefully supervised application of a limited amount of localized heat as approved by the Engineer. The temperature of the heated areas as measured by approved methods shall not exceed 600°C [1100°F] for quenched and tempered steel nor 650°C [1200°F] (a dull, red color) for other steels. The part to be heated for straightening shall be substantially free of stress and from external forces, except those stresses resulting from the mechanical straightening method used in conjunction with the application of heat."

ZPMC acknowledges that this piece was overheated. In the future, work crews who perform overheating will be fined in order to pay for the overheated part. This financial penalty will be a deterrent to workers performing overheating. In this case, ZPMC conducted hardness testing of the heated area (Area 1-4) and an adjacent area unaffected by overheating (Area 5) to show that the heating did not adversely affect the material hardness. After heating, ZPMC performed NDT and is providing the result to show the material is acceptable. Based on this ZPMC requests closure of this NCR.

The proposed resolution is acceptable. This NCR is considered closed.

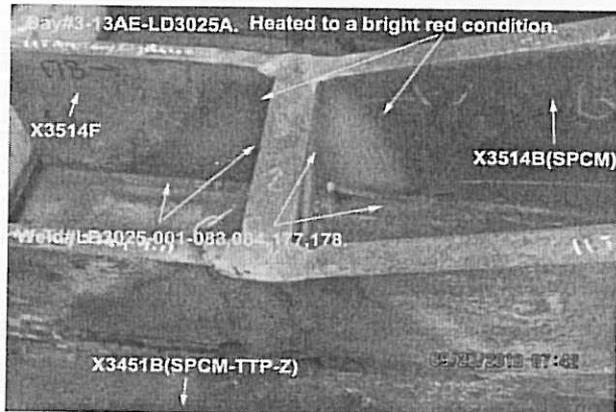
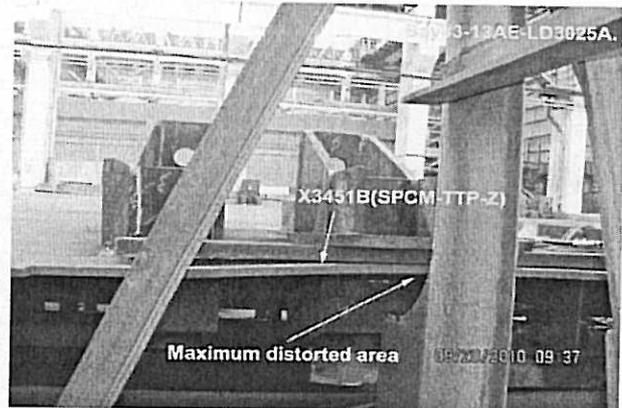
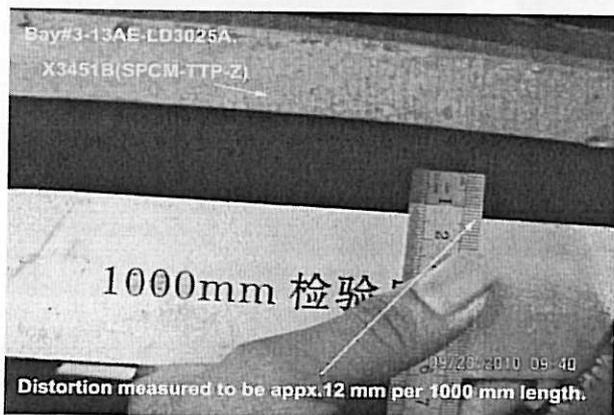
During Caltrans Quality Assurance in-process observations of the Longitudinal Diaphragm, LD3025A, fabrication, this Quality Assurance Inspector (QA) observed ZPMC personnel performing heat straightening work under the guidelines of an HSR1 when an HSR was required. Furthermore, the metal was heated above the maximum allowable temperature during heat straightening. Specific details pertaining to this incident are listed below:

- Material was heated to a bright red condition.
- This QA Inspector observed that a 760°C Tempilstik melted when struck against the heated area of the material. -A temperature indicating crayon, digital temperature measurement gauge, or other similar means of monitoring the temperature was not utilized by ZPMC Quality Control (QC) and the actual maximum attained temperature was not measured.
- The effected welds are identified as LD3025-001-083,084,177 and 178.
- These welds are Complete Joint Penetration (CJP) butt joints, joining Lifting Lug plates X3514F and X3514B (SPCM) to LD web plate X3451B (SPCM and TTP).
- The LD web plate material thickness is 18 mm.
- Distortion was measured to be approximately 12mm over a distance of 1000mm.
- ZPMC QC provided HSR1 identified as HSR1 7375 when asked for the recoding documents.
- The affected member is located in Sub assembly Bay#3.

For further information, please see the pictures below.

Caltrans Special Provisions Section 8-3: "For material more than 16 mm, the Contractor shall not heat straighten members more than 3 in 1000 without prior approval of the Engineer".

AWS 1.5 2002 section 3.7.3 "Members distorted by welding shall be straightened by mechanical means or by carefully supervised application of a limited amount of localized heat as approved by the Engineer. The temperature of the heated areas as measured by approved methods shall not exceed 600°C [1100°F] for quenched and tempered steel nor 650°C [1200°F] (a dull, red color) for other steels. The part to be heated for straightening shall be substantially free of stress and from external forces, except those stresses resulting from the mechanical straightening method used in conjunction with the application of heat."

"ZPMC acknowledges that this piece was overheated. In the future, work crews who perform overheating will be fined in order to pay for the overheated part. This financial penalty will be a deterrent to workers performing overheating. In this case, ZPMC conducted hardness testing of the heated area (Area 1-4) and an adjacent area unaffected by overheating (Area 5) to show that the heating did not adversely affect the material hardness. After heating, ZPMC performed NDT and is providing the result to show the material is acceptable."
