Contract #: 04-0120F4
 Cty: SF/ALA Rte: 80 PM: 13.2/13.9
 File #: 69.25B

QUALITY ASSURANCE -- NON-CONFORMANCE REPORT

Report No: NCR-000850

Reference Description: QA found a missed MT longitudinal crack after ZPMC had tested and accepted the welds in Bikepath Assembly

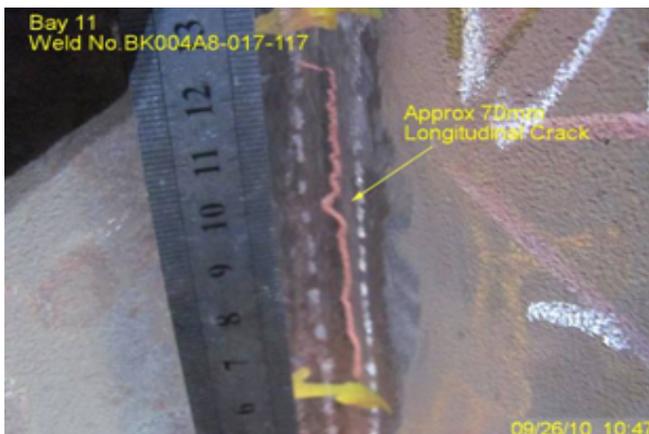
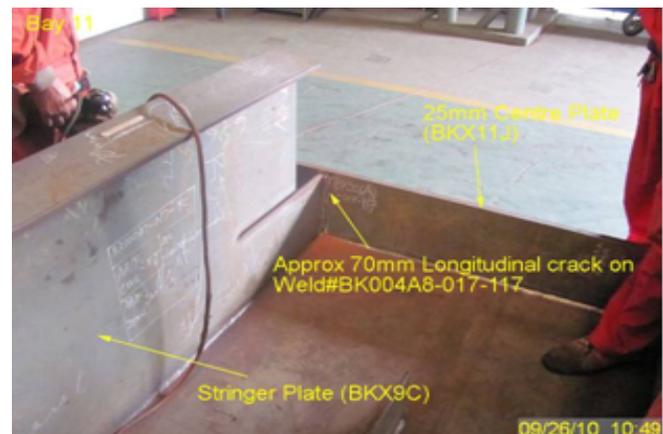
During the Quality Assurance (QA) Magnetic particle Testing (MT) review of welds located on Bike path BK004A-017, this QA Inspector discovered the following issue:

- One Longitudinal Crack that measured approximately 70mm in length.
- The weld is identified as BK004A8-017-117.
- The weld is a fillet joint, joining the Stringer plate (BKX9C) to the 25mm centre plate (BKX11J).
- The Y Location is 130mm from the cope hole.
- The OBG Bike path is located in BAY#11.
- This crack is clearly marked on the material on/near the weld.
- The bike path material is Non-Seismic performance critical (Non-SPCM) weld member.
- The Notice of Witness Inspection Number (NWIT) is 006773.
- The indication is located within the area that has been previously tested and accepted by ZPMC Quality Control (QC).

AWS D1.5 (02) Section 6.26.2 – “Welds that are subject to MT in addition to visual inspection shall have no cracks.

ZPMC has repaired the indication noted in the NCR and is providing NDT documentation after the repair to show the indication has been removed. ABFJV has noted which inspector was responsible for this missed indication and is monitoring his performance as well as all inspector performance, if he continues to miss indications disciplinary action will be undertaken. Based on these actions, ZPMC requests closure of this NCR.

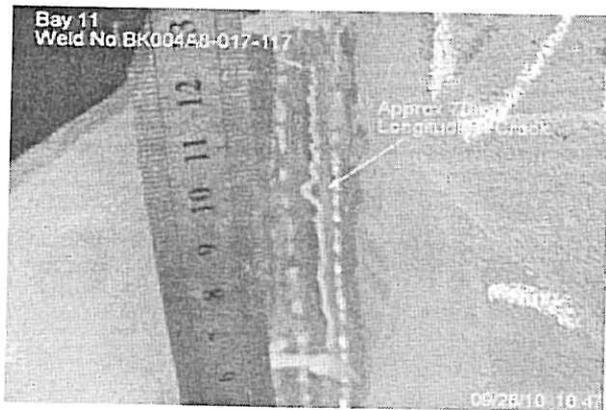
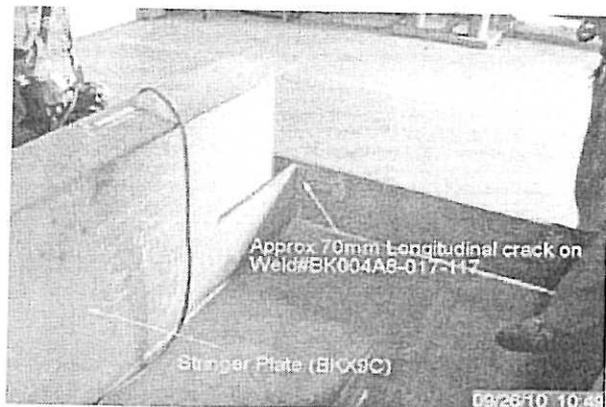
During the Quality Assurance (QA) Magnetic particle Testing (MT) review of welds located on Bike path BK004A-017, this QA Inspector discovered the following issue:

- One Longitudinal Crack that measured approximately 70mm in length.
- The weld is identified as BK004A8-017-117.
- The weld is a fillet joint, joining the Stringer plate (BKX9C) to the 25mm centre plate (BKX11J).
- The Y Location is 130mm from the cope hole.
- The OBG Bike path is located in BAY#11.
- This crack is clearly marked on the material on/near the weld.
- The bike path material is Non-Seismic performance critical (Non-SPCM) weld member.
- The Notice of Witness Inspection Number (NWIT) is 006773.
- The indication is located within the area that has been previously tested and accepted by ZPMC Quality Control (QC).

AWS D1.5 (02) Section 6.26.2 – “Welds that are subject to MT in addition to visual inspection shall have no cracks.

Contractor repaired the indication and provided the NDT documentation to prove the weld is acceptable. Contractor has identified the inspector responsible and is monitoring his performance.
