Quality Assurance and Source Inspection

Contract #: 04-0120F4Cty: SF/ALA Rte: 80 PM: 13.2/13.9File #: 69.25B**QUALITY ASSURANCE -- NON-CONFORMANCE REPORT****Location:** Changxing Island, Shanghai, P.R. China**Report No:** NCR-000853**Prime Contractor:** American Bridge/Fluor Enterprises, a JV**Date:** 29-Sep-2010**Submitting Contractor:** Zhenhua Port Machinery Company, Ltd (ZPMC), Changxing Island**NCR #:** ZPMC-0815**Type of problem:**

Reference Description: Skin E, Fit lug-119m have been cut without Engineer's approval**Description of Non-Conformance:**

Job Name: SAS Superstructure
Document No: 05.03.06-000810

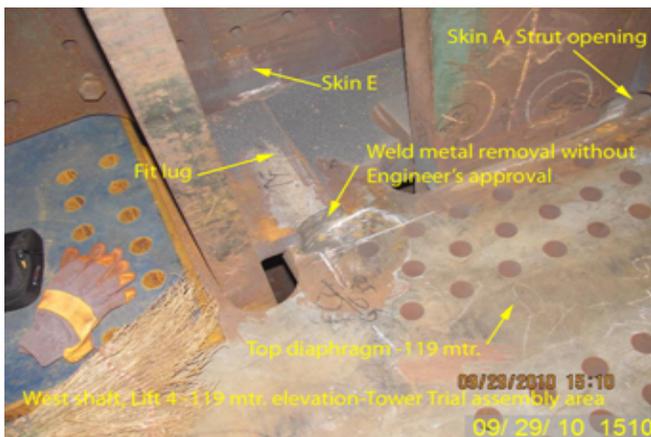
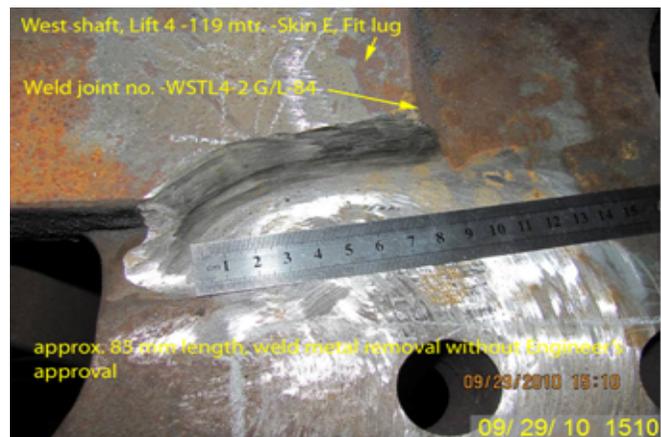
- Approximately 85mm in length, (25mm wide) of Fit Lug that was welded to the top diaphragm. Skin Plate E was removed without engineer approval.

- The Fit lug found in top diaphragm, skin E, Lift 4- 119 mtr, West Tower,
- The Weld removed has the following Weld ID: WSTL4-2 C/L-86.

AWS D1.5 Section 3.7.5- "The Engineer shall be notified before improperly fitted and welded members are cut apart."

Contractor submitted TC-RFI-0166 expressing there's an interference between the Tower flange splice plate and a fit lug at the 119M elevation. Conflict required coping the fit lug (55mmX35mm) to allow full contact with the splice plate's faying surface. For future constructability issues, ZPMC will instruct the workers to report to QC first, obtain prior approval from Engineer, and then proceed ahead with the agreed upon resolution.

TC-RFI-0166 response accepted to leave the fit-lug plate cut-out (maximum depth of 35mm as shown) to clear the diaphragm splice plate, provided that the trim was tapered in a 2:1 transition and MT was performed to ensure no cracks after grinding smooth. Work was performed in conformance with TC-RFI-0166, NDT reports received. ZPMC instructed their workers to notify QC immediately whenever there are questions regarding constructability, and can only perform remedial work with prior Engineer's approval.

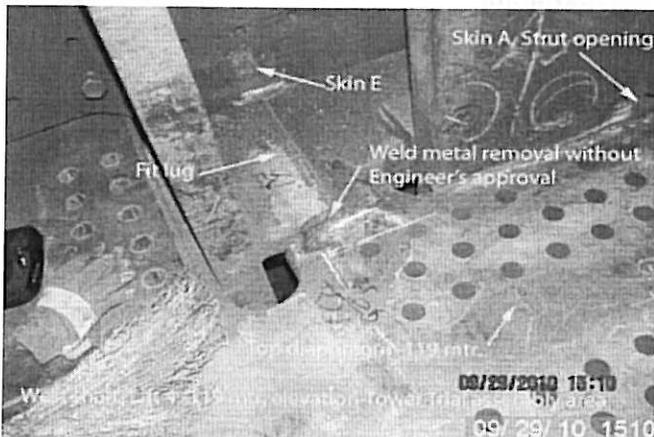
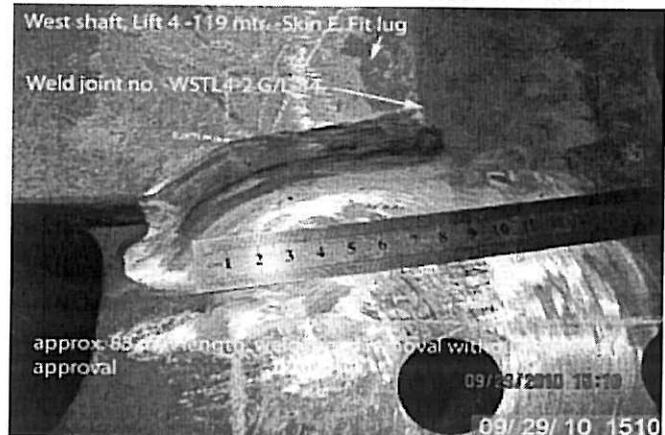
- Approximately 85mm in length, (25mm wide) of Fit Lug that was welded to the top diaphragm. Skin Plate E was removed without engineer approval.

- The Fit lug found in top diaphragm, skin E, Lift 4- 119 mtr, West Tower,
- The Weld removed has the following Weld ID: WSTL4-2 C/L-86.

AWS D1.5 Section 3.7.5- "The Engineer shall be notified before improperly fitted and welded members are cut apart."

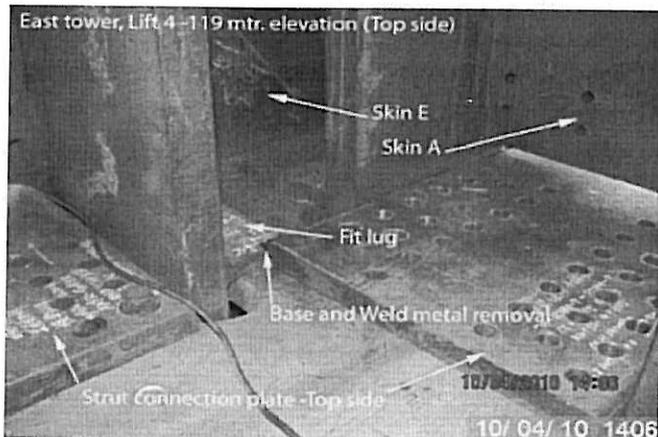
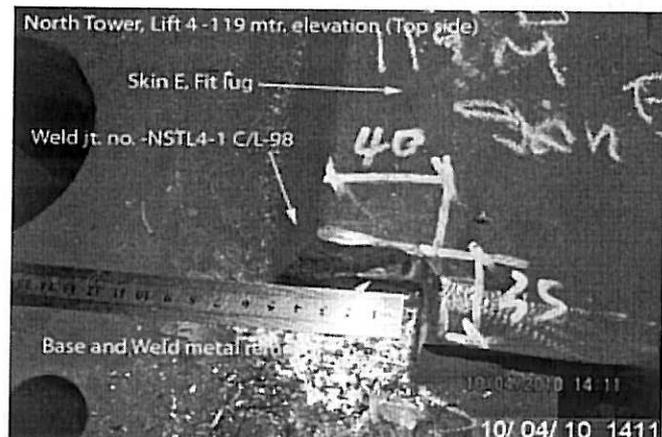
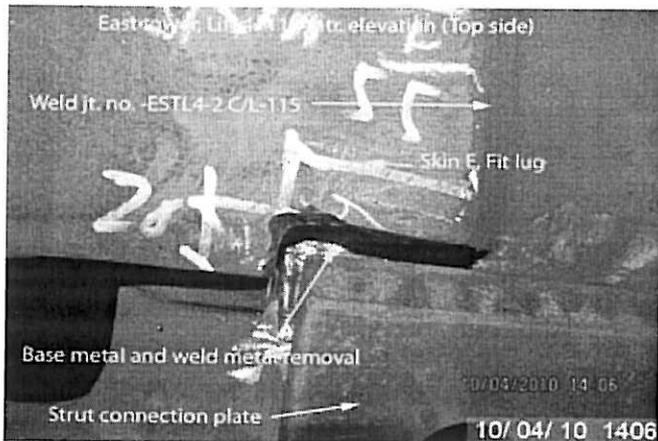
-Approx. 55 mm length, 25 mm width, weld metal and base metal removal observed in Skin E, fit lug weld without Engineer's approval.

-The fit lug found in East Tower, Lift 4- 119m top diaphragm.

-The weld joint no. of the fit lug weld found to be ESTL4-2 C/L-115.

-Approx. 50 mm length, 35 mm width, weld metal and base metal removal observed in Skin E, fit lug weld without engineer's approval.

-The fit lug found in North Tower, Lift 4- 119m top diaphragm.

-The weld joint no. of the fit lug weld found to be NSTL4-1 C/L-98.

AWS D 1.5 Section 3.7.4 – “Prior approval of the Engineer shall be obtained for repairs to base metal (other than those required by 3.2), repair of major or delayed cracks, repairs to ESW and EGW welds with internal defects, or for a revised design to compensate for deficiencies.”

AWS D1.5 Section 3.7.5- “The Engineer shall be notified before improperly fitted and welded members are cut apart.”

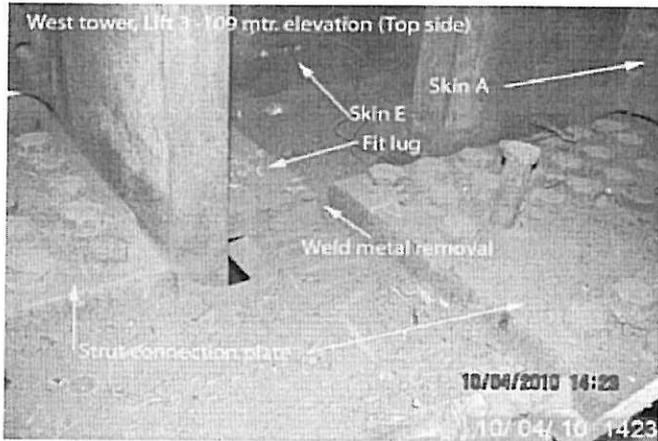
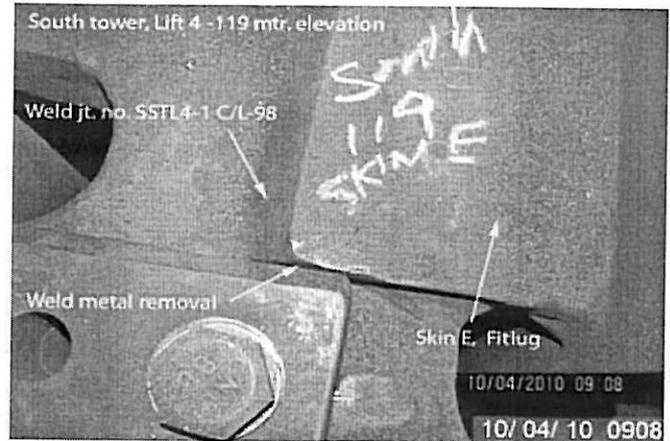
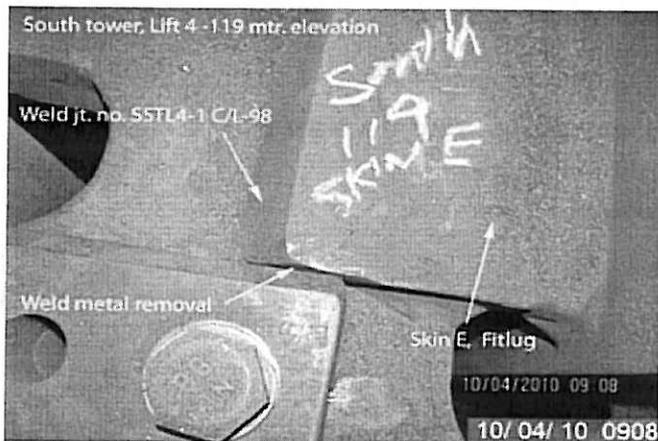
- Approx. 50mm length, weld metal removal observed in Skin E, fit lug weld, without Engineer's approval.
- The fit lug found in West Tower, Lift 3- 109m top diaphragm.
- The weld joint no. of the fit lug weld found to be WSTL3-4 I / K-128.

- Approx. 55mm length, weld metal removal observed in Skin E, fit lug weld, without Engineer's approval.
- The fit lug found in South Tower, Lift 4- 119m top diaphragm.
- The weld joint no. of the fit lug weld found to be SSTL4-1 C/L-98.

AWS D1.5 Section 3.7.5- "The Engineer shall be notified before improperly fitted and welded members are cut apart."
