Contract #: 04-0120F4Cty: SF/ALA Rte: 80 PM: 13.2/13.9File #: 69.25B**QUALITY ASSURANCE -- NON-CONFORMANCE REPORT****Location:** Changxing Island, Shanghai, P.R. China**Report No:** NCR-000854**Prime Contractor:** American Bridge/Fluor Enterprises, a JV**Date:** 03-Oct-2010**Submitting Contractor:** Zhenhua Port Machinery Company, Ltd (ZPMC), Changxing Island**NCR #:** ZPMC-0816**Type of problem:****Welding****Concrete****Other****Welding****Curing****Procedural****Bridge No:** 34-0006**Joint fit-up****Coating****Other****Component:** Longitudinal Diaphragm in Segment 10CW**Procedural****Procedural****Description:**

**Reference Description:** Flame cutting performed without Engineer's approval and utilizing mechanical guide on LD (Segment 10CW)

**Job Name:** SAS Superstructure  
**Document No:** 05.03.06-000811

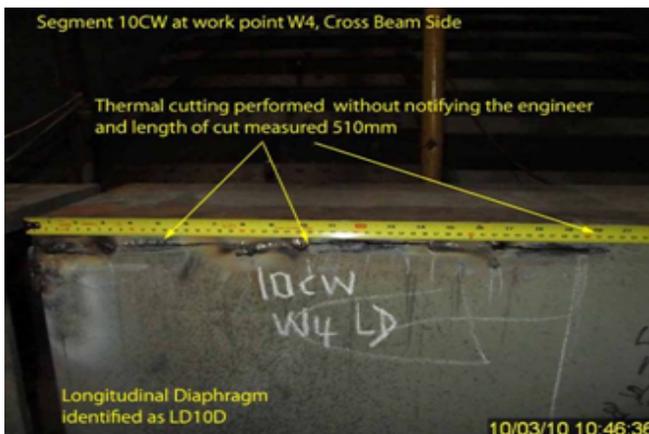
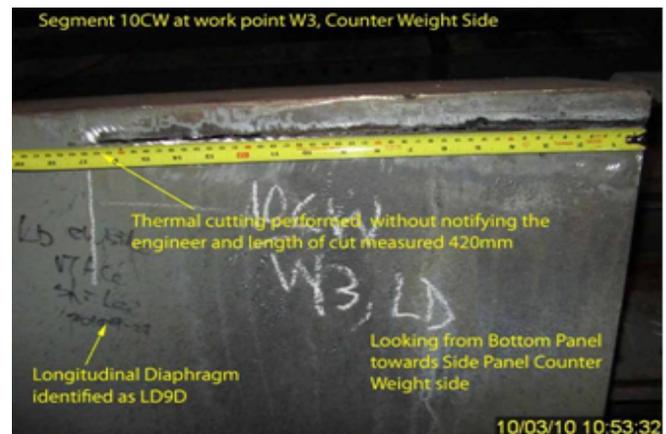
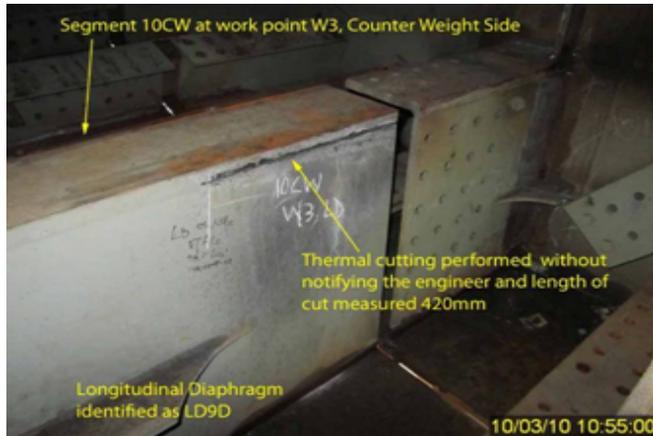
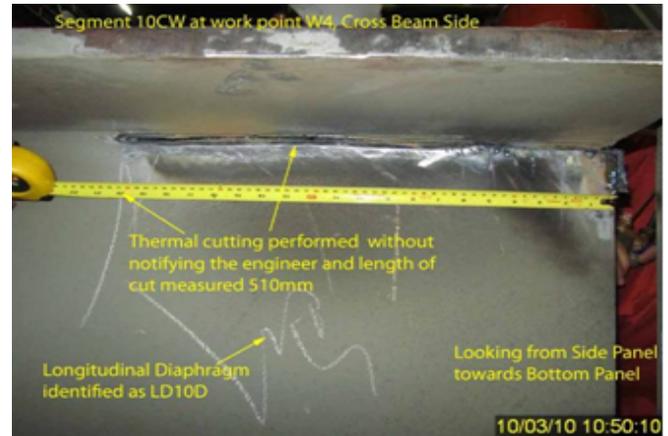
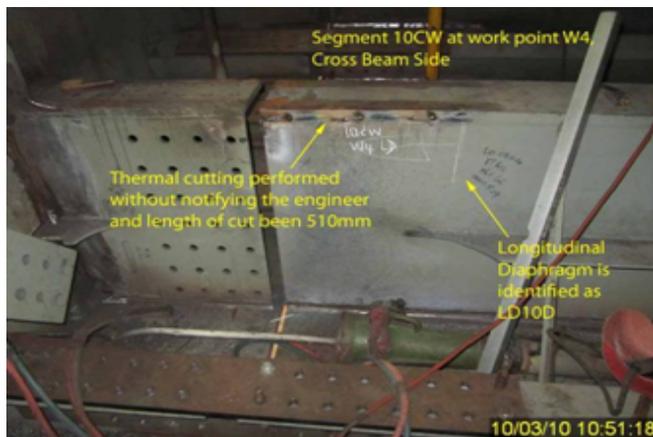
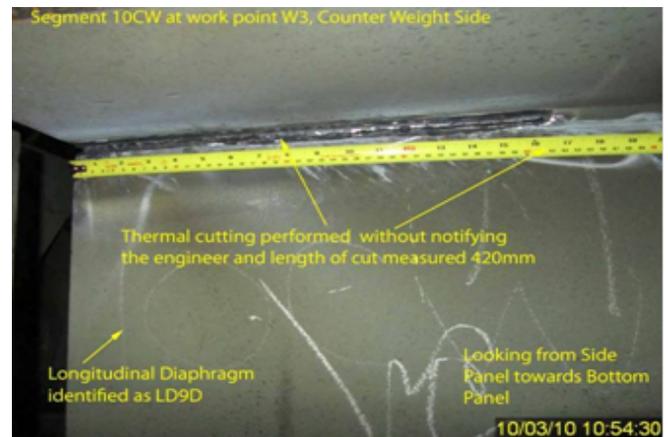
- ZPMC workers have removed a weld joint connecting Longitudinal Diaphragm (LD) web to flange side with an approximate length of 510mm at LD located at work point W4 and 420mm at LD located at work point W3.
- The Contractor failed to notify the Engineer of the intent to remove/cut the above welds.
- The removal of the welds was performed by free-hand flame cutting while it is possible to perform mechanically guided flame cutting.
- These free hand flame cutting performed were not in the scope of "Submittal 872R1: Free Hand Flame Cutting Procedure," as the cuts were over 300mm and that mechanical guides are available.
- These welds are Complete Joint Penetration (CJP), joining Longitudinal Diaphragm Web to Flange: Longitudinal Diaphragm at work point W3 identified as LD9D; Longitudinal Diaphragm at work point W4 identified as LD10D.

-AWS D1.5 (02) Section 3.7.5: The Engineer shall be notified before improperly fitted and welded members are cut apart.

-Submittal 872R1: Free Hand Flame Cutting Procedure: "Request Engineer's approval for flame cutting when mechanically guided flame cutting is not practical due to accessibility, cross sectional geometry and or position."  
"

Propose a resolution for the identified non-conformance with revised procedures to prevent future occurrences. A response for the resolution of this issue is expected within 7 days.

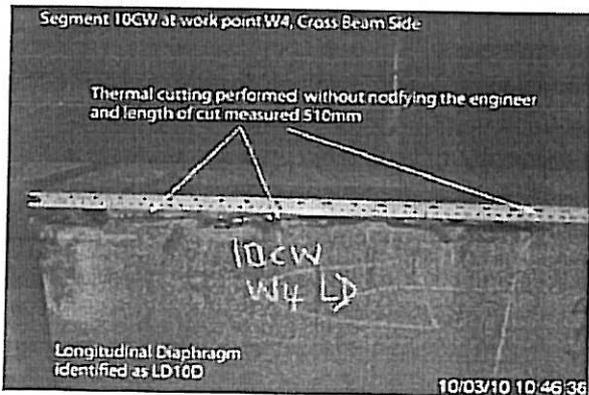
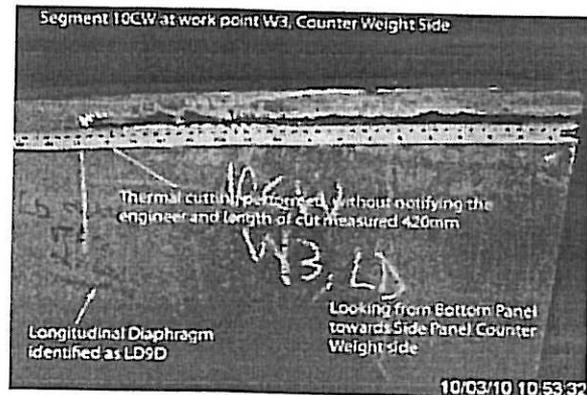
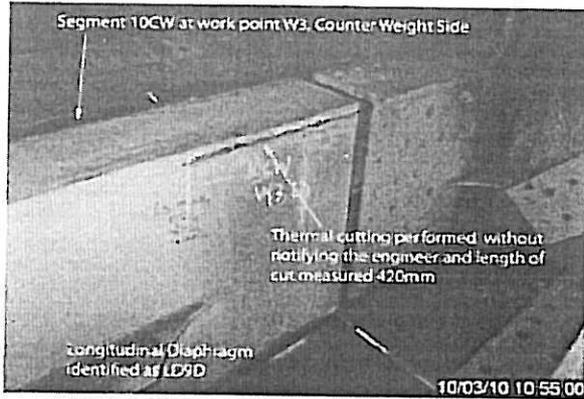
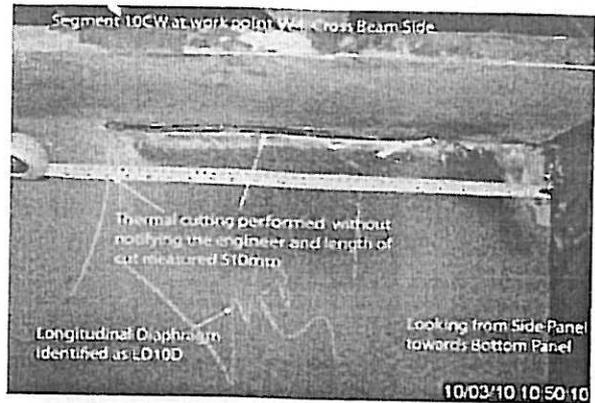
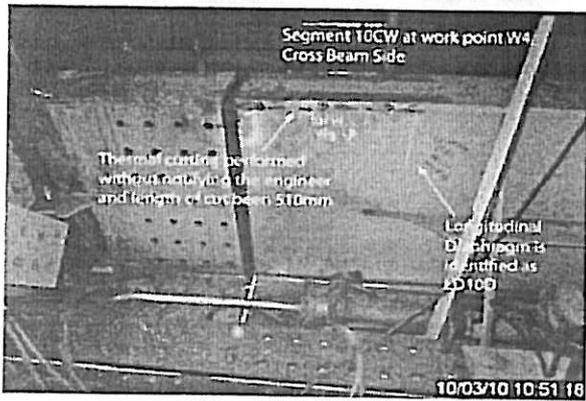
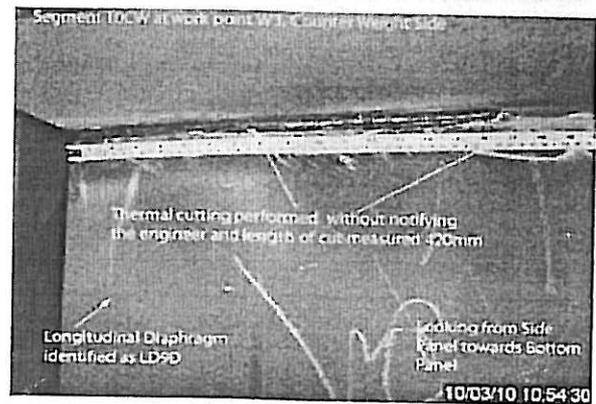
- ZPMC workers have removed a weld joint connecting Longitudinal Diaphragm (LD) web to flange side with an approximate length of 510mm at LD located at work point W4 and 420mm at LD located at work point W3.
- The Contractor failed to notify the Engineer of the intent to remove/cut the above welds.
- The removal of the welds was performed by free-hand flame cutting while it is possible to perform mechanically guided flame cutting.
- These free hand flame cutting performed were not in the scope of "Submittal 872R1: Free Hand Flame Cutting Procedure," as the cuts were over 300mm and that mechanical guides are available.
- These welds are Complete Joint Penetration (CJP), Joining Longitudinal Diaphragm Web to Flange: Longitudinal Diaphragm at work point W3 identified as LD9D; Longitudinal Diaphragm at work point W4 identified as LD10D.

-AWS D1.5 (02) Section 3.7.5: The Engineer shall be notified before improperly fitted and welded members are cut apart.

-Submittal 872R1: Free Hand Flame Cutting Procedure: "Request Engineer's approval for flame cutting when mechanically guided flame cutting is not practical due to accessibility, cross sectional geometry and or position."

Contractor repaired the work per WRR provided. NDT performed after repair. NDT documentation showed the repair is acceptable. Contractor conducted refresher training to reduce to personnel involved to ensure similar non-conformance will not be repeated in future.

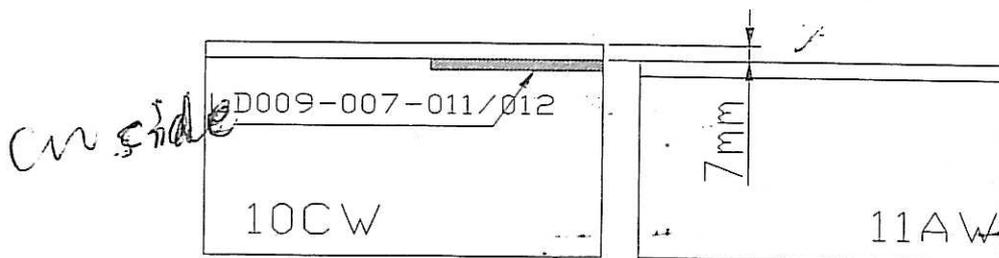
非联系梁侧

After inspection 10CW and 11AW, the misalignment was 7mm at longitudinal diaphragm non face cross beam, 10mm at longitudinal diaphragm face cross beam, and needed to remove welds at longitudinal diaphragm skin plate and edge plate, welds ID: LD009-007-011/012; LD010-007-011/012. the detail sees the following draft.

Remark: cut weld on shadow.

Weld distortion and fabricate error.

- 1.Remove the weld on shadow by gouging or heat cutting.
- 2.Adjust the misalignment and the straightness to meet the tolerance by outer force.
3. Prepare right excavation according to the approved WPS.
4. Perform 100% VT and MT inspection to the groove to ensure no defects exist prior to welding;
5. Preheat and weld according to approved WPS.
- 6: Grind the welds with a smooth surface.
7. Perform NDT inspection to the repair area according to work drawing.
