QUALITY ASSURANCE -- NON-CONFORMANCE REPORT

Location: Changxing Island, Shanghai, China**Report No:** NCR-000868**Prime Contractor:** American Bridge/Fluor Enterprises, a JV**Date:** 18-Oct-2010**Submitting Contractor:** Zhenhua Port Machinery Company, Ltd (ZPMC), Changxing Island**NCR #:** ZPMC-0830**Type of problem:**

Reference Description: Missed UT Indication Discovered by Quality Assurance**Description of Non-Conformance:**

Subject: NCR No. ZPMC-0830

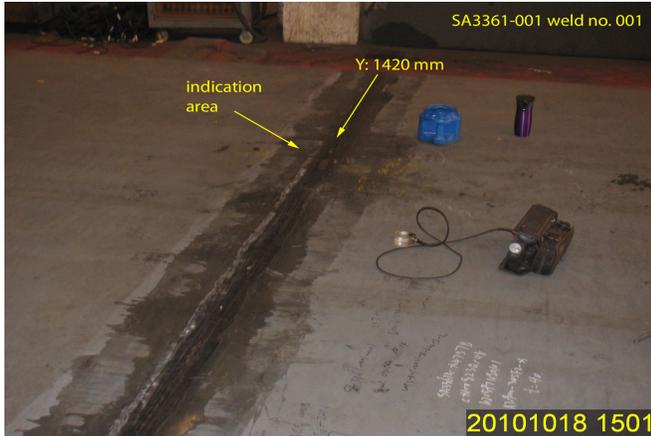
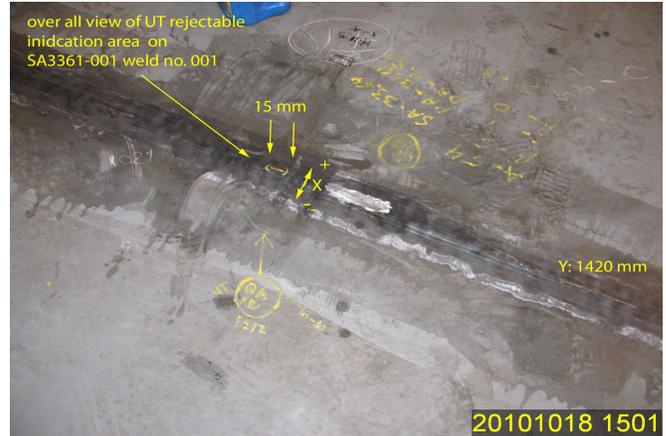
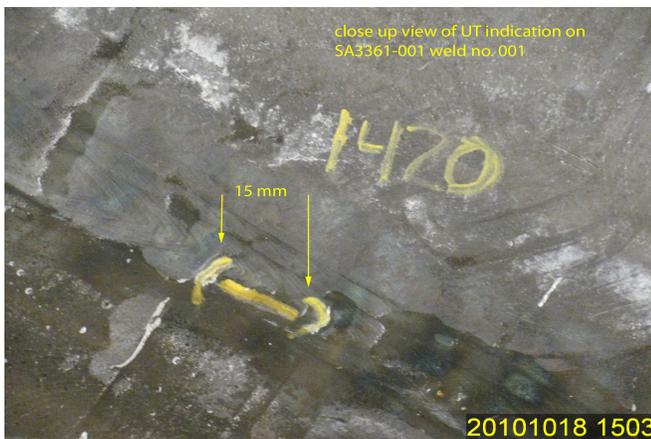
During the Quality Assurance Ultrasonic Testing (UT) review of welds located on OBG Sub Assembly SA3361-001 this Quality Assurance Inspector (QA) discovered the following issues:

- One ultrasonic longitudinal linear indication measuring approximately 15mm in length on a 40mm thick plate.
- The weld is identified as: SA3361-001-001.
- Indication rating is 0 dbs.
- Depth of indication is 12mm
- Y location is approximately 1420mm from the edge of the plate.
- The weld is a Complete Joint Penetration (CJP) joint, joining web plate X4757A to web plate X4757B.
- The OBG Sub assembly SA3161-001 is located in Bay 4 west side.

The NDT Inspection Notification Sheet is Document No. 07013. The indication is located within an area that has been previously tested and accepted by ZPMC Quality Control (QC) personnel. According to the contract documents, ZPMC's QC personnel are required to perform 100% UT inspection of this weld.

AWS D1.5 (02) Table 6.3 – “Specifies a Class A indication having a dbS rating of 4 and lower for material thicknesses between 38mm and 60mm.”

Contractor repaired and provided acceptable NDT records to close the issues. The proposed resolution is acceptable. This NCR is closed.

ZPMC acknowledged the indication was missed and has issued an internal NCR to address this problem. ZPMC has repaired the indication and is providing the NDT record to show the acceptance of this weld. Based on this, ZPMC is requesting closure of this NCR.
