Contract #: 04-0120F4Cty: SF/ALA Rte: 80 PM: 13.2/13.9File #: 69.25B**QUALITY ASSURANCE -- NON-CONFORMANCE REPORT****Location:** Changxing Island, Shanghai, P.R. China**Report No:** NCR-000870**Prime Contractor:** American Bridge/Fluor Enterprises, a JV**Date:** 19-Oct-2010**Submitting Contractor:** Zhenhua Port Machinery Company, Ltd (ZPMC), Changxing Island**NCR #:** ZPMC-0832**Type of problem:**

**Reference Description:** QA found 5 missed MT cracks after ZPMC had tested and accepted these welds in various Crossbeam 16 components

**Job Name:** SAS Superstructure  
**Document No:** 05.03.06-000827

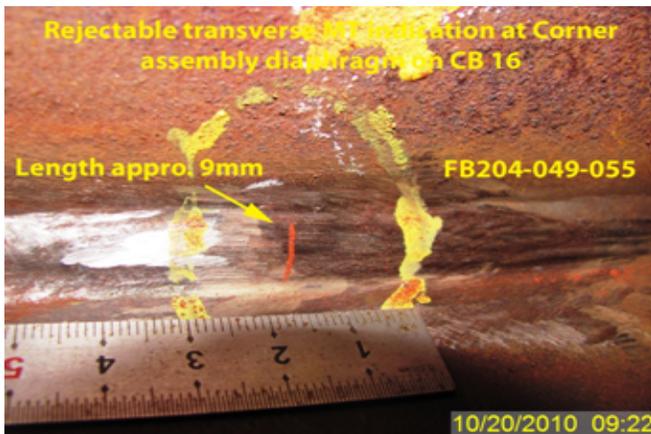
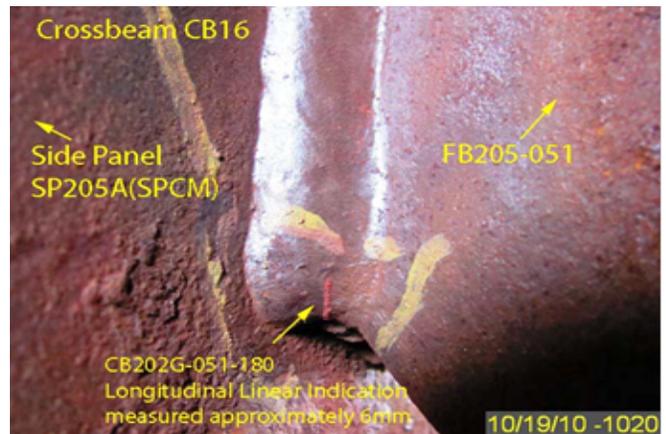
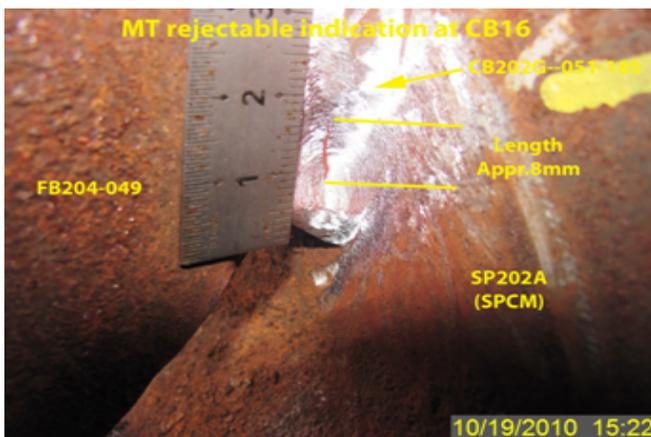
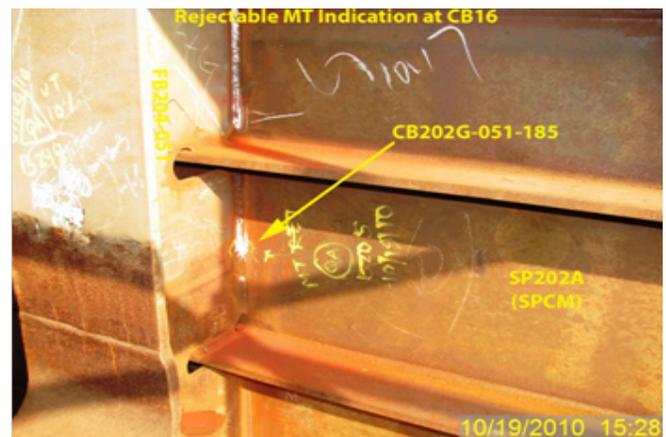
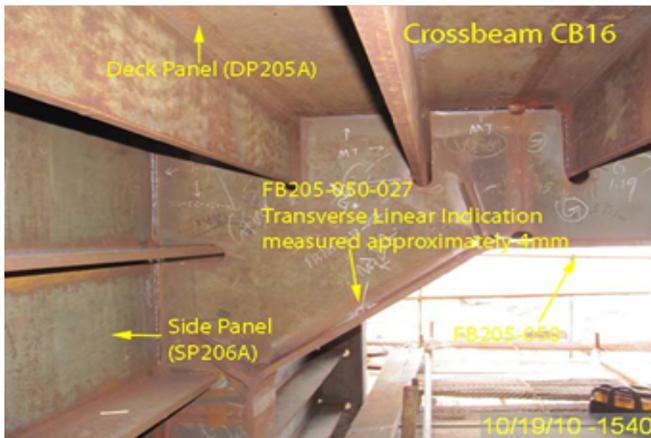
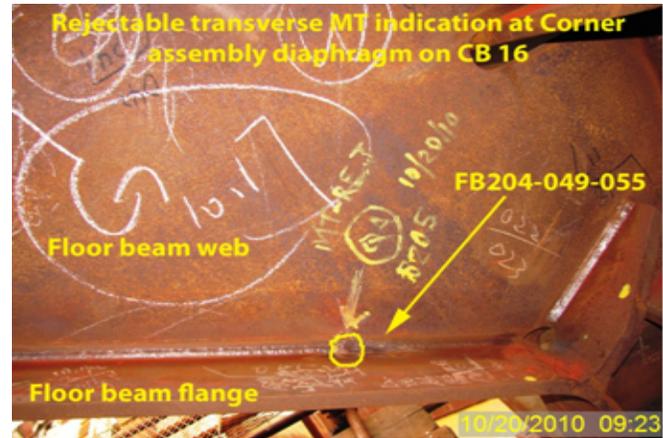
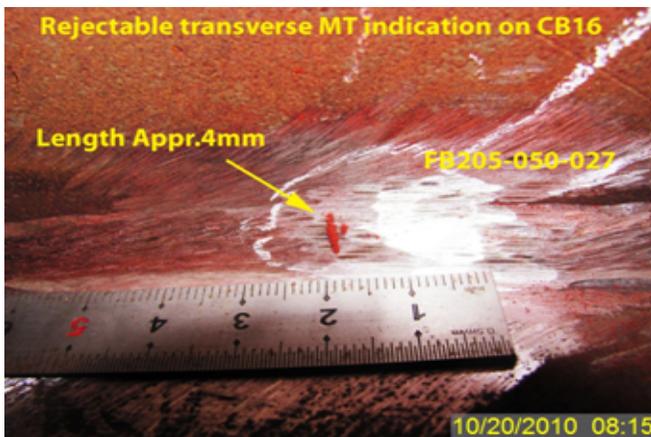
During the Quality Assurance (QA) Magnetic Particle Testing (MT) review of welds located on Orthotropic Box Girder (OBG) Cross Beam CB16, this QA Inspector discovered the following issues:

- One Transverse Linear crack measuring approximately 4mm.
- The weld is identified as FB205-050-027.
- The weld is a fillet weld joining floor beam diaphragm web plate to flange.
- Y location is approximately 550mm from west side panel identified as SP206A.

- One Transverse Linear crack measuring approximately 9mm.
- The weld is identified as FB204-049-55.
- The weld is the fillet weld joining flange to floor beam diaphragm web plate.
- Y location is approximately 250mm from east side cope hole.
- Three (3) Longitudinal Linear cracks in welds identified as CB202G-051-180, CB202G-051-185 & CB202G-049-185.
- Weld CB202G-051-180.
- Longitudinal Linear indication measures approximately 6mm.
- Y location is 0mm from the Side panel (SP205A).
- Weld CB202G-051-180 is a Fillet Weld joining Floor Beam Intermediate Diaphragm FB205-051 to Side Panel SP205A.
- SP205A is designated as SPCM.

- Weld CB202G-051-185.
- Longitudinal Linear indication measuring approximately 4mm.
- Y location is 0mm from the Side panel (SP202A)
- Weld CB202G-051-185 is a Fillet Weld joining Floor Beam Intermediate Diaphragm FB204-051 to Side

Panel SP202A.

-SP202A is designated as SPCM.

-Weld CB202G-049-185.

-Longitudinal Linear indication measuring approximately 8mm.

-Y location is 0mm from the Side panel (SP202A)

-Weld CB202G-049-185 is a Fillet Weld joining Floor Beam Intermediate Diaphragm FB204-049 to Side Panel SP202A.

-Weld FB205-050-027 is within an area previously tested and accepted by ZPMC Quality Control (QC) personnel. ZPMC's QC personnel are required to perform 10% MT of this weld.

-Welds CB202G-051-180, CB202G-051-185 & CB202G-049-185 are within an area previously tested and accepted by ZPMC Quality Control (QC) personnel. ZPMC's QC personnel are required to perform 100% MT inspection of these welds.

AWS D1.5 (02) Table 6.8 specifies fusion type discontinuities greater than 1.6mm in length shall be rejected on 6mm fillet welds.

AWS D1.5 (02) Section 6.26.2 "Welds that are subject to MT in addition to visual inspection shall have no cracks."

**Reference Resolution:** ZPMC has repaired the indications noted in the NCR and is providing NDT documentation after the repair to show the indications has been removed

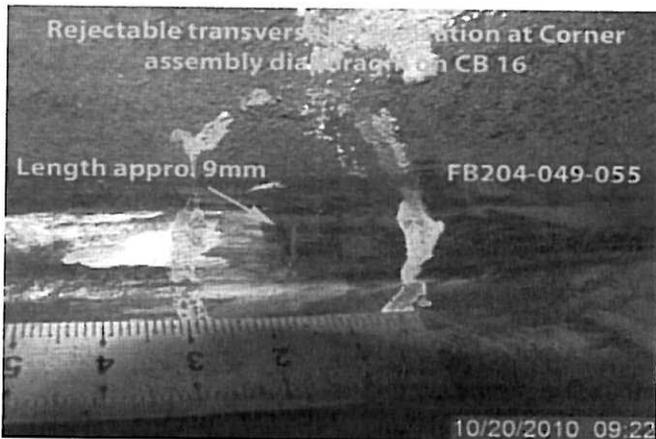
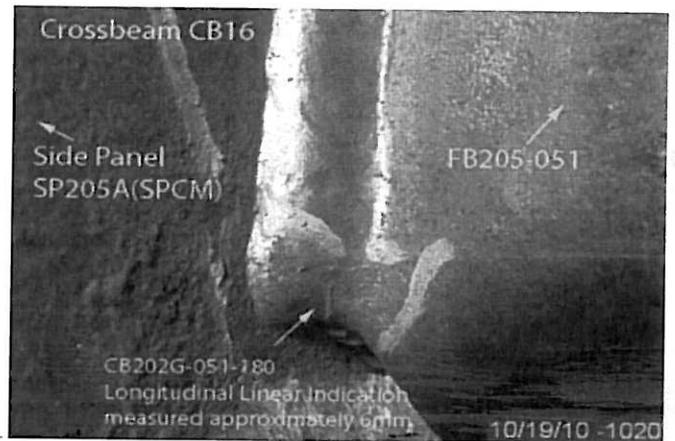
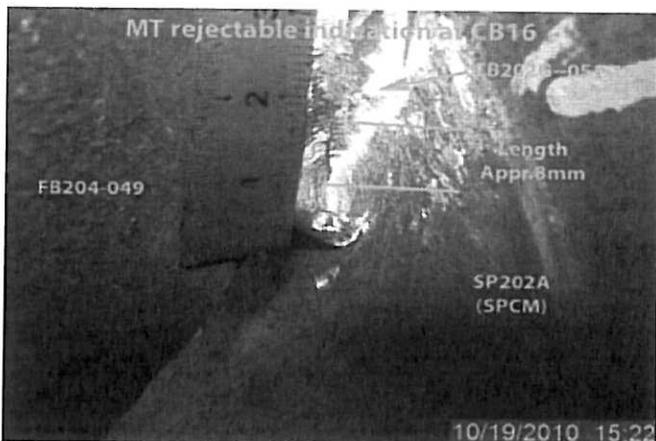
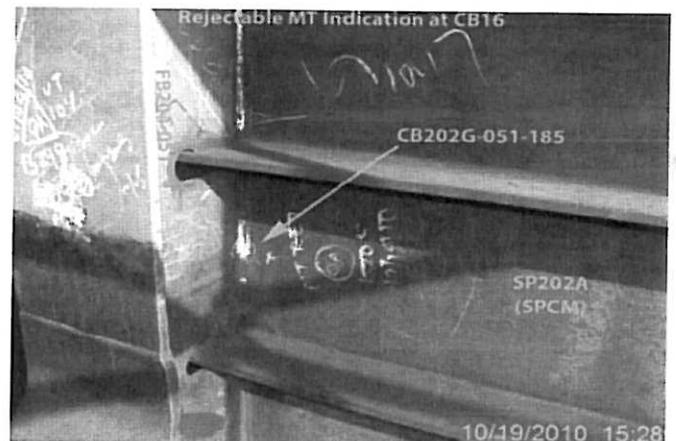
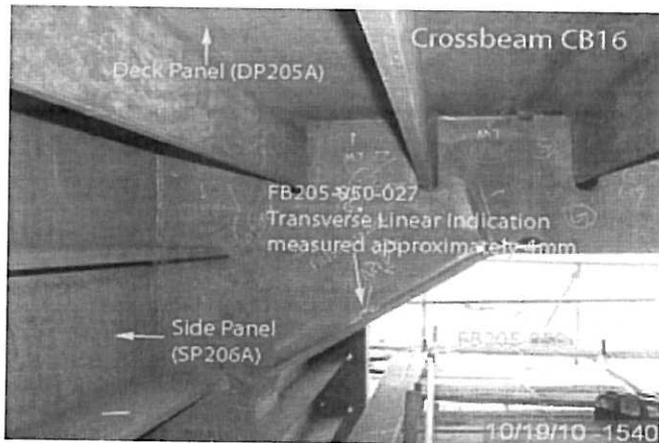
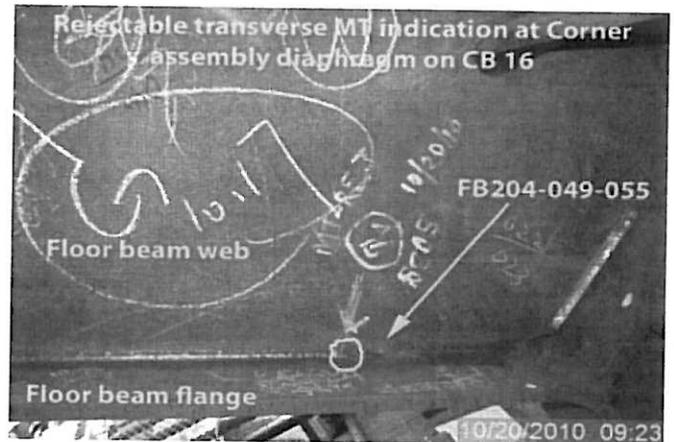
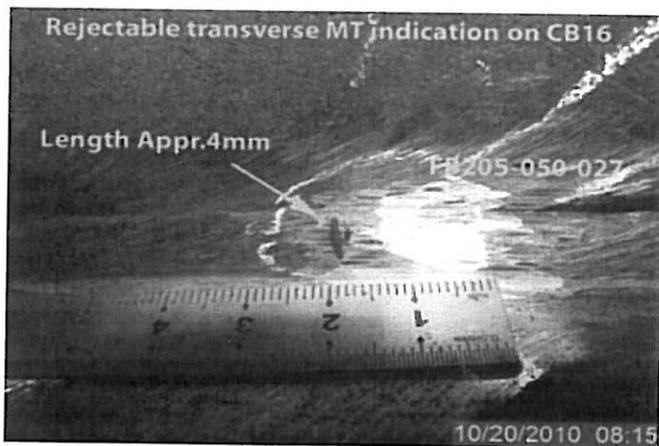
During the Quality Assurance (QA) Magnetic Particle Testing (MT) review of welds located on Orthotropic Box Girder (OBG) Cross Beam CB16, this QA Inspector discovered the following issues:

- One Transverse Linear crack measuring approximately 4mm.
- The weld is identified as FB205-050-027.
- The weld is a fillet weld joining floor beam diaphragm web plate to flange.

- Y location is approximately 550mm from west side panel identified as SP206A.
- One Transverse Linear crack measuring approximately 9mm.
- The weld is identified as FB204-049-55.

- The weld is the fillet weld joining flange to floor beam diaphragm web plate.
- Y location is approximately 250mm from east side cope hole.
- Three (3) Longitudinal Linear cracks in welds identified as CB202G-051-180, CB202G-051-185 & CB202G-049-185.

- Weld CB202G-051-180.
- Longitudinal Linear indication measures approximately 6mm.
- Y location is 0mm from the Side panel (SP205A).
- Weld CB202G-051-180 is a Fillet Weld joining Floor Beam Intermediate Diaphragm FB205-051 to Side Panel SP205A.

- SP205A is designated as SPCM.
- Weld CB202G-051-185.
- Longitudinal Linear indication measuring approximately 4mm.
- Y location is 0mm from the Side panel (SP202A)

- Weld CB202G-051-185 is a Fillet Weld joining Floor Beam Intermediate Diaphragm FB204-051 to Side

-Weld CB202G-049-185.

-Longitudinal Linear indication measuring approximately 8mm.

-Y location is 0mm from the Side panel (SP202A)

-Weld CB202G-049-185 is a Fillet Weld joining Floor Beam Intermediate Diaphragm FB204-049 to Side Panel SP202A.

-Weld FB205-050-027 is within an area previously tested and accepted by ZPMC Quality Control (QC) personnel. ZPMC's QC personnel are required to perform 10% MT of this weld.

-Welds CB202G-051-180, CB202G-051-185 & CB202G-049-185 are within an area previously tested and accepted by ZPMC Quality Control (QC) personnel. ZPMC's QC personnel are required to perform 100% MT inspection of these welds.

AWS D1.5 (02) Table 6.8 specifies fusion type discontinuities greater than 1.6mm in length shall be rejected on 6mm fillet welds.

AWS D1.5 (02) Section 6.26.2 "Welds that are subject to MT in addition to visual inspection shall have no cracks."
