Contract #: 04-0120F4
 Cty: SF/ALA Rte: 80 PM: 13.2/13.9
 File #: 69.25B

QUALITY ASSURANCE -- NON-CONFORMANCE REPORT

Report No: NCR-000872

Welding	Concrete	Other	
Welding	Curing	Procedural	Bridge No: 34-0006
Joint fit-up	Coating	Other	Component: OBG Bike path. (Lift 8E)
Procedural	Procedural	Description:

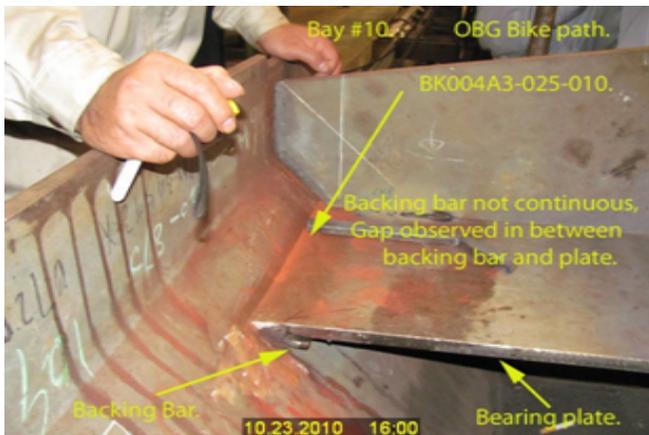
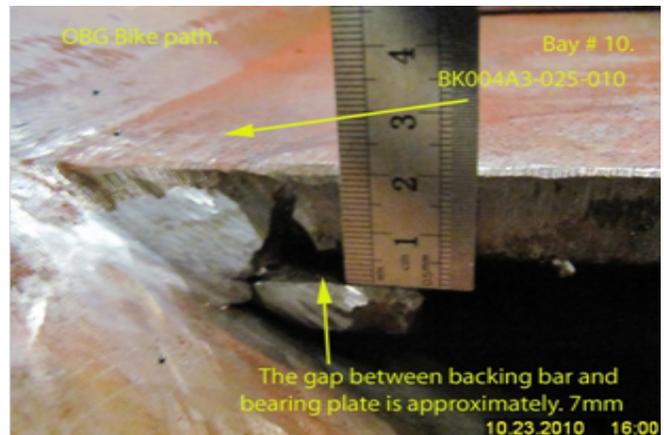
During the Caltrans Quality Assurance (QA) in-process observations of the fabrication of OBG Bike path plate BK004A-025 (Lift 8E), this QA Inspector discovered the following issue:

- Steel backing was not properly placed and held in intimate contact with the base metal.
- The gap between steel backing and bearing stiffener plate is observed approximately 7mm.
- The weld is Complete Joint Penetration (CJP) with steel backing joining the Bearing Plate and End Plate (side plate) of bike path.
- The weld is identified as: BK004A3-025-010.
- The member is located in bay #10.
- The Notice of Witness Inspection Number (NWIT) is 07078. ZPMC had inspected this weld prior to submitting the NWIT.

-AWS D1.5 2002, Section 3.13.5: "Steel backing shall be placed and held in intimate contact with the base metal. The maximum gap between steel backing and the base metal at the weld root shall be 2 mm."

NDT and VT have been performed on the weld area where the backing bar was removed and the results are acceptable. To prevent future occurrences, the inspector fit up inspection will verify that the backing bar is tacked sufficiently to ensure that it will remain in place during welding. ZPMC has written an internal NCR to this effect to inform their inspectors.

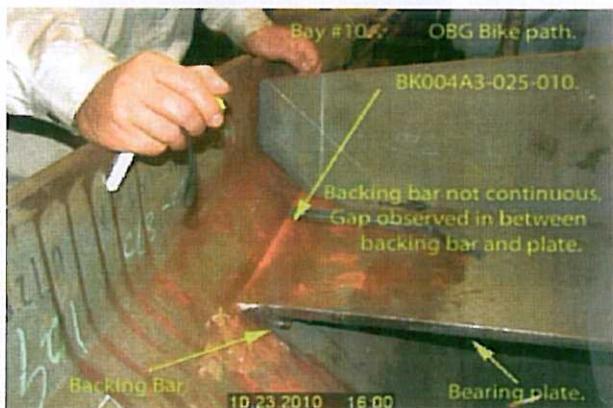
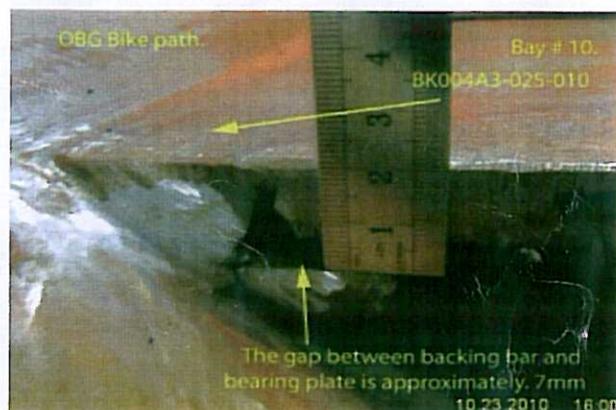
During the Caltrans Quality Assurance (QA) in-process observations of the fabrication of OBG Bike path plate BK004A-025 (Lift 8E), this QA Inspector discovered the following issue:

- Steel backing was not properly placed and held in intimate contact with the base metal.
- The gap between steel backing and bearing stiffener plate is observed approximately 7mm.
- The weld is Complete Joint Penetration (CJP) with steel backing joining the Bearing Plate and End Plate (side plate) of bike path.
- The weld is identified as: BK004A3-025-010.
- The member is located in-bay #10.
- The Notice of Witness Inspection Number (NWIT) is 07078. ZPMC had inspected this weld prior to submitting the NWIT.

-AWS D1.5 2002, Section 3.13.5: "Steel backing shall be placed and held in intimate contact with the base metal. The maximum gap between steel backing and the base metal at the weld root shall be 2 mm."

NDT and VT were performed on the weld area where the backing bar was removed, and the results are acceptable. Contractor issued the internal NCR to the inspector.
