QUALITY ASSURANCE -- NON-CONFORMANCE REPORT

Location: Changxing Island, Shanghai, P.R. China**Report No:** NCR-000874**Prime Contractor:** American Bridge/Fluor Enterprises, a JV**Date:** 24-Oct-2010**Submitting Contractor:** Zhenhua Port Machinery Company, Ltd (ZPMC), Changxing Island**NCR #:** ZPMC-0836**Type of problem:**

Reference Description: QA found 2 MT indications after ZPMC notified CT to inspect the welds at the Bikepath Assembly BK004A2-053

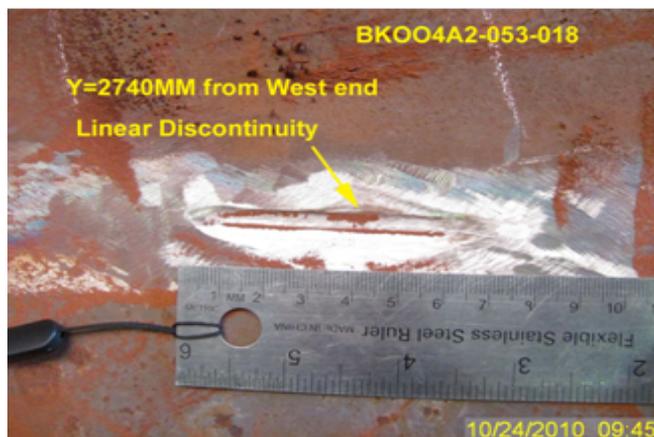
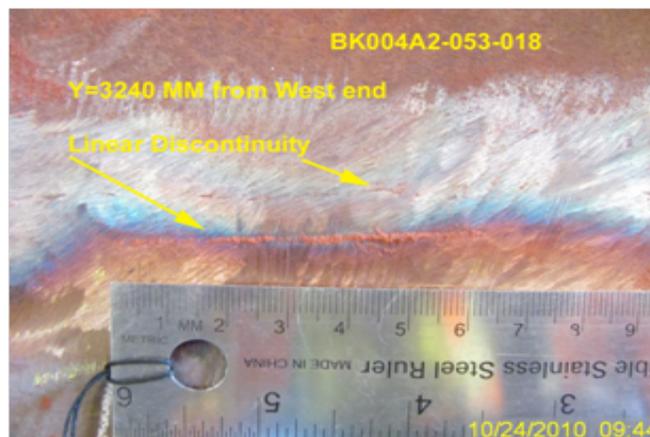
- One longitudinal linear indication measuring approximately 62mm.
- The weld is identified as: BK004A2-053-018
- The Y location is approximately 2740 MM from the top of the weld as shown on drawing BK004A2.
- The Weld is a Complete Joint Penetration (CJP) splice weld joining the bike path bottom identified as BKPL5A to bike path bottom plate identified as BKPL4B.
- The weld is not SPCM.

- One longitudinal linear indication measuring approximately 59mm.
- The weld is identified as: BK004A2-053-018
- The Y location is approximately 3240 MM from the top of the weld as shown on drawing BK004A2.
- The Weld is a Complete Joint Penetration (CJP) splice weld joining the bike path bottom identified as BKPL5A to bike path bottom plate identified as BKPL4B.
- The weld is not SPCM.

- The Notice of Witness Inspection Number (NWIT) is 7081. ZPMC has previously inspected and accepted the weld as indicated by the marking on the steel.
- After this QA discovered the above mentioned indications, ZPMC canceled the NDT notification, stating that they did not complete MT inspection on this weld.

AWS D1.5 2002 Table 6.8: Specifies indications greater than 1.6mm in length in welds of this size (6mm) are rejectable.

Reference Resolution: ZPMC has repaired the indications noted in the NCR and is providing NDT documentation after the repair to show the indication has been removed.

ZPMC acknowledged the indications were missed and has issued an internal NCR to address this problem. ZPMC has repaired the indications and is providing the NDT records to show the acceptance of this weld. Based on this, ZPMC is requesting closure of this NCR.

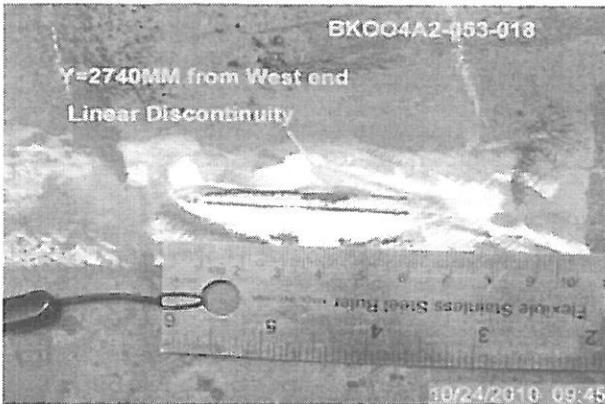
- One longitudinal linear indication measuring approximately 62mm.
- The weld is identified as: BK004A2-053-018
- The Y location is approximately 2740 MM from the top of the weld as shown on drawing BK004A2.
- The Weld is a Complete Joint Penetration (CJP) splice weld joining the bike path bottom identified as BKPL5A to bike path bottom plate identified as BKPL4B.
- The weld is not SPCM.

- One longitudinal linear indication measuring approximately 59mm.
- The weld is identified as: BK004A2-053-018
- The Y location is approximately 3240 MM from the top of the weld as shown on drawing BK004A2.
- The Weld is a Complete Joint Penetration (CJP) splice weld joining the bike path bottom identified as BKPL5A to bike path bottom plate identified as BKPL4B.
- The weld is not SPCM.

- The Notice of Witness Inspection Number (NWIT) is 7081. ZPMC has previously inspected and accepted the weld as indicated by the marking on the steel.
- After this QA discovered the above mentioned indications, ZPMC canceled the NDT notification, stating that they did not complete MT inspection on this weld.

AWS D1.5 2002 Table 6.8: Specifies indications greater than 1.6mm in length in welds of this size (6mm) are rejectable.

Contractor will repair the indications. Contractor will provide the the NDT report after repair. Contractor will identify the inspector and monitor his performance. Disciplinary action will be undertaken, if the inspector missed the indication continuously.
