Contract #: 04-0120F4  
 Cty: SF/ALA Rte: 80 PM: 13.2/13.9  
 File #: 69.25B

## QUALITY ASSURANCE -- NON-CONFORMANCE REPORT

**Report No:** NCR-000875

**Reference Description:** QA found 4 missed VT cracks after ZPMC had tested and accepted these welds for the steel barriers

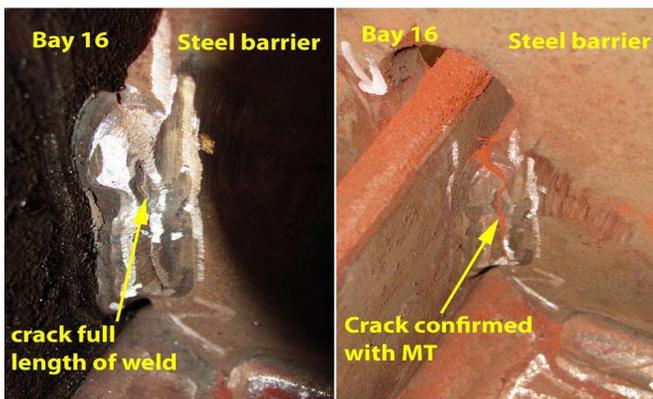
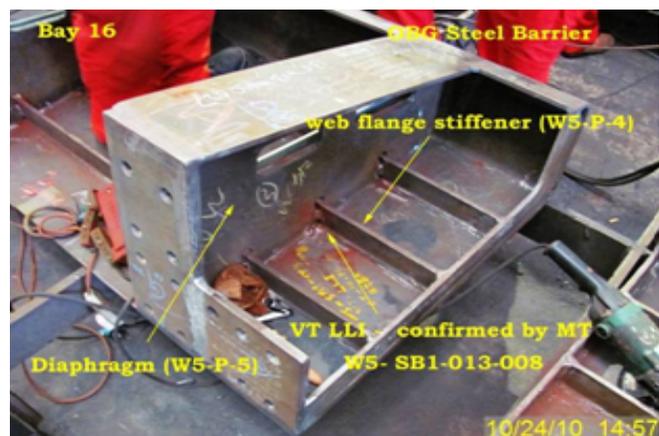
During random Quality Assurance (QA) visual verification of welds located on OBG Component steel barrier, Caltrans (CT) QA Inspectors discovered the following issues:

- Four Longitudinal cracks measuring approximately 20 to 25mm in length.
- The cracks were found on barriers identified as W5-SB1-013-008, W5- SB1-032-002, W5- SB1-029-042, and W5- SB2-002-033.
- These welds are fillet welds, joining the diaphragm (W5-P-5) to the web stiffener (W5-P-4).
- The indications are clearly marked on the material near the weld.
- OBG Component Steel barriers are located in Bay#16.
- The indications were discovered visually and confirmed by Magnetic particle Testing (MT) by Caltrans QA.
- The Notice of Witness Inspection Number (NWIT) is 007081. The Longitudinal Linear Indications are located within an area that had been previously inspected by ZPMC Quality Control (QC) personnel. As per contract documents ZPMC is required to perform 100% Visual Testing (VT) of these welds.

AWS D1.5 (02) Section 6.26.1.1 – “The Weld shall have no cracks.”

**Reference Resolution:** ZPMC has repaired the indications noted in the NCR and is providing NDT documentation after the repair to show the indication has been removed

Contractor repaired and provided acceptable NDT records to close the issues. The proposed resolution is acceptable. This NCR is closed.

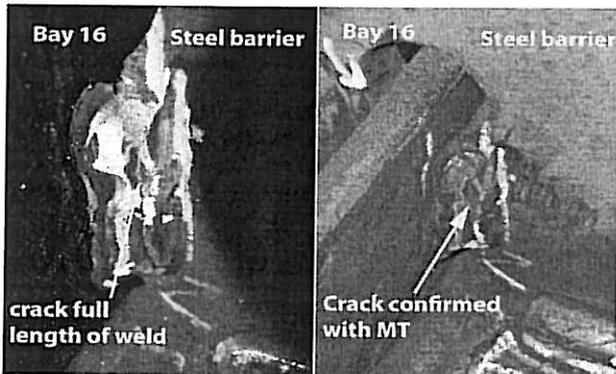
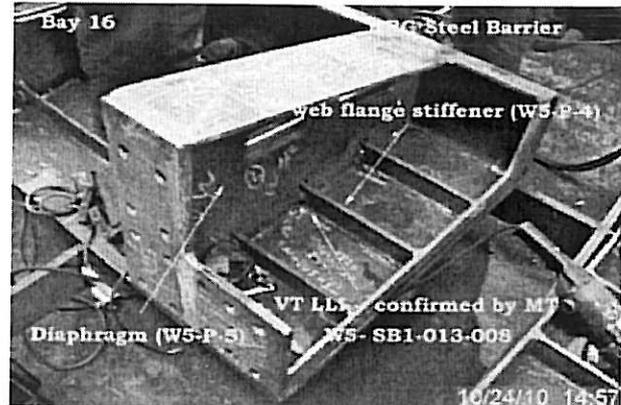
During random Quality Assurance (QA) visual verification of welds located on OBG Component steel barrier, Caltrans (CT) QA Inspectors discovered the following issues:

- Four Longitudinal cracks measuring approximately 20 to 25mm in length.
- The cracks were found on barriers identified as W5-SB1-013-008, W5- SB1-032-002, W5- SB1-029-042, and W5- SB2-002-033.
- These welds are fillet welds, joining the diaphragm (W5-P-5) to the web stiffener (W5-P-4).
- The indications are clearly marked on the material near the weld.
- OBG Component Steel barriers are located in Bay#16.
- The indications were discovered visually and confirmed by Magnetic particle Testing (MT) by Caltrans QA.
- The Notice of Witness Inspection Number (NWIT) is 007081. The Longitudinal Linear Indications are located within an area that had been previously inspected by ZPMC Quality Control (QC) personnel. As per contract documents ZPMC is required to perform 100% Visual Testing (VT) of these welds.

AWS D1.5 (02) Section 6.26.1.1 – “The Weld shall have no cracks.”

Contractor proposes to repair the weld indication, and provide NDT report to prove the weld is acceptable. Contractor will monitor the inspector who missed the indication, and take disciplinary action should be continuously making similar mistakes.

Contractor repaired and provided acceptable NDT records to close the issues. Contractor identified the inspector responsible and is monitoring his performance.
