Contract #: 04-0120F4Cty: SF/ALA Rte: 80 PM: 13.2/13.9File #: 69.25B**QUALITY ASSURANCE -- NON-CONFORMANCE REPORT****Location:** Changxing Island, Shanghai, P.R. China**Report No:** NCR-000880**Prime Contractor:** American Bridge/Fluor Enterprises, a JV**Date:** 28-Oct-2010**Submitting Contractor:** Zhenhua Port Machinery Company, Ltd (ZPMC), Changxing Island**NCR #:** ZPMC-0842**Type of problem:**

**Reference Description:** QA found a missed UT indication after ZPMC had tested and accepted the weld in OBG Steel Barrier W2-SB9-017

# QUALITY ASSURANCE -- NON-CONFORMANCE REPORT

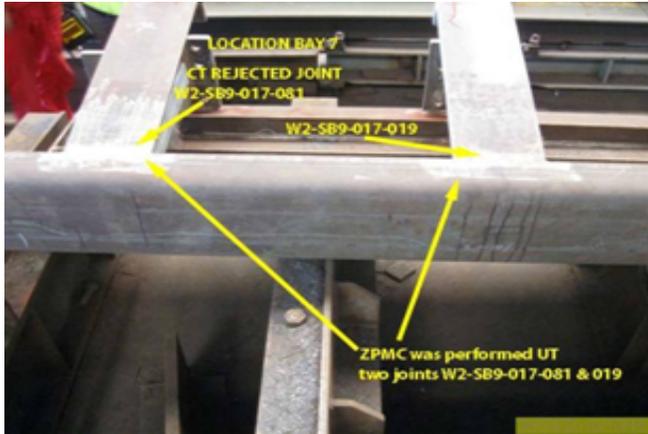
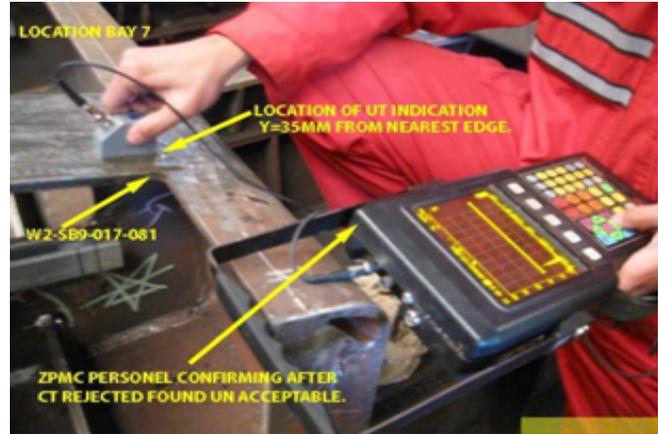
During the Quality Assurance (QA) Ultrasonic Testing (UT) review of weld located on the Steel Barrier (SB), this QA Inspector discovered the following issue:

- One Class "A" rejectable indication measuring approximately 10 mm in length.
- The indication rating is -4dB.
- The depth of the indication was 5-6 mm
- The weld joint is identified as W2-SB9-017-081.
- This weld is a Complete Joint Penetration (CJP) splice joint, joining SB Skin plate to the Diaphragm Flange plate.
- The thickness of the steel material is 12 mm.
- The "Y" location is approximately 35 mm from the nearest end of the weld.
- The indication is clearly marked on or near the weld.
- This SB is located in sub assembly Bay # 7.

The Notice of Witness Inspection Number (NWIT) is 07136. The indication is located within the area that has been previously tested and accepted by ZPMC Quality Control (QC) personnel. As per the contract documents, ZPMC's QC personnel are required to perform 10% UT inspection of this weld.

ZPMC has repaired the indication noted in the NCR and is providing NDT documentation after the repair to show the indication has been removed. ABFJV has noted which inspector was responsible for this missed indications and is monitoring his performance as well as all inspector performance, if he continues to miss indications disciplinary action will be undertaken. Based on these actions, ZPMC requests closure of this NCR.

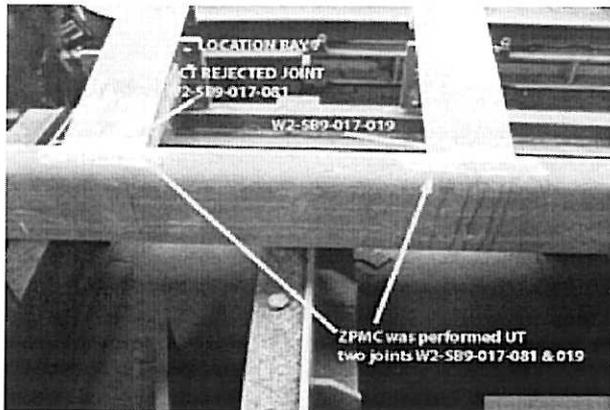
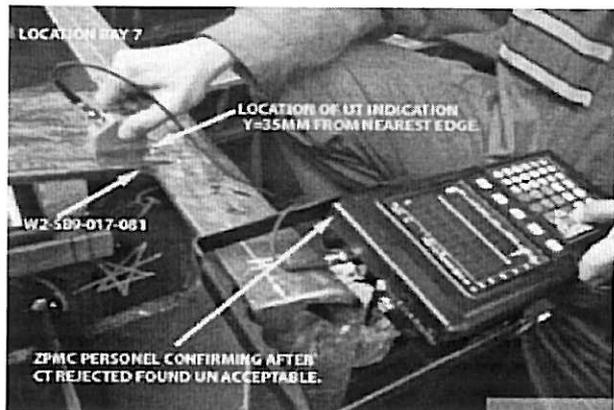
During the Quality Assurance (QA) Ultrasonic Testing (UT) review of weld located on the Steel Barrier (SB), this QA Inspector discovered the following issue:

- One Class "A" rejectable indication measuring approximately 10 mm in length.
- The indication rating is -4dB.
- The depth of the indication was 5-6 mm
- The weld joint is identified as W2-SB9-017-081.
- This weld is a Complete Joint Penetration (CJP) splice joint, joining SB Skin plate to the Diaphragm Flange plate.
- The thickness of the steel material is 12 mm.
- The "Y" location is approximately 35 mm from the nearest end of the weld.
- The indication is clearly marked on or near the weld.
- This SB is located in sub assembly Bay # 7.

The Notice of Witness Inspection Number (NWIT) is 07136. The indication is located within the area that has been previously tested and accepted by ZPMC Quality Control (QC) personnel. As per the contract documents, ZPMC's QC personnel are required to perform 10% UT inspection of this weld.

The missed indications have been removed and NDT report has been submitted to verify the repair has been completed satisfactorily. The inspector involved was disciplined and his performance is being monitored.

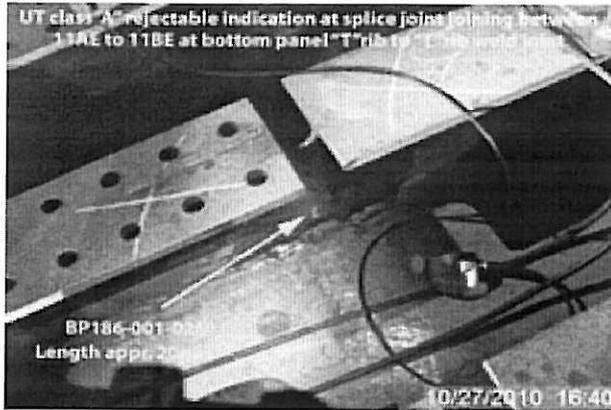
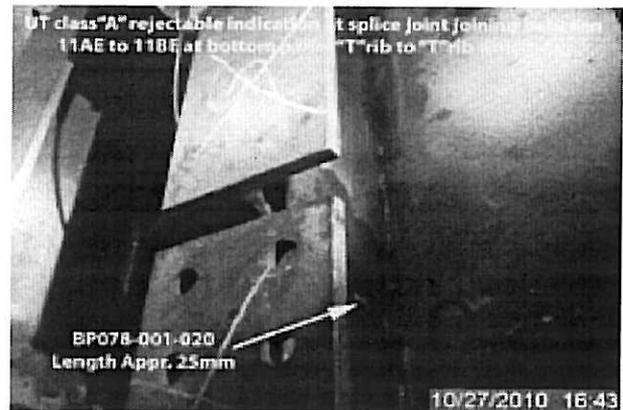
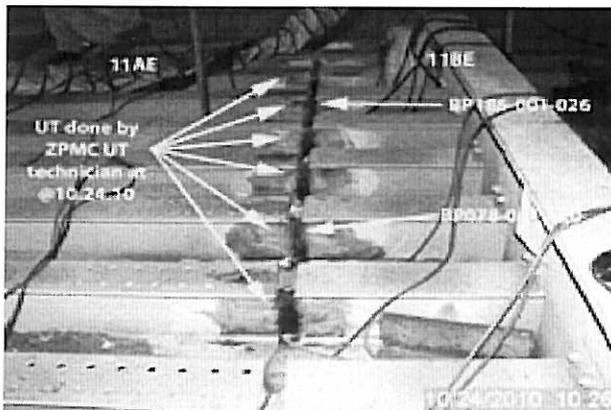
During the Quality Assurance (QA) Ultrasonic Testing (UT) review of welds located on Orthotropic Box Girder (OBG) Segment 11AE to 11BE splice joint, this QA Inspector discovered the following issues:

- Two (2) longitudinal linear Class "A" rejectable indications measuring approximately 20 and 25mm in length.
- The welds are identified as BP186-001-026 and BP078-001-020 respectively.
- Material thickness is 10mm.
- The depth of the indications: approximately 6 and 8mm respectively.
- The indication dBs ratings are +7 and +9 respectively.
- The welds are Complete Joint Penetration (CJP) butt joints, joining bottom plate T-ribs on 11AE to bottom plate T-ribs on 11BE.
- The welds are designated as non Seismic Performance Critical Material (Non SPCM).
- The indications are clearly marked near the welds.
- The Y distance for weld joint BP186-001-026 is 35 mm from bottom cope hole.
- The Y distance for weld joint BP078-001-020 is 45 mm from bottom cope hole.
- The segments are located in the OBG Trial Assembly area.

The Notice of Witness Inspection (NWIT) No. is 007134. The indications are located within an area previously tested and accepted by ZPMC Quality Control (QC) personnel. Per the contract documents, ZPMC's QC personnel are required to perform 25% UT inspection of these welds.

For indication location details, see the attached Photos (The first photo, dated 10/24/10, is included in this incident report for the purpose of confirming that ZPMC QC was previously observed by this QA, performing Ultrasonic Testing (UT) on the welds addressed in this report)

ZPMC acknowledged the indications were missed and has issued an internal NCR to address this problem. ZPMC has repaired the indications and is providing the NDT records to show the acceptance of this weld. Based on this, ZPMC is requesting closure of this NCR.
