Contract #: 04-0120F4
 Cty: SF/ALA Rte: 80 PM: 13.2/13.9
 File #: 69.25B

QUALITY ASSURANCE -- NON-CONFORMANCE REPORT

Report No: NCR-000883

| Joint fit-up | Coating | Other | Component: OBG Steel Barriers |

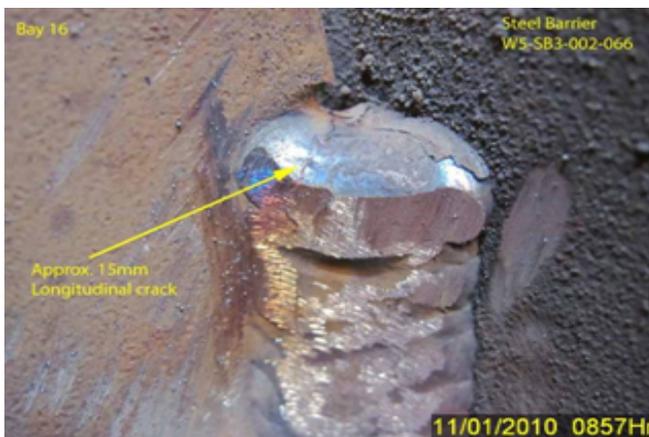
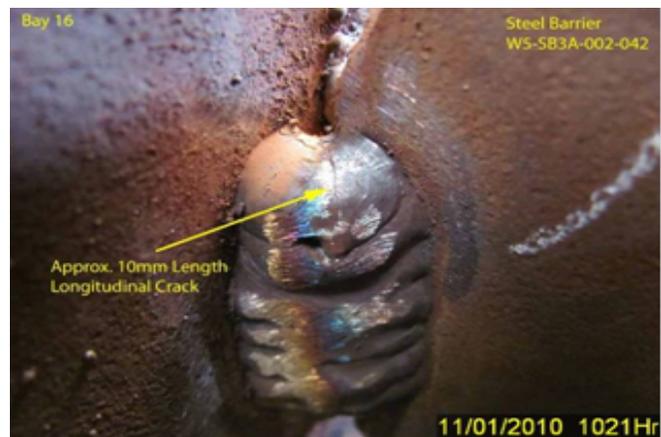
- Two Longitudinal cracks measuring approximately 10 to 15mm in length.
- The welds are identified as W5-SB3A-002-042 and W5-SB3-002-066 respectively.
- The welds are fillet welds, joining the web stiffener (W5-P-4) to the diaphragm (W5-P-5).
- The indications are clearly marked on the material near the weld.
- OBG steel barriers are located in Bay#16.
- The indications were discovered visually and confirmed by Magnetic particle Testing (MT) by Caltrans QA.
- The Notice of Witness Inspection Number (NWIT) is 007083. The cracks are located within an area that has been previously tested and accepted by ZPMC Quality Control (QC) personnel. -As per contract documents ZPMC is required to perform 100% Visual Testing (VT) of these welds.

-AWS D1.5 (02) Section 6.26.1.1 – “The Weld shall have no cracks.”

ZPMC has repaired the VT indications and confirmed their removal using MT and is providing NDT documentation after the repair to show the indication has been removed. ABFJV has noted which inspector was responsible for these missed indications and is monitoring his performance as well as all inspector performance, if he continues to miss indications disciplinary action will be undertaken. Based on these actions, ZPMC requests closure of this NCR.

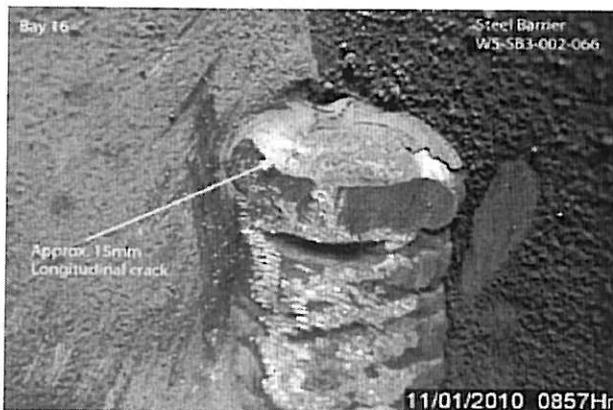
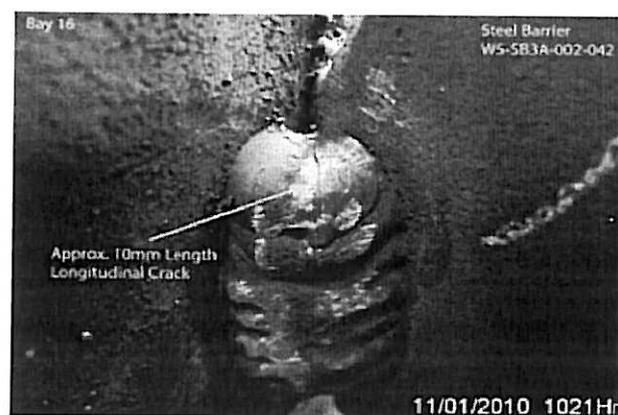
- Two Longitudinal cracks measuring approximately 10 to 15mm in length.
- The welds are identified as W5-SB3A-002-042 and W5-SB3-002-066 respectively.
- The welds are fillet welds, joining the web stiffener (W5-P-4) to the diaphragm (W5-P-5).
- The indications are clearly marked on the material near the weld.
- OBG steel barriers are located in Bay#16.
- The indications were discovered visually and confirmed by Magnetic particle Testing (MT) by Caltrans QA.
- The Notice of Witness Inspection Number (NWIT) is 007083. The cracks are located within an area that has been previously tested and accepted by ZPMC Quality Control (QC) personnel. -As per contract documents ZPMC is required to perform 100% Visual Testing (VT) of these welds.

-AWS D1.5 (02) Section 6.26.1.1 – “The Weld shall have no cracks.”

The missed VT indications have been removed and NDT report has been submitted to verify the repair has been completed satisfactorily. The inspector involved was disciplined and his performance is being monitored
