Contract #: 04-0120F4Cty: SF/ALA Rte: 80 PM: 13.2/13.9File #: 69.25B**QUALITY ASSURANCE -- NON-CONFORMANCE REPORT****Location:** Changxing Island, Shanghai, P.R. China**Report No:** NCR-000888**Prime Contractor:** American Bridge/Fluor Enterprises, a JV**Date:** 08-Nov-2010**Submitting Contractor:** Zhenhua Port Machinery Company, Ltd (ZPMC), Changxing Island**NCR #:** ZPMC-0850**Type of problem:**

Reference Description: Lift 5 Grillage West Shaft Non-fusion Backing bar**Description of Non-Conformance:**

Subject: NCR No. ZPMC-0850

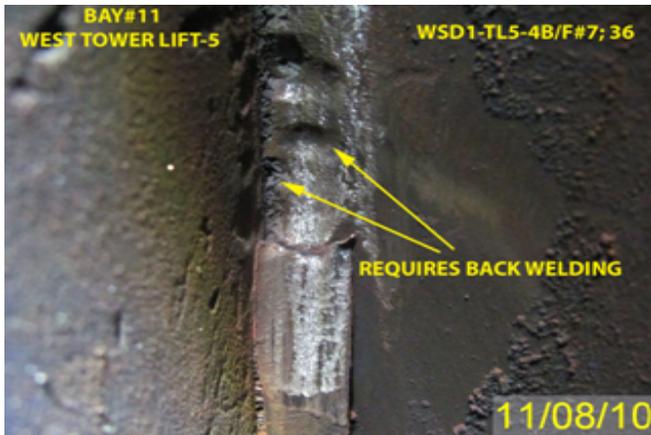
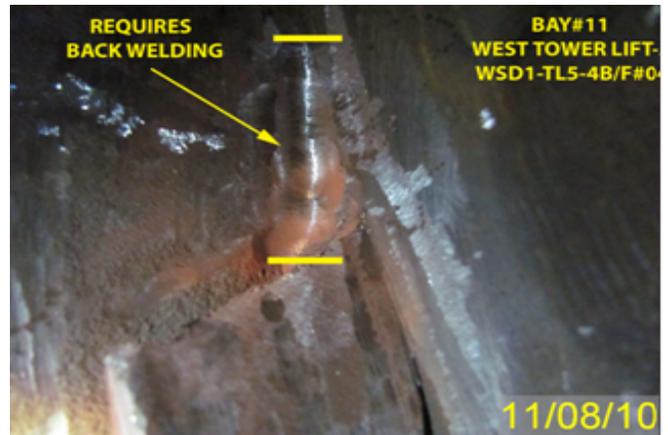
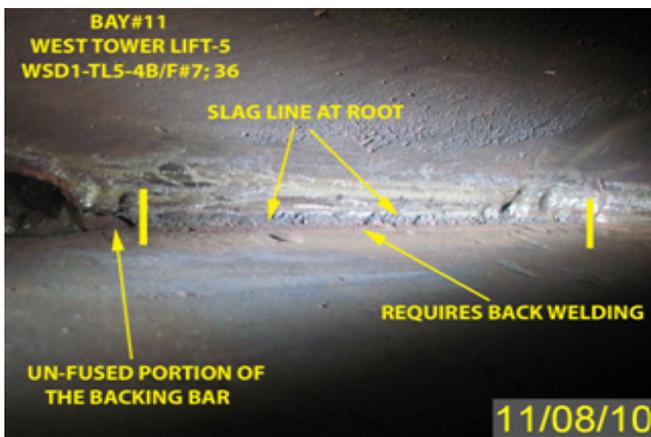
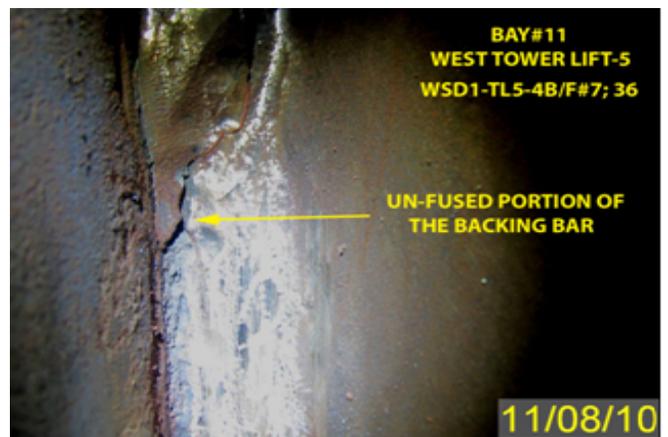
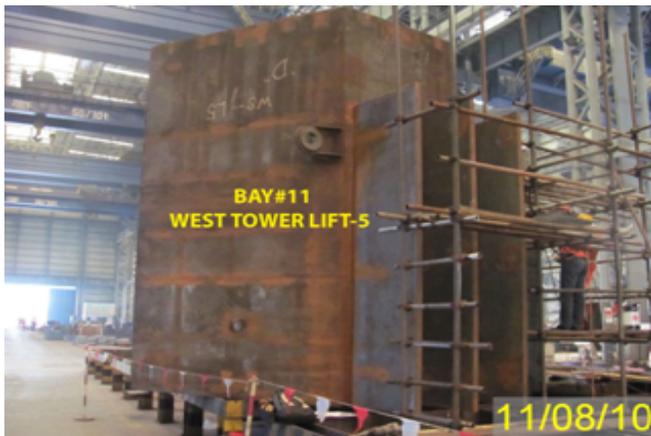
- 1) WSD1-TL5-4B/F#07; 36 – Non-fused backing bar has not been completely removed. There is a slag line at the entire visible root pass area.
- 2) WSD1-TL5-4B/F#04 – Root pass has been ground out to an average depth of 1.5mm. Back welding has not been performed.

-Welds are T-Joint Complete Joint Penetration (CJP) welds.

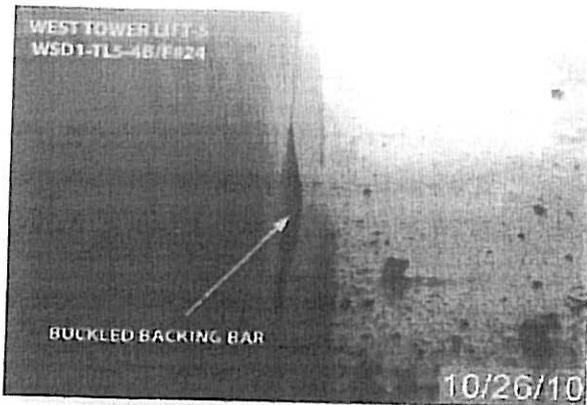
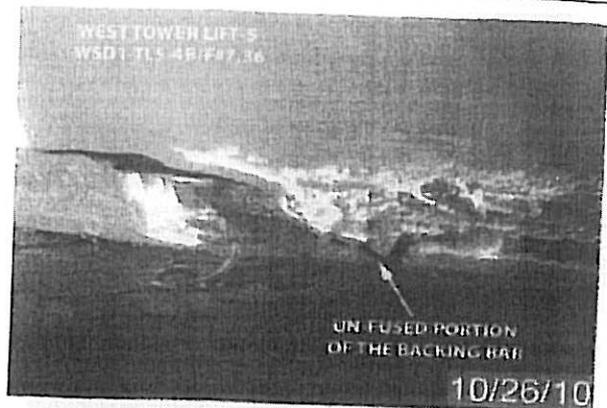
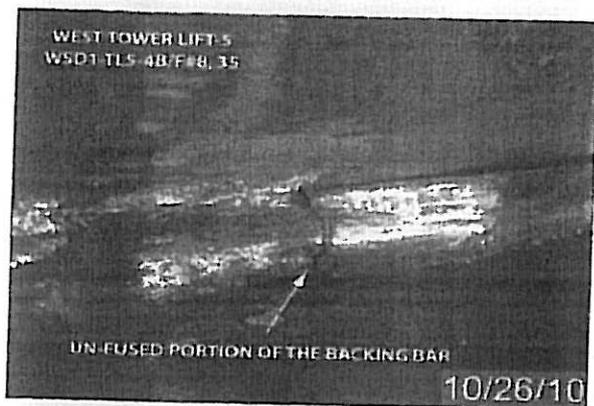
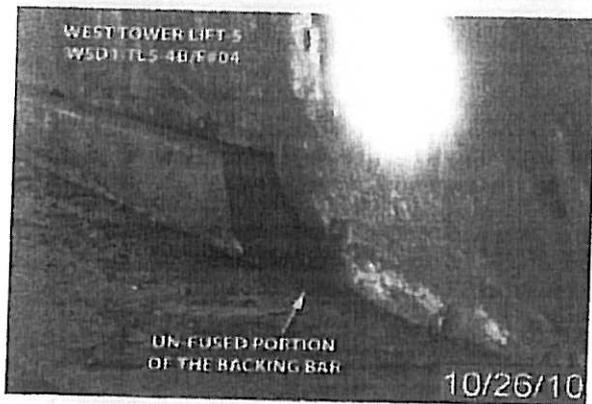
- 1) Non-Fused backing bar requires removal -joint -WSD1-TL5-4B/F#7,36
- 2) Non-Fused backing bar requires removal -joint-WSD1-TL5-4B/F#8,35
- 3) Buckled backing bar requires removal -joint-WSD1-TL5-4B/F#24
- 4) Non-Fused backing bar requires removal -joint-WSD1-TL5-4B/F#4

- 1) Area where backing bar has been removed requires back welding -joint ESD1-TL5-2B/F#23

-As per AWS D1.5 the RFI-002099R0 the groove welds made with steel backing shall have the weld metal thoroughly fused. The remaining ends of the backing bar shall be tapered in with and in depth at a slope no steeper than 1:2.5, as shown in the sketch attached with the referenced RFI.

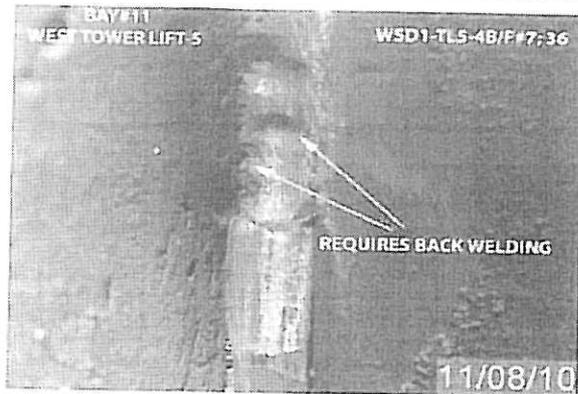
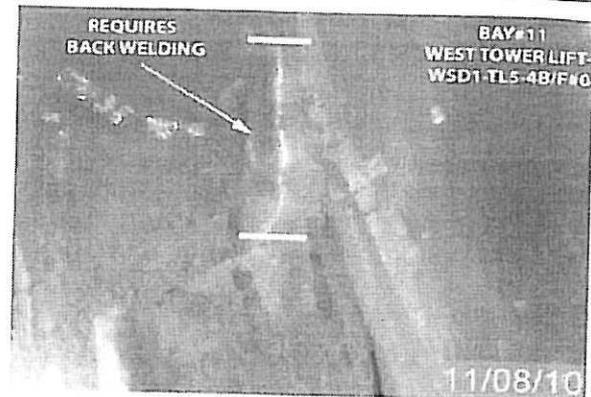
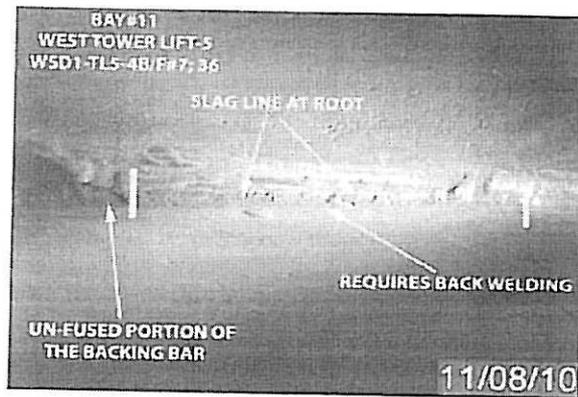
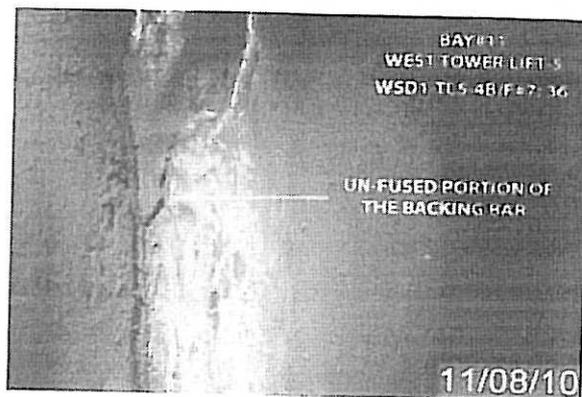
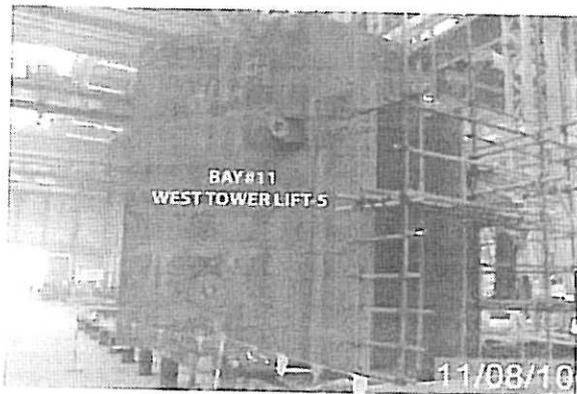
1) WSD1-TL5-4B/F#07; 36 – Non-fused backing bar has not been completely removed. There is a slag line at the entire visible root pass area.

2) WSD1-TL5-4B/F#04 – Root pass has been ground out to an average depth of 1.5mm. Back welding has not been performed.
