QUALITY ASSURANCE -- NON-CONFORMANCE REPORT

Location: Changxing Island, Shanghai, P.R. China **Report No:** NCR-000889
Prime Contractor: American Bridge/Fluor Enterprises, a JV **Date:** 09-Nov-2010
Submitting Contractor: Zhenhua Port Machinery Company, Ltd (ZPMC), Changxing Island **NCR #:** ZPMC-0851

Reference Description: QA found non-approved drilled holes on the service platform electrical panel support SP6.

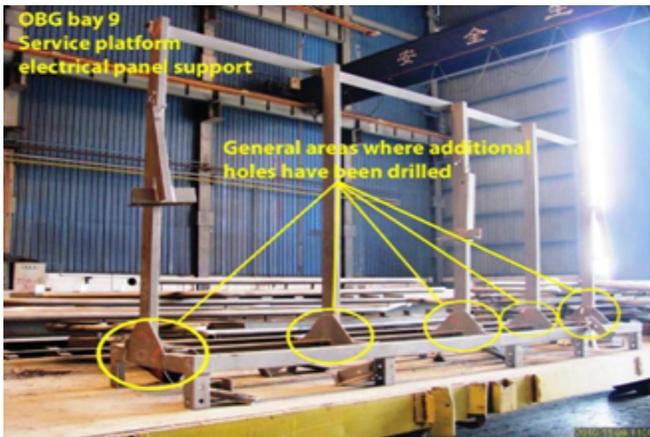
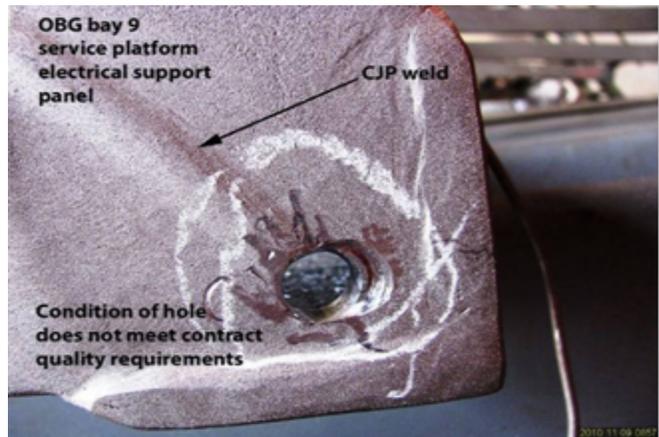
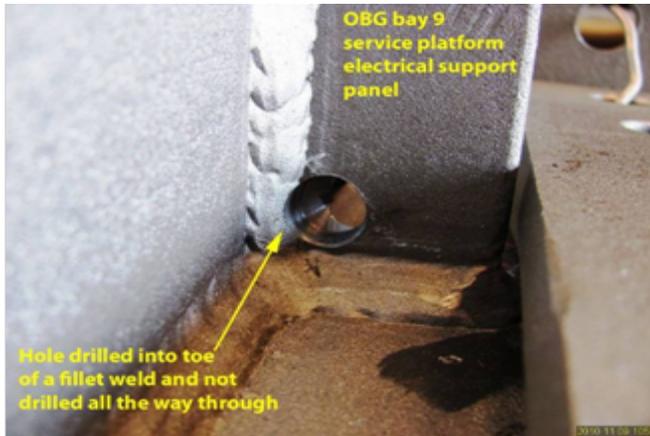
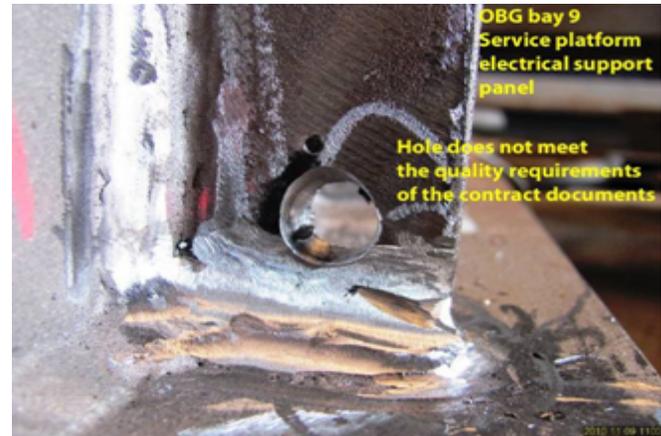
- During Quality Assurance (QA) random visual inspection after grit blasting of OBG Service Platform Electrical Panel Support, this Caltrans QA Inspector observed the following issues:
- ZPMC has drilled approximately 15 to 20 holes which were not specified on the approved shop drawings.
 - The additional holes were drilled in a service platform electrical panel support SP6.
 - These holes were added without the Engineer’s approval.
 - Additionally, The holes do not appear to meet the quality requirements of the contract documents.
 - A number of the holes have been drilled into fillet and CJP welds.
 - The approved shop drawings are identified as SPEP1-A.
 - OBG Service Platform Electrical Panel Support components are located at bay#9.

ZPMC has repaired the misdrilled holes which overlap with existing welds. Attached is the repair report as well as the NDT performed after to show that it is acceptable. Based on this ZPMC requests closure of this NCR.

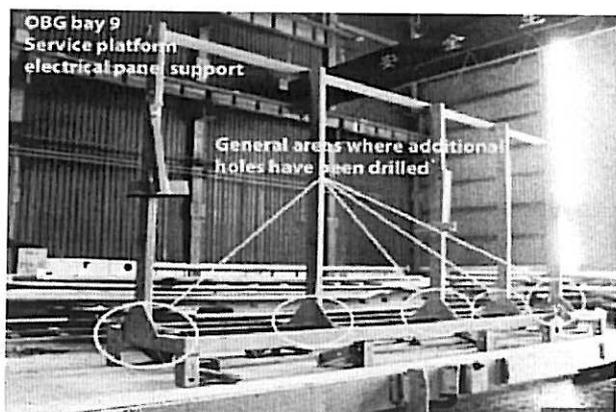
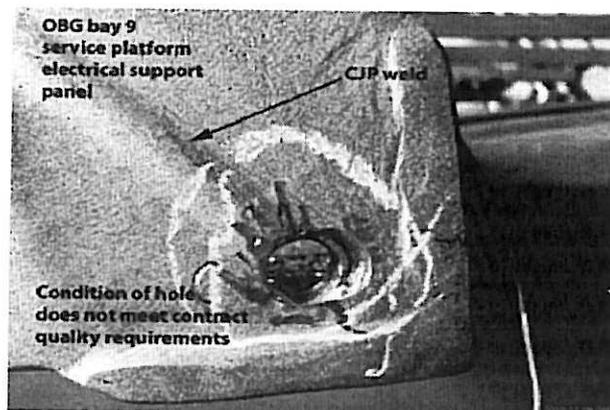
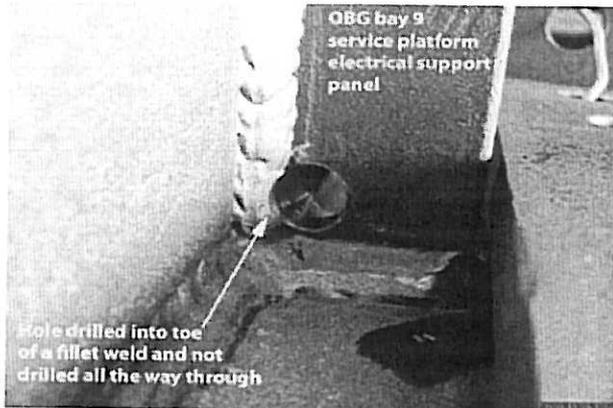
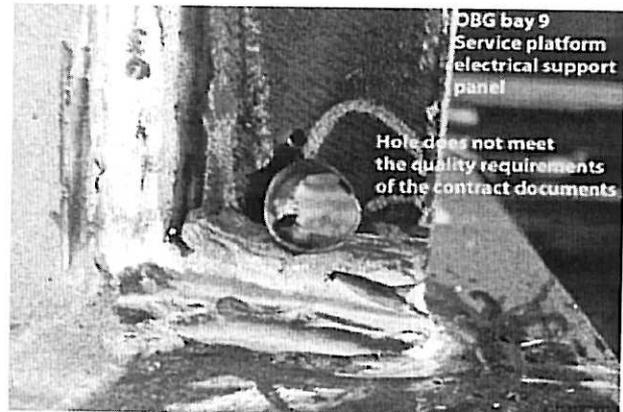
During Quality Assurance (QA) random visual inspection after grit blasting of OBG Service Platform Electrical Panel Support, this Caltrans QA Inspector observed the following issues:

- ZPMC has drilled approximately 15 to 20 holes which were not specified on the approved shop drawings.
- The additional holes were drilled in a service platform electrical panel support SP6.
- These holes were added without the Engineer's approval.
- Additionally, The holes do not appear to meet the quality requirements of the contract documents.
- A number of the holes have been drilled into fillet and CJP welds.
- The approved shop drawings are identified as SPEP1-A.
- OBG Service Platform Electrical Panel Support components are located at bay#9.

As agreed with you yesterday, holes drilled into the fillet and CJP welds of the service platforms' electrical panel frames shall be repaired per an approved procedure with 100% VT and 100% MT performed on the repairs, and any damaged galvanizing shall be repaired in conformance with the Contract requirements.

As for holes not drilled into the welds, these holes are acceptable to remain, provided they can be brought into conformance with the Contract requirements as identified in the NCR and the damaged galvanizing repair requirements.
