Contract #: 04-0120F4Cty: SF/ALA Rte: 80 PM: 13.2/13.9File #: 69.25B**QUALITY ASSURANCE -- NON-CONFORMANCE REPORT****Location:** Changxing Island, Shanghai, P.R. China**Report No:** NCR-000890**Prime Contractor:** American Bridge/Fluor Enterprises, a JV**Date:** 11-Nov-2010**Submitting Contractor:** Zhenhua Port Machinery Company, Ltd (ZPMC), Changxing Island**NCR #:** ZPMC-0852**Type of problem:**

**Reference Description:** Remove 119m Backfill plate weld without Engineer's approval**Description of Non-Conformance:**

## NON-CONFORMANCE REPORT TRANSMITTAL

## NCR PROPOSED RESOLUTION

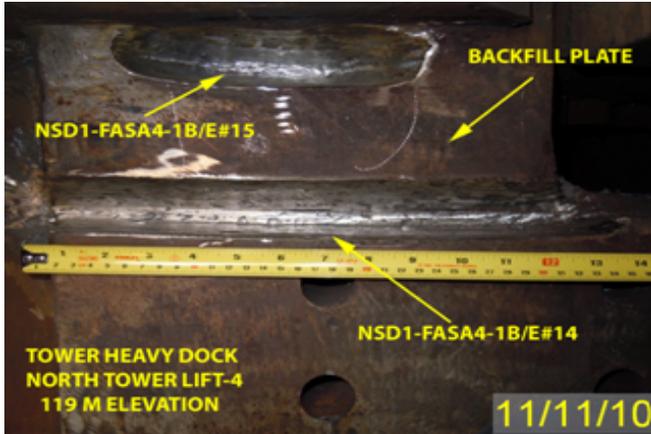
During the Caltrans Quality Assurance (QA) in-process observation on Lift-4 tower shafts, this QA Inspector discovered the following issues:

-After Ultrasonic Testing (UT) rejection of backfill plate welds by ZPMC quality control personnel, ZPMC fabrication personnel removed a total four (4) Non-SPCM welds in North, South and East shafts respectively without notifying the Engineer .

- The Non-SPCM welds are Butt-Joint Complete Joint Penetration (CJP) welds joining backfill plate to doubler plate.

- These welds measured to be approximately 330 mm in length.

- Backfill plate thickness is 50 mm.

- The whole length of the Non-SPCM welds has been removed.

- The components are located at 119m, Tower Heavy Dock.

AWS D1.5 2002 Section 3.7.5: "The Engineer shall be notified before improperly fitted and welded members are cut apart".

Special Provision 8-3 Welding Section: " The Engineer shall be notified immediately in writing when welding problems, deficiencies, base metal repairs, or any other type of repairs not submitted in the WQCP are discovered and also of the proposed repair procedures to correct them."

Propose resolutions for the identified non-conformance items and document that the various deficiencies have been brought in compliance with contract requirements. Also propose a resolution that addresses the apparent failure of Quality Control to identify the non-conformance. Provide documentation of the steps taken by the Quality Control Manager to prevent future occurrences.

We have indicated to the sub-contractor that it was a wrong procedure for the fabrication. And the sub-contractor is required to make an education for his workers. QC department will also issue punishment list for the sub-contractor for that such thing will not happen again. Now, all these welds have passed NDT and are green tagged.

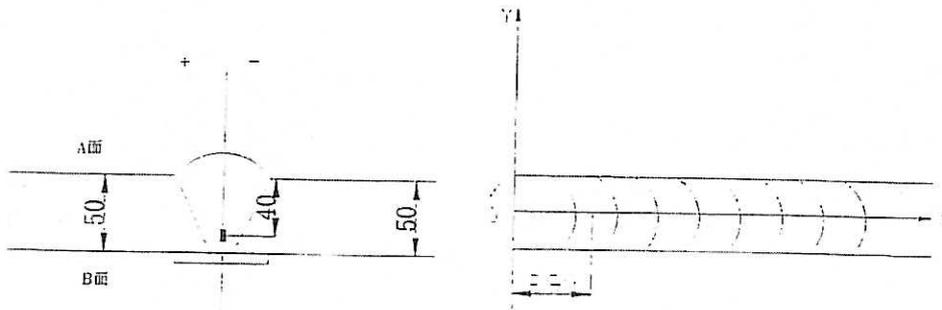
WELD NUMBER: ESD1-FASA4-2B/E-27

Weld No. 焊缝编号为: ESD1-FASA4-2B/E-27Welder ID No. (焊工编号): 046769Position:(位置) : 1G检验员 (Inspector) : Dai Gengsheng日期(Date) : 2010.11.10

1. Did not clear the weld pass completely in time.

1. Prepare the joint according to the approved WPS.
2. Grind or gouge the repair area to a smooth finish according to the approved repair WPS.
3. Remove all defects by grinding to ensure all defects are completely removed if defects still exist.
4. Preheat and weld according to the approved WPS.
5. Grind the weld flush after welding.
6. Perform NDT of the repair area.

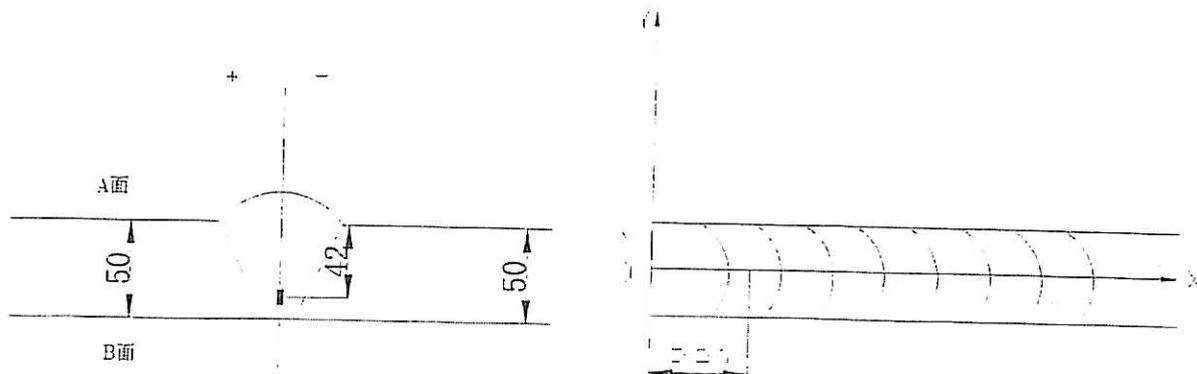
WELD NUMBER: ESD1-FASA4-2B/E-26

Weld No. 焊缝编号为: ESD1-FASA4-2B/E-26Welder ID No. (焊工编号): 046769Position:(位置) : 1G检验员 (Inspector) : Dai Gengsheng日期(Date) : 2010.11.10

1. Did not clear the weld pass completely in time.

1. Prepare the joint according to the approved WPS.
2. Grind or gouge the repair area to a smooth finish according to the approved repair WPS.
3. Remove all defects by grinding to ensure all defects are completely removed if defects still exist.
4. Preheat and weld according to the approved WPS.
5. Grind the weld flush after welding.
6. Perform NDT of the repair area.

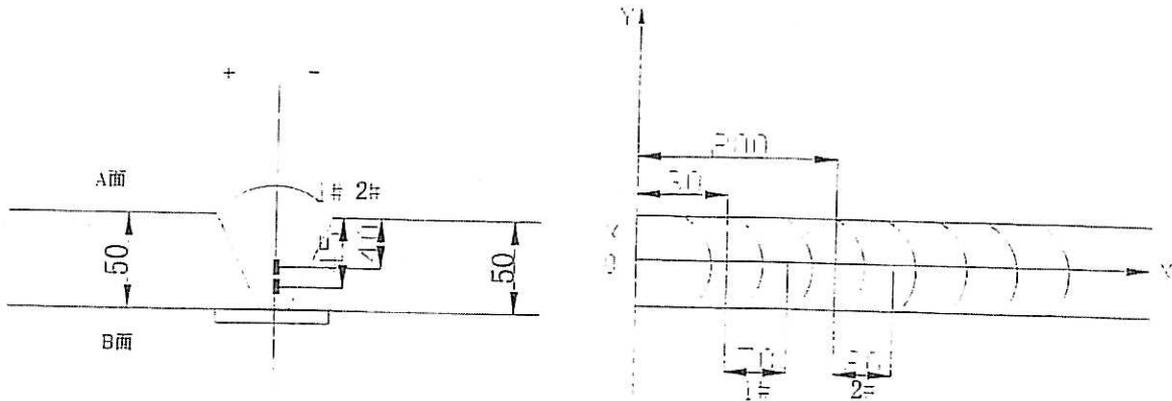
WELD NUMBER: NSD1-FASA4-1B/E-17

Weld No. 焊缝编号为： NSD1-FASA4-1B/E-17

1. 焊道未及时处理干净。
1. Did not clear the weld pass completely in time.

1. 准备一个正确的接头形式, 具体参见返修的WPS;
  2. 按照焊接返修工艺规程 (WPS) 打磨或碳刨缺陷区域至光滑;
  3. 如果仍发现有缺陷, 通过打磨的方法去除所有缺陷以确认缺陷完全被消除;
  4. 根据批准的焊接返修工艺规程 (WPS) 进行预热及焊接;
  5. 将焊接区域打磨至与母材平齐;
  6. 对返修区域作NDT检测。
- 
1. Prepare the joint according to the approved WPS.
  2. Grind or gouge the repair area to a smooth finish according to the approved repair WPS.
  3. Remove all defects by grinding to ensure all defects are completely removed if defects still exist.
  4. Preheat and weld according to the approved WPS.
  5. Grind the weld flush after welding.
  6. Perform NDT of the repair area.

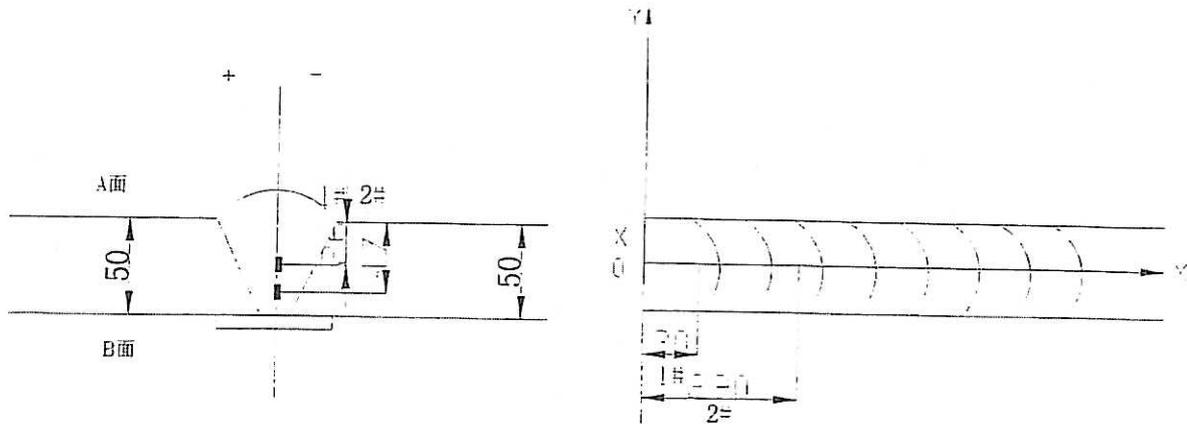
WELD NUMBER: NSD1-FASA4-1B/E-14

Weld No. 焊缝编号为: NSD1-FASA4-1B/E-14Welder ID No. (焊工编号): 040582Position:(位置) : 2G*Lin Jian*检验员 (Inspector) : Lin Jian日期(Date) : 2010.11.10

1. Did not clear the weld pass completely in time.

1. Prepare the joint according to the approved WPS.
2. Grind or gouge the repair area to a smooth finish according to the approved repair WPS.
3. Remove all defects by grinding to ensure all defects are completely removed if defects still exist.
4. Preheat and weld according to the approved WPS.
5. Grind the weld flush after welding.
6. Perform NDT of the repair area.

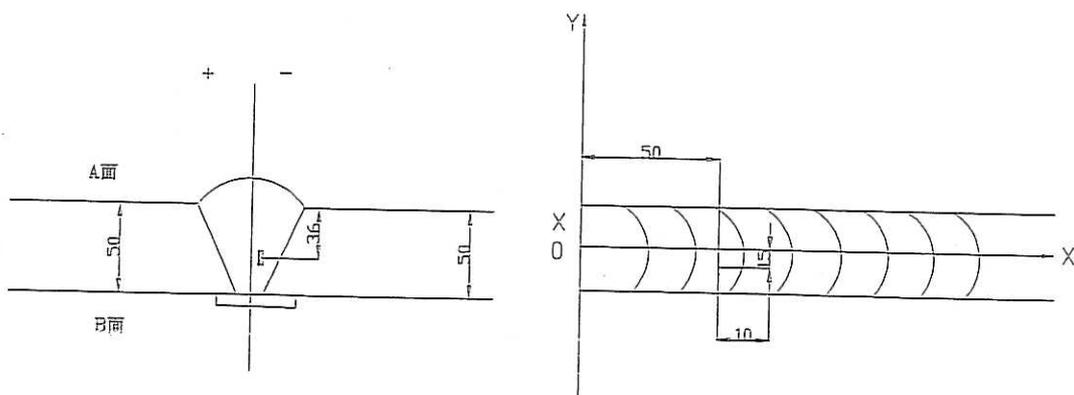
WELD NUMBER: ESD1-FASA4-2B/E-27

Weld No. 焊缝编号为: ESD1-FASA4-2B/E-27

1. Did not clear the weld pass completely in time.

1. Prepare the joint according to the approved WPS.
2. Grind or gouge the repair area to a smooth finish according to the approved repair WPS.
3. Remove all defects by grinding to ensure all defects are completely removed if defects still exist.
4. Preheat and weld according to the approved WPS.
5. Grind the weld flush after welding.
6. Perform NDT of the repair area.

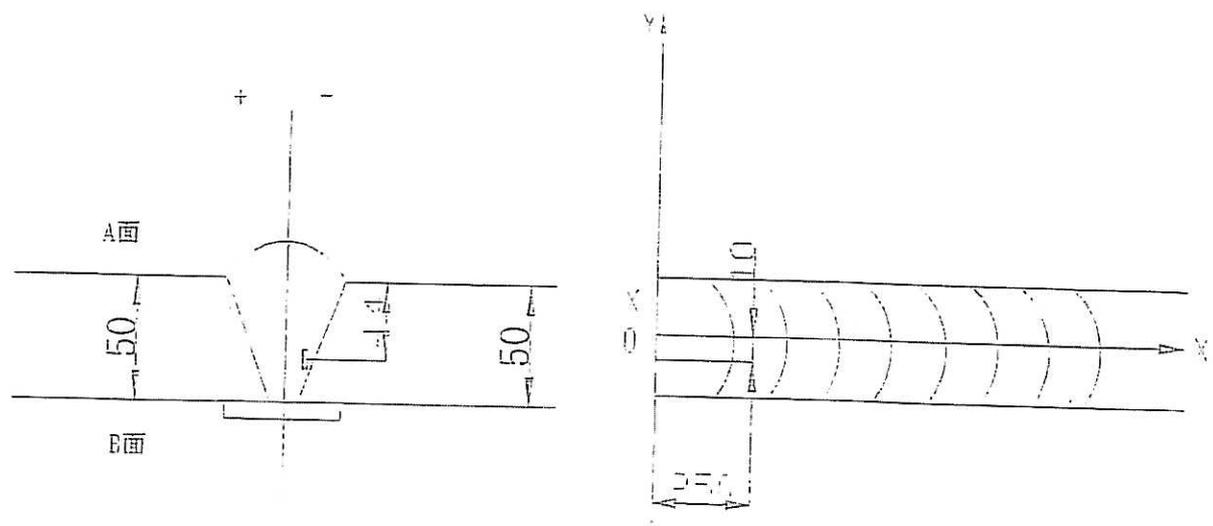
WELD NUMBER: ESD1-FASA4-2B/E-26

超过二次以上UT缺陷返修  
over two times repair

1. The weld defect location may not have been properly identified prior to grinding, i.e. the X and Y location was incorrect or the excavation was not centered on the defect, therefore the excavation did not encompass the whole defect.
1. 打磨前缺陷的位置没有标识清楚, 例如: XY的位置标的不正确, 或者没有将缺陷完全清除, 因此没有清楚所有的缺陷。

1. QC /CWI shall monitor and direct all gouging, grinding and welding during the repair procedure.
  2. Remove defects by gouging and /or grinding. If gouging is used, preheat the repair area to a minimum temperature of 65°C.

3. Prepare excavation according to the approved repair WPS.
  4. Grind the repair area to a smooth and shiny surface.
  5. Verify that no defects are present by VT and MT prior to welding.

6. Clean excavation of all loose debris and MT powder.
  7. Weld according to the approved WPS.
  8. Preheat and maintain interpass temperature control in accordance to the approved WPS.

9. QC shall ensure all slag has been removed prior to the deposition of the next pass.
  10. Blend the weld repaired areas into the adjacent weld or base metal by grinding.

11. Perform VT, MT and UT inspection to the repaired areas.
- 
1. QC 和 CWI 应当监督和指导所有碳刨、打磨和焊接工作;
  2. 使用碳刨和打磨方式去除缺陷, 如果使用碳刨方式, 则在碳刨前须将返修区域预热到 65° C;
  3. 根据返修 WPS 准备合适的刨槽;
