QUALITY ASSURANCE -- NON-CONFORMANCE REPORT

Location: Changxing Island, Shanghai, P.R. China**Report No:** NCR-000929**Prime Contractor:** American Bridge/Fluor Enterprises, a JV**Date:** 04-Dec-2010**Submitting Contractor:** Zhenhua Port Machinery Company, Ltd (ZPMC), Changxing Island**NCR #:** ZPMC-0891**Type of problem:**

Reference Description: QA found a missed MT indication after ZPMC had tested and accepted the weld (base metal repair) in Segment 11EE Side Panel

Job Name: SAS Superstructure
Document No: 05.03.06-000887

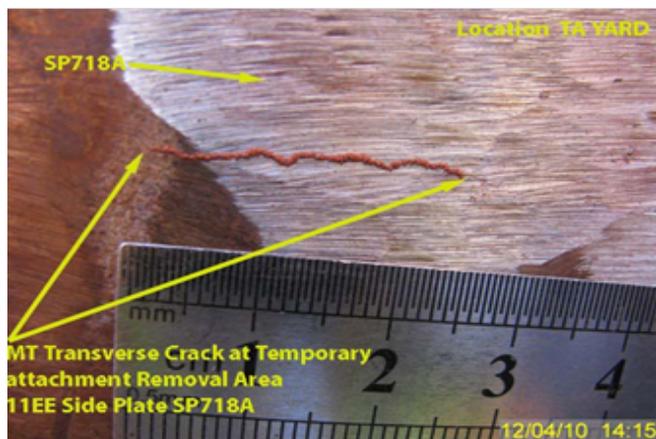
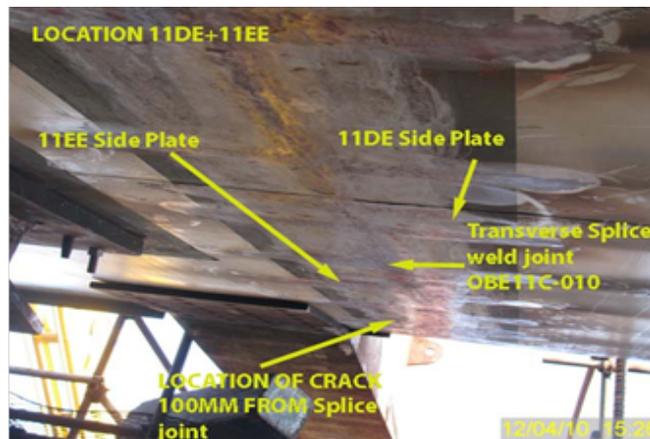
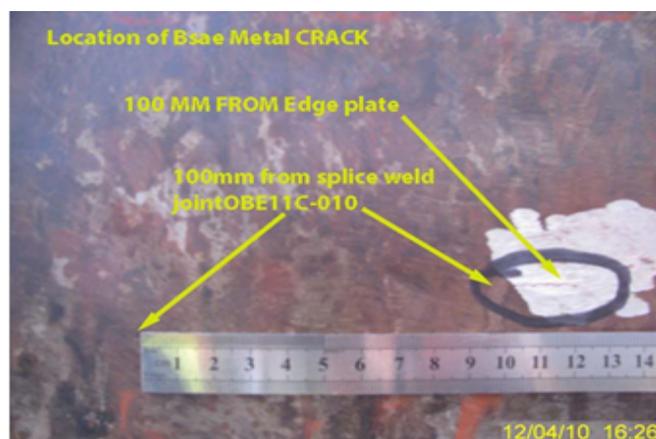
During the Quality Assurance (QA) Magnetic Particle Testing (MT) review of welds Temporary attachment Removal Area located on Orthotropic Box Girder (OBG) 11DE/11EE Transverse Splice Joint, this QA Inspector discovered the following issues:

- One transverse crack was found at the base metal after the removal of the temporary attachment. It is located near the Transverse Splice Weld Joint OBE11C-010 (joining 11DE/11EE).
- The affected side plate identified as SP718A (Segment 11EE).
- Base metal crack length measured approximately = 25mm.
- Y location = 100mm from the Transverse Splice Weld Joint OBE11C-010; 100mm from Edge Plate.
- The indication is clearly marked on the material.
- OBG 11DE/11EE is located at the trial assembly area.
- The Notice of Witness Inspection Number (NWIT) is 07619.

-This weld (base metal repair) is within an area previously tested and accepted by ABF Quality Control (QC) personnel. ABF's QC personnel are required to perform 100% MT inspection.

AWS D1.5 (02) Section 6.26.2 Welds that subject to RT or MT in addition to visual inspection shall have no cracks

Contractor will repair the defective area, and provide NDT report to prove the repairs are acceptable. ZPMC will identify the inspector involved, issue an internal NCR and monitor his work. Disciplinary action will be taken if the inspector misses indications continuously.

Contractor repaired the defects, and provided the NDT report to prove the repairs are acceptable. The inspector involved has been identified and his performance is being monitored.

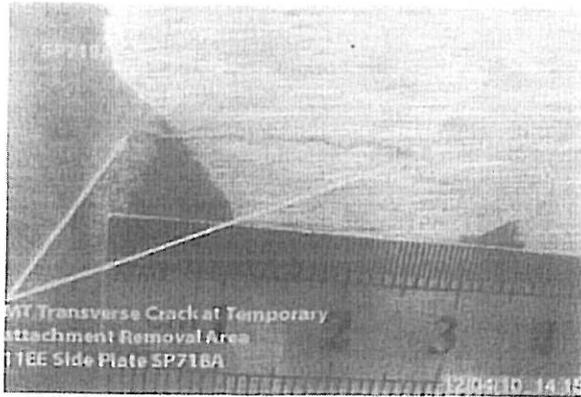
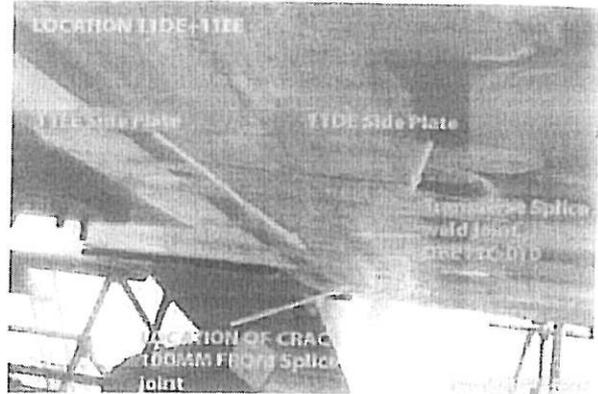
During the Quality Assurance (QA) Magnetic Particle Testing (MT) review of welds Temporary attachment Removal Area located on Orthotropic Box Girder (OBG) 11DE/11EE Transverse Splice Joint, this QA Inspector discovered the following issues:

- One transverse crack was found at the base metal after the removal of the temporary attachment. It is located near the Transverse Splice Weld Joint OBE11C-010 (joining 11DE/11EE).
- The affected side plate identified as SP718A (Segment 11EE).
- Base metal crack length measured approximately = 25mm.
- Y location = 100mm from the Transverse Splice Weld Joint OBE11C-010; 100mm from Edge Plate.
- The indication is clearly marked on the material.
- OBG 11DE/11EE is located at the trial assembly area.
- The Notice of Witness Inspection Number (NWIT) is 07619.

-This weld (base metal repair) is within an area previously tested and accepted by ABF Quality Control (QC) personnel. ABF's QC personnel are required to perform 100% MT inspection.

AWS D1.5 (02) Section 6.26.2 Welds that subject to RT or MT in addition to visual inspection shall have no cracks
