QUALITY ASSURANCE -- NON-CONFORMANCE REPORT

Location: Changxing Island, Shanghai, China **Report No:** NCR-000945
Prime Contractor: American Bridge/Fluor Enterprises, a JV **Date:** 14-Dec-2010
Submitting Contractor: Zhenhua Port Machinery Company, Ltd (ZPMC), Changxing Island **NCR #:** ZPMC-0904

Reference Description: Missed MT Crack Discovered by Quality Assurance on Lift 13CE Deck Panel

Job Name: SAS Superstructure

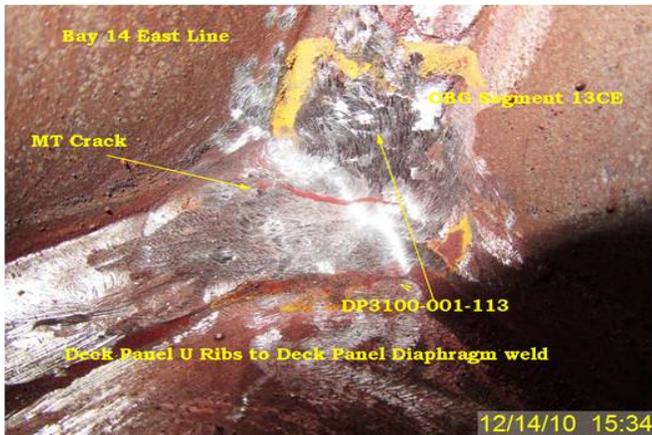
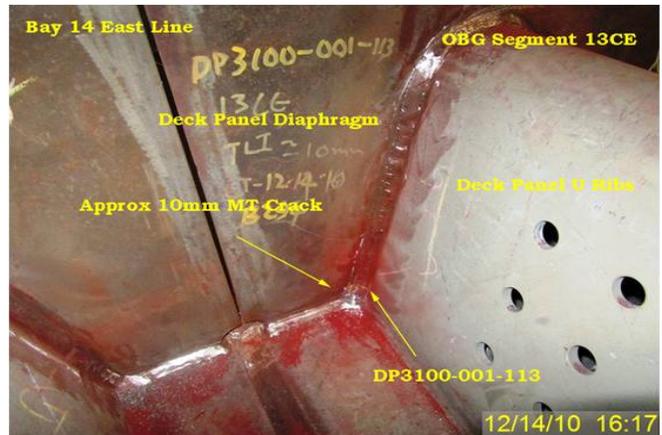
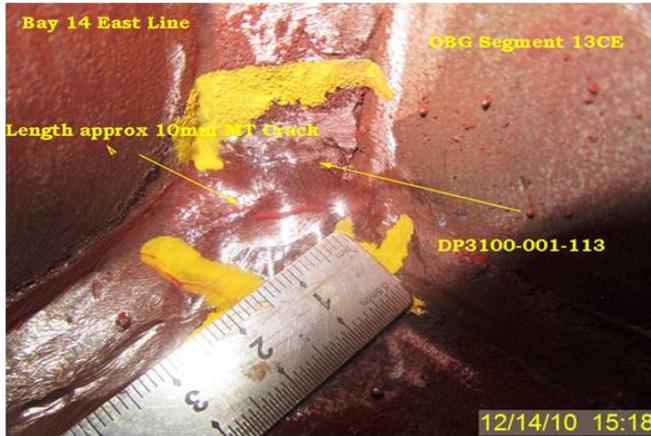
- One (1) transverse crack measuring approximately 10mm in length.
- The weld is identified as: DP3100-001-113.
- The weld is an 8mm fillet weld joining the Deck Panel U-Rib to Deck Panel Diaphragm.
- The weld is designated as a Seismic Performance Critical Member (SPCM).
- The indication is clearly marked on the material near the weld.
- OBG segment 13CE is located South Side of Bay 14 area.

The Notice of Witness Inspection Number (NWIT) is 07772. The Indication is located within an area that has been previously tested by ZPMC Quality Control (QC) personnel. As per contract documents ZPMC is required to perform 100% Magnetic particle Testing (MT) of this weld.

For further information, please see the attached pictures below.

AWS D1.5 (02) Section 6.26.2 – “Welds that are subject to MT in addition to visual inspection shall have no cracks.”

ZPMC has repaired the indication in accordance with an approved CWR and performed NDT after to show that the weld is acceptable. ZPMC has written an internal NCR and ABFJV has noted which inspector missed the indication so that the inspector can receive additional training if he shows a pattern of missed indications. Based on this ZPMC requests closure of this NCR.

ZPMC acknowledged this problem and has issued an internal NCR. This indication has been removed, repaired and re-tested to be acceptable. ZPMC is providing the NDT record and is requesting closure of this NCR.

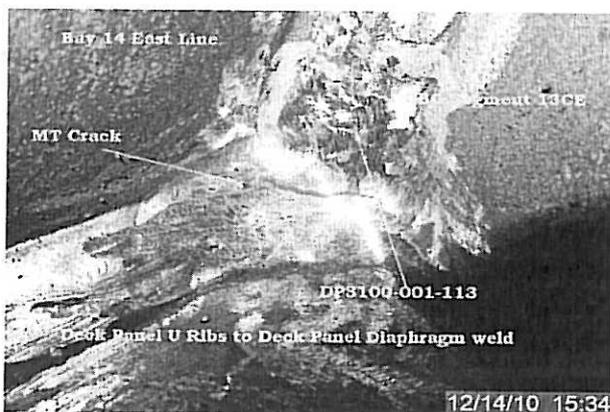
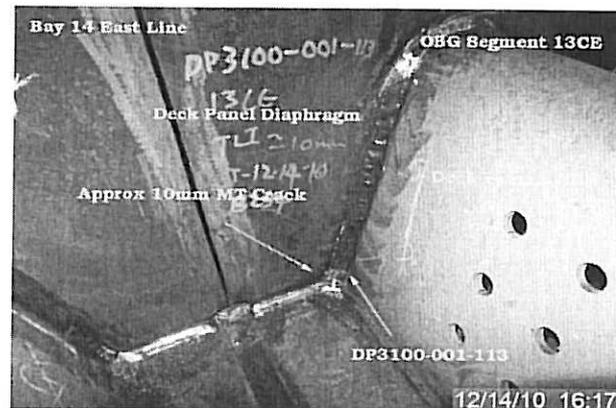
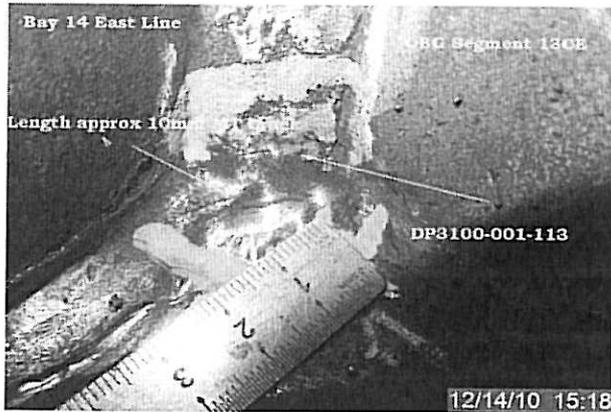
- One (1) transverse crack measuring approximately 10mm in length.
- The weld is identified as: DP3100-001-113.
- The weld is an 8mm fillet weld joining the Deck Panel U-Rib to Deck Panel Diaphragm.
- The weld is designated as a Seismic Performance Critical Member (SPCM).
- The indication is clearly marked on the material near the weld.
- OBG segment 13CE is located South Side of Bay 14 area.

The Notice of Witness Inspection Number (NWIT) is 07772. The Indication is located within an area that has been previously tested by ZPMC Quality Control (QC) personnel. As per contract documents ZPMC is required to perform 100% Magnetic particle Testing (MT) of this weld.

For further information, please see the attached pictures below.

AWS D1.5 (02) Section 6.26.2 – “Welds that are subject to MT in addition to visual inspection shall have no cracks.”

Contractor repaired the weld and provided the NDT documentation to prove the weld is acceptable. The inspector involved has been identified, and his performance being monitored.
