Contract #: 04-0120F4
 Cty: SF/ALA Rte: 80 PM: 13.2/13.9
 File #: 69.25B

QUALITY ASSURANCE -- NON-CONFORMANCE REPORT

Report No: NCR-000953

Reference Description: Lift 5 West Skin B- Weld repair without paint removal

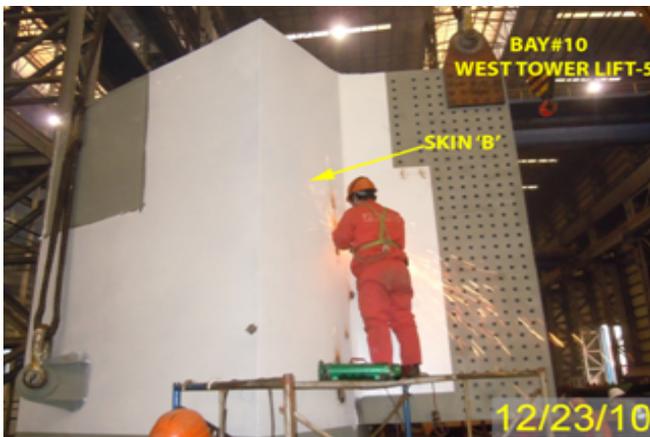
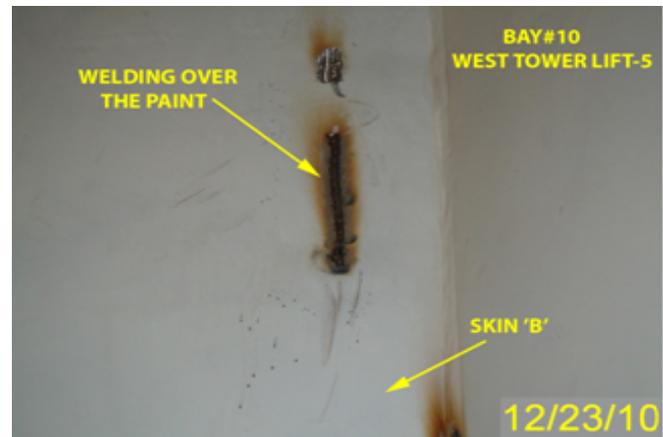
During the Caltrans Quality Assurance (QA) in-process observation on West Tower Lift-5, this QA Inspector discovered the following issue:

- ZPMC personnel performing base metal repair welding without removing the paint on West Shaft Skin 'B'.
- Location observed to be approximately 1700 mm from the top of the Shaft.
- This member is Non-Seismic Performance Critical Member (SPCM).
- This component located at fabrication Bay#10.

AWS D1.5-2002, Section 3.2.1: "...Surfaces to be welded and surfaces adjacent to a weld shall also be free from loose or thick scale, slag, rust moisture, grease, and other foreign material that would prevent proper welding or produce objectionable fumes."

Standard Specifications-1999, Section 55-3.16: "... Surfaces of metal in contact shall be thoroughly cleaned of

rust, mill scale, dirt, grease, paint or other material foreign to the metal before assembly.”

Contractor will provide NDT report to prove the weld repair is acceptable. Area of damaged paint will require repairing in accordance with PQWP repair procedure.

Contractor performed the weld repair, and the NDT report shows the weld is acceptable. Contractor repaired the paint area per the approved PQWP and is now in conformance with contract requirements.

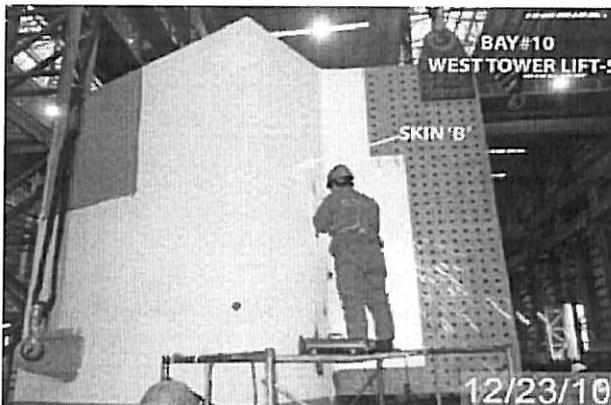
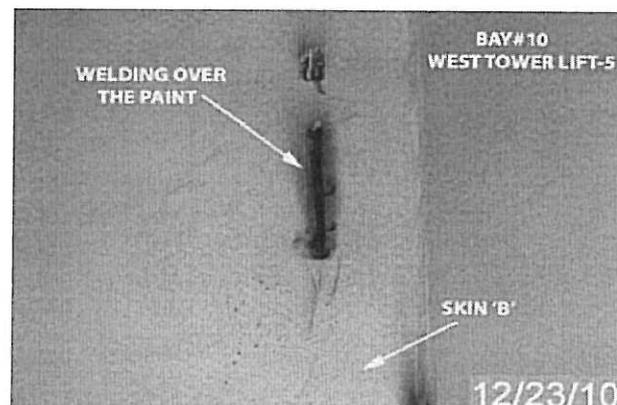
During the Caltrans Quality Assurance (QA) in-process observation on West Tower Lift-5, this QA Inspector discovered the following issue:

- ZPMC personnel performing base metal repair welding without removing the paint on West Shaft Skin 'B'.
- Location observed to be approximately 1700 mm from the top of the Shaft.
- This member is Non-Seismic Performance Critical Member (SPCM).
- This component located at fabrication Bay#10.

AWS D1.5-2002, Section 3.2.1: "...Surfaces to be welded and surfaces adjacent to a weld shall also be free from loose or thick scale, slag, rust moisture, grease, and other foreign material that would prevent proper welding or produce objectionable fumes."

Standard Specifications-1999, Section 55-3.16: "... Surfaces of metal in contact shall be thoroughly cleaned of

rust, mill scale, dirt, grease, paint or other material foreign to the metal before assembly.”
