Contract #: 04-0120F4Cty: SF/ALA Rte: 80 PM: 13.2/13.9File #: 69.25B**QUALITY ASSURANCE -- NON-CONFORMANCE REPORT****Location:** Changxing Island, Shanghai, P.R. China**Report No:** NCR-000959**Prime Contractor:** American Bridge/Fluor Enterprises, a JV**Date:** 28-Dec-2010**Submitting Contractor:** Zhenhua Port Machinery Company, Ltd (ZPMC), Changxing Island**NCR #:** ZPMC-0918**Type of problem:**

Reference Description: QA found 2 missed transverse UT indications in Lift 13AE Bottom Panel to Side Panel splice

Job Name: SAS Superstructure
Document No: 05.03.06-000916

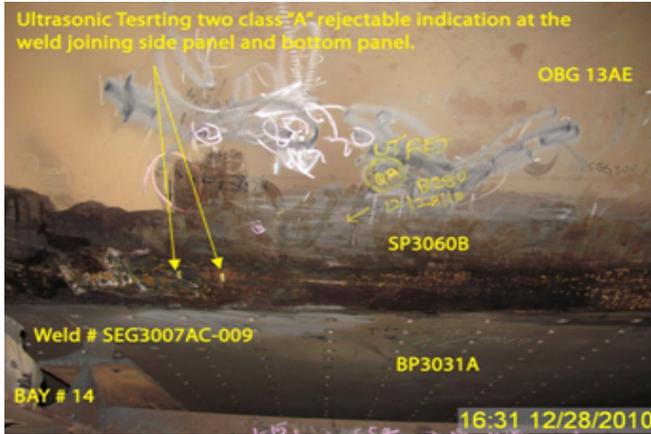
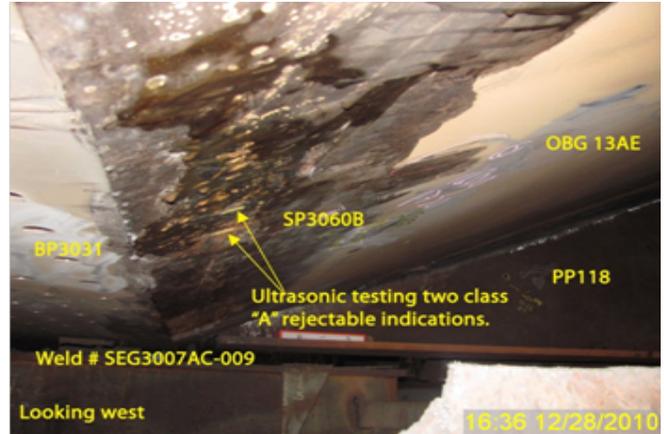
During the Quality Assurance (QA) Ultrasonic Testing (UT) review of welds located on Orthotropic Box Girder (OBG) Segment 13AE, this QA Inspector discovered the following issues:

- Two (2) transverse linear Class "A" rejectable indications measuring approximately 10 and 8mm in length.
- The weld is identified as SEG3007AC-009.
- Material thickness is 22mm.
- The depths of the indications are approximately 17 and 15mm respectively.
- The indications dB ratings are -5 and -1 respectively.
- The weld is Complete Joint Penetration (CJP) corner joints, joining bottom plate to side plate.
- Bottom plate identified as BP3031A
- Side plate identified as SP3060B
- The welds are not designated as Seismic Performance Critical Material (Non SPCM).
- The indications are clearly marked near the welds.
- The Y distances measured approximately 1720 and 1800mm respectively.
- The OBG segment 13AE is located in the bay 14.

The Notice of Witness Inspection (NWIT) No. is 007956. The indications are located within an area previously tested and accepted by ZPMC Quality Control (QC) personnel. As per the contract documents, ZPMC's QC personnel are required to perform 100% UT inspection of these welds.

AWS D1.5-02 Section 6; Table 6.3 specifies a class "A" indication as having a rating of 8dbs and under for material thicknesses 20mm through 38mm.

Contractor will remove the indications and repair the weld, providing the NDT report to prove the weld is acceptable. ZPMC will issue an internal NCR to the QC personnel involved and monitor his performance, taking disciplinary actions if he continues to miss indications.

Contractor removed the indications and repaired the weld, and provided the NDT reports to prove the weld is acceptable. Contractor issued an internal NCR to the QC personnel and monitor his performance.

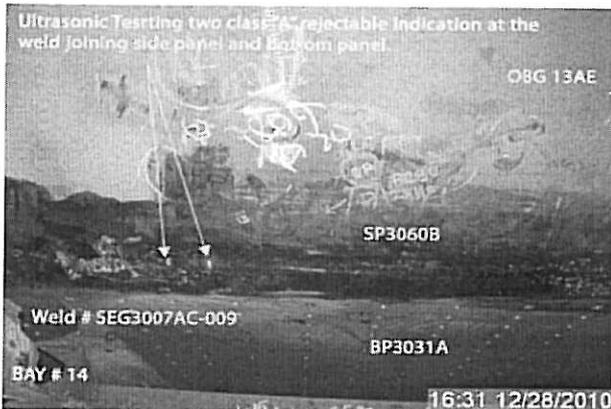
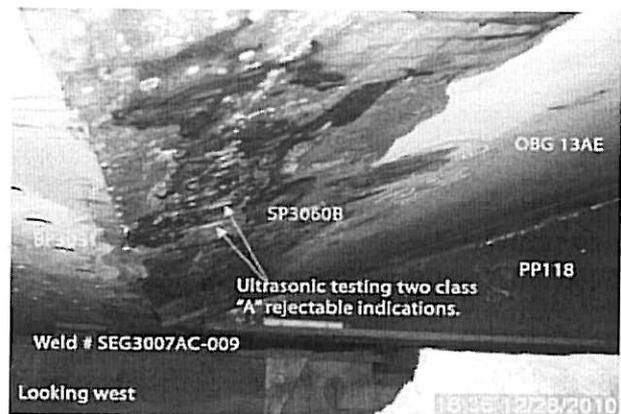
During the Quality Assurance (QA) Ultrasonic Testing (UT) review of welds located on Orthotropic Box Girder (OBG) Segment 13AE, this QA Inspector discovered the following issues:

- Two (2) transverse linear Class "A" rejectable indications measuring approximately 10 and 8mm in length.
- The weld is identified as SEG3007AC-009.
- Material thickness is 22mm.
- The depths of the indications are approximately 17 and 15mm respectively.
- The indications dB ratings are -5 and -1 respectively.
- The weld is Complete Joint Penetration (CJP) corner joints, joining bottom plate to side plate.
- Bottom plate identified as BP3031A
- Side plate identified as SP3060B
- The welds are not designated as Seismic Performance Critical Material (Non SPCM).
- The indications are clearly marked near the welds.
- The Y distances measured approximately 1720 and 1800mm respectively.
- The OBG segment 13AE is located in the bay 14.

The Notice of Witness Inspection (NWIT) No. is 007956. The indications are located within an area previously tested and accepted by ZPMC Quality Control (QC) personnel. As per the contract documents, ZPMC's QC personnel are required to perform 100% UT inspection of these welds.

AWS D1.5-02 Section 6; Table 6.3 specifies a class "A" indication as having a rating of 8dbs and under for material thicknesses 20mm through 38mm.
