Contract #: 04-0120F4  
 Cty: SF/ALA Rte: 80 PM: 13.2/13.9  
 File #: 69.25B

**QUALITY ASSURANCE -- NON-CONFORMANCE REPORT**

**Location:** Changxing Island, Shanghai, P.R. China **Report No:** NCR-000962  
**Prime Contractor:** American Bridge/Fluor Enterprises, a JV **Date:** 30-Dec-2010  
**Submitting Contractor:** Zhenhua Port Machinery Company, Ltd (ZPMC), Changxing Island **NCR #:** ZPMC-0921

**Reference Description:** QA found 1 missed UT indication in Segment 13AE Bottom to Floorbeam joint

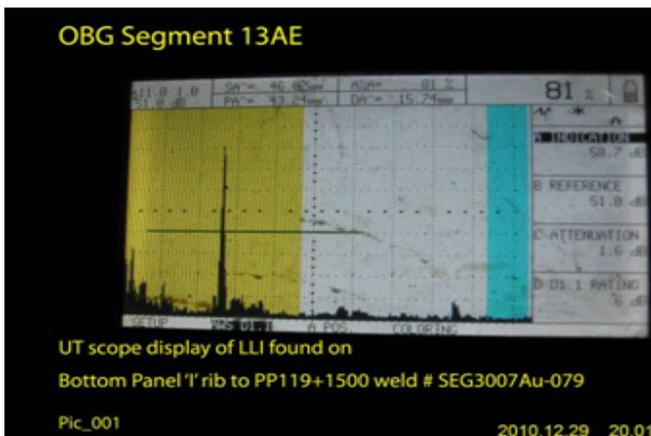
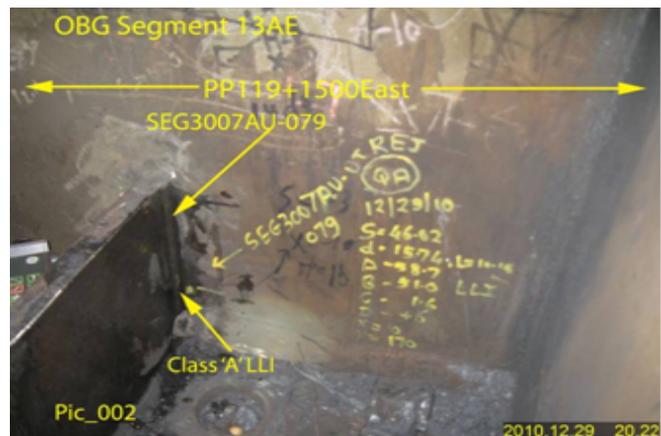
- One (1) longitudinal Class "A" rejectable indication measuring approximately 15mm in length in the Bottom Panel Rib Stiffener attachment weld to the Floor beam at panel point 119+1500.
- The weld is identified as SEG3007AU-079.
- The Indication dB rating is +6dB.
- Material thickness is 28 mm and depth of the indication is approximately 15.74 mm.
- The indication is clearly marked near weld.
- The 'Y' location of indication is 170 mm from upper leading edge of the 'I' Rib.
- Segment 13AE is located in Bay 14.
- The notice of witness inspection (NWIT) no. is 07974. The indication is located within the area which was previously tested and accepted by ZPMC Quality Control (QC) personnel. As per contract documents, ZPMC's QC personnel are required to perform hundred (100%) percent UT inspection of this weld.

AWS D1.5-02 Section 6; Table 6.3 specifies a class "A" indication as having a rating of 8dbs and under for material thicknesses 20mm through 38mm.

Contractor proposes to repair the weld and remove the indications. Contractor will provide the NDT report after repairing. ZPMC will identify the inspector and issue an internal NCR to him. Contractor will monitor his performance. If he misses the indications continuously, disciplinary action will be taken.

Contractor removed the indications, and repaired the weld. Contractor provided the NDT report to prove the welds are acceptable. Contractor identified the inspector and monitors his performance.

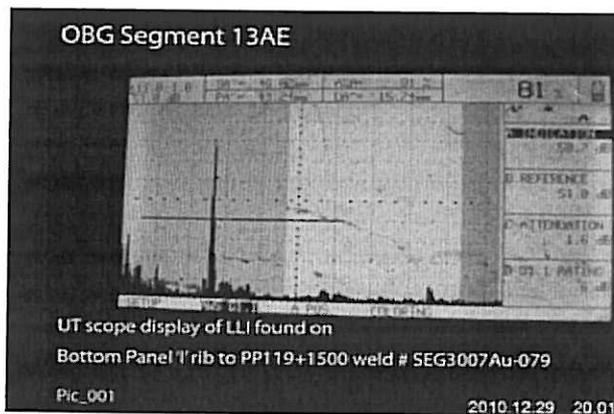
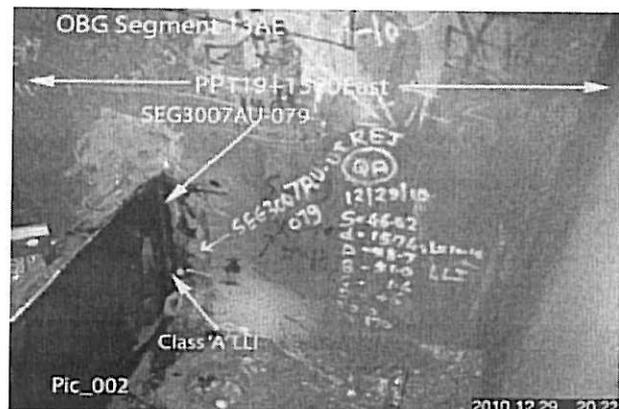
-One (1) longitudinal Class "A" rejectable indication measuring approximately 15mm in length in the Bottom Panel Rib Stiffener attachment weld to the Floor beam at panel point 119+1500.

-The weld is identified as SEG3007AU-079.

-The Indication dB rating is +6dB.

-Material thickness is 28 mm and depth of the indication is approximately 15.74 mm.

-The indication is clearly marked near weld.

-The 'Y' location of indication is 170 mm from upper leading edge of the 'I' Rib.

-The notice of witness inspection (NWIT) no. is 07974. The indication is located within the area which was previously tested and accepted by ZPMC Quality Control (QC) personnel. As per contract documents, ZPMC's QC personnel are required to perform hundred (100%) percent UT inspection of this weld.
