Contract #: 04-0120F4Cty: SF/ALA Rte: 80 PM: 13.2/13.9File #: xx.25B**QUALITY ASSURANCE -- NON-CONFORMANCE REPORT****Location:** Changxing Island, Shanghai, China**Report No:** NCR-000970**Prime Contractor:** American Bridge/Fluor Enterprises, a JV**Date:** 14-Jan-2011**Submitting Contractor:** Zhenhua Port Machinery Company, Ltd (ZPMC), Changxing Island**NCR #:** ZPMC-0929**Type of problem:**

**Reference Description:** Missed Longitudinal Toe Crack (MT) Discovered by QA Lift 13AW RS Stiffener to Bottom Plate

Contract #: 04-0120F4Cty: SF/ALA Rte: 80 PM: 13.2/13.9File #: xx.25A**QUALITY ASSURANCE -- NON-CONFORMANCE RESOLUTION****Location:** Changxing Island, Shanghai, China**Report No:** NCS-000913**Prime Contractor:** American Bridge/Fluor Enterprises, a JV**Date:** 23-Feb-2011**Submitting Contractor:** Zhenhua Port Machinery Company, Ltd (ZPMC), Changxing Island **NCR #:** ZPMC-0929**Type of problem:**

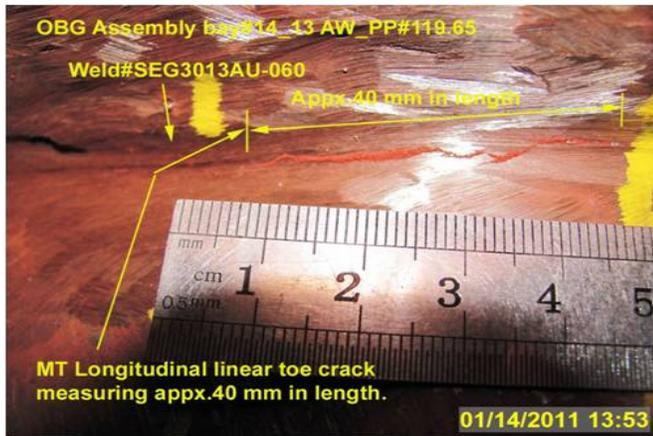
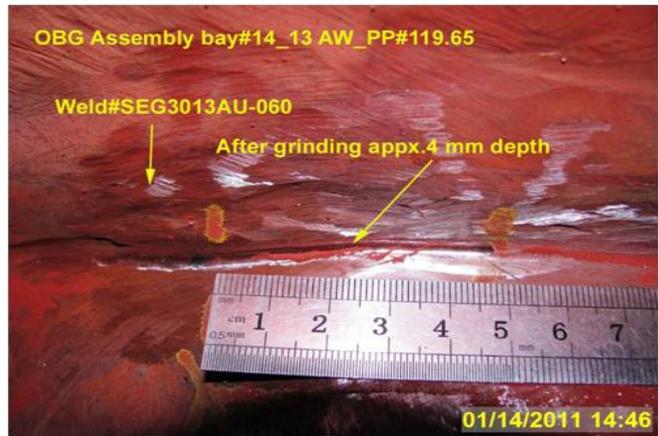
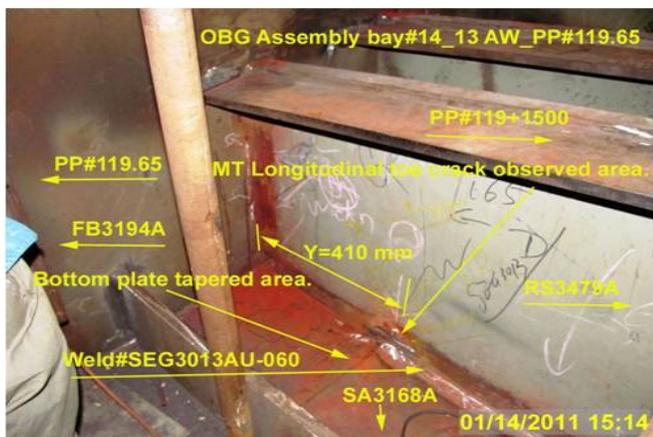
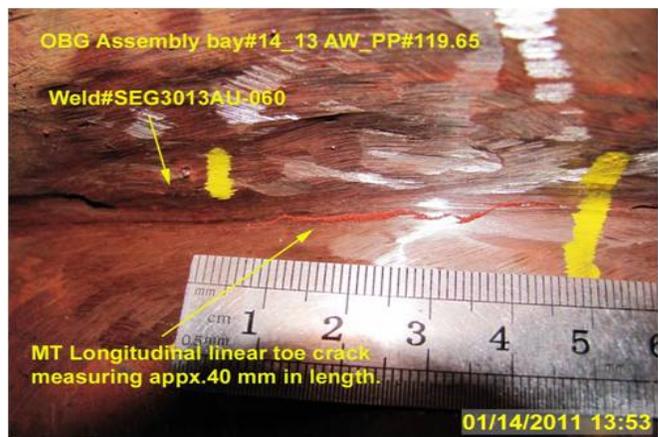
During Quality Assurance Magnetic Particle Testing (MT) review of welds located on Orthotropic Box Girder (OBG) Lift 13AW, this Quality Assurance Inspector (QA) discovered the following issue:

- One Longitudinal Linear toe crack measuring approximately 40 mm in length.
- The weld is identified as: SEG3013AU-060.
- The weld is designated as Fracture Critical Weld (FCW).
- This weld is a Partial Joint Penetration (PJP) with reinforcement weld joining bottom plate (SA3168A) to Stiffener plate (RS3479A).
- The "Y" location is approximately 410mm East side of the weld termination.
- The "Y" location measured from Panel Point no.119.65 Floor beam identified as FB3194A (as shown on picture below).
- The bottom plate and stiffener plate thickness is 100 mm and 45 mm respectively.
- 13AW is currently located in the OBG assembly Bay # 14.

The Notice of Witness Inspection Number (NWIT) is 08164. The indication is located within an area that has been previously tested and accepted by ZPMC Quality Control (QC) personnel. As per the contract documents, The contractors personnel are required to perform 100% MT inspection of this weld.

AWS D1.5 (02) Section 6.26.2 – “Welds that are subject to MT in addition to visual inspection shall have no cracks”.

**Reference Resolution:** ZPMC has repaired the indication noted in the NCR and is providing NDT documentation after the repair to show the indication has been removed.

ZPMC acknowledged this problem and has issued an internal NCR. This indication has been removed, repaired and re-tested to be acceptable. ZPMC is providing the NDT record and is requesting closure of this NCR.

Contractor removed and the indication and repaired the weld. The NDT report confirms the repaired area is acceptable. ZPMC issued an internal NCR to the QC personnel. The inspector's performance is being monitored.
