Contract #: 04-0120F4Cty: SF/ALA Rte: 80 PM: 13.2/13.9File #: 69.25B**QUALITY ASSURANCE -- NON-CONFORMANCE REPORT****Location:** Changxing Island, Shanghai, China**Report No:** NCR-000971**Prime Contractor:** American Bridge/Fluor Enterprises, a JV**Date:** 17-Jan-2011**Submitting Contractor:** Zhenhua Port Machinery Company, Ltd (ZPMC), Changxing Island**NCR #:** ZPMC-0930**Type of problem:**

**Reference Description:** Visually discovered crack on Segment 13CW Longitudinal Diaphragm Stiffener to Floorbeam

# QUALITY ASSURANCE -- NON-CONFORMANCE REPORT

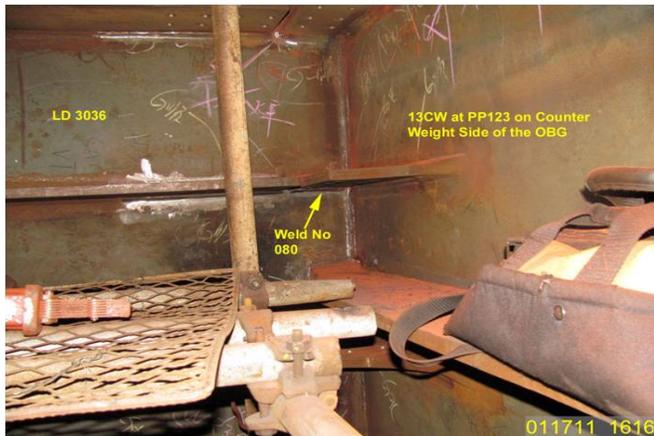
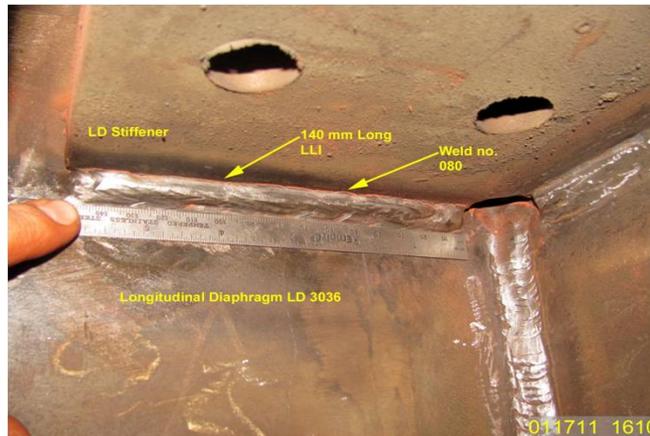
During Quality Assurance Magnetic Particle Testing (MT) verification of (1) weld located on OBG longitudinal diaphragm stiffener to floor beam, Caltrans (CT) Quality Assurance (QA) inspectors discovered the following issues:

- One Longitudinal toe crack measuring approximately 140mm.
- The crack was discovered visually and verified using Magnetic Particle Testing (MT).
- The weld is a fillet weld joining the floor beam (FB3224A) stiffener (X4486B) to longitudinal diaphragm (LD3036A SPCM).
- The weld is designated as SPCM.
- OBG segment 13CW is located in Bay No. 14
- The member and weld number are identified as follows:

1. SEG3015N-080.

The notice of witness Inspection Number (NWIT) is 08201. The Longitudinal crack is located within an area that has been previously tested and accepted by ABF Quality Control (QC) personnel. As per contract documents the contractor is required to perform 100% visual testing (VT) of these welds.

AWS D1.5 (02) Section 6.26.1.1 – “The weld shall have no cracks.”

**Reference Resolution:** ZPMC has repaired the indication noted in the NCR and is providing NDT documentation after the repair to show the indication has been removed.

This proposed resolution is acceptable. The documentation received is sufficient and the Department concurs that Non-Conformance ZPMC-0930 is closed.

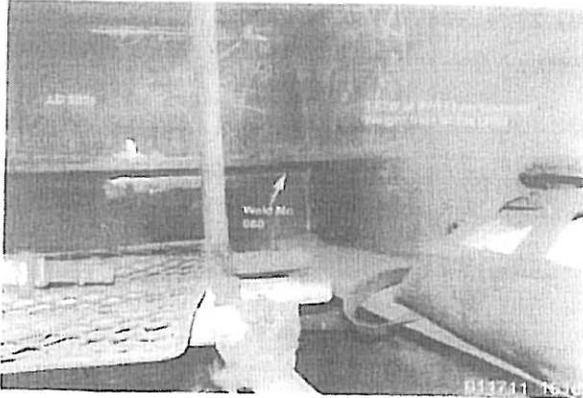
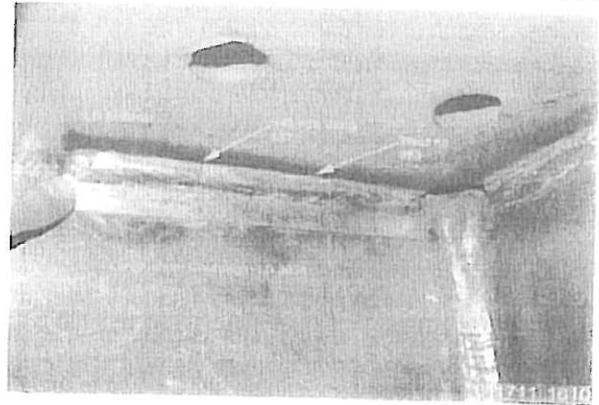
During Quality Assurance Magnetic Particle Testing (MT) verification of (1) weld located on OBG longitudinal diaphragm stiffener to floor beam, Caltrans (CT) Quality Assurance (QA) inspectors discovered the following issues:

- One Longitudinal toe crack measuring approximately 140mm.
- The crack was discovered visually and verified using Magnetic Particle Testing (MT).
- The weld is a fillet weld joining the floor beam (FB3224A) stiffener (X4486B) to longitudinal diaphragm (LD3036A SPCM).
- The weld is designated as SPCM.
- OBG segment 13CW is located in Bay No. 14
- The member and weld number are identified as follows:

1. SEG3015N-080.

The notice of witness Inspection Number (NWIT) is 08201. The Longitudinal crack is located within an area that has been previously tested and accepted by ABF Quality Control (QC) personnel. As per contract documents the contractor is required to perform 100% visual testing (VT) of these welds.

AWS D1.5 (02) Section 6.26.1.1 – “The weld shall have no cracks.”

Contractor repaired the indication, and submitted NDT report showing the weld was acceptable. Contractor has identified the inspector who did the weld and his performance is being monitored.
