Contract #: 04-0120F4Cty: SF/ALA Rte: 80 PM: 13.2/13.9File #: 69.25B**QUALITY ASSURANCE -- NON-CONFORMANCE REPORT****Location:** Changxing Island, Shanghai, P.R. China**Report No:** NCR-000973**Prime Contractor:** American Bridge/Fluor Enterprises, a JV**Date:** 21-Jan-2011**Submitting Contractor:** Zhenhua Port Machinery Company, Ltd (ZPMC), Changxing Island**NCR #:** ZPMC-0932**Type of problem:**

**Reference Description:** ZPMC welded at the interior deck plate while the exterior deck plate surface (at the same location) was wet

**Job Name:** SAS Superstructure  
**Document No:** 05.03.06-000930

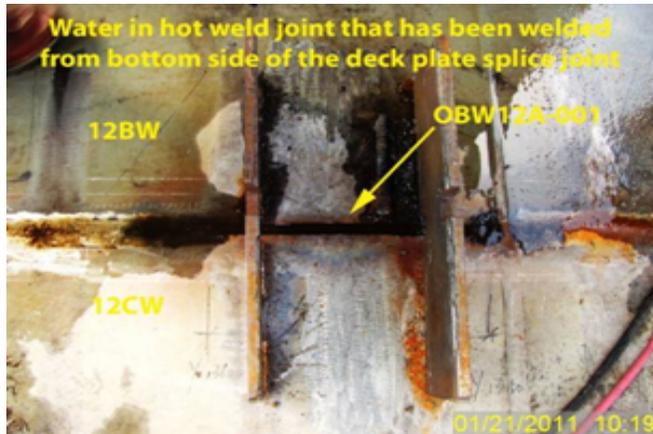
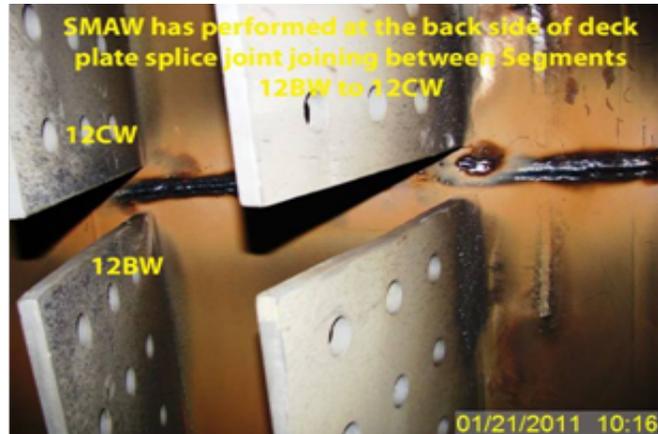
During random in-process visual inspection of welds located on Orthotropic Box Girder (OBG) Segment 12BW and 12CW, this Quality Assurance (QA) Inspector discovered the following issues:

- ZPMC personnel performed Shielded Metal Arc Welding (SMAW) at the interior face of the deck plate splice joint for segments 12BW to 12CW while surfaces are wet on the exterior face of the deck plate (at the same location).
- Before welding started, QA Inspector reminded ZPMC foreman Ghong Ging at 09:15 that the weld area shall be dried prior to performing welding repair.
- At approximately 09:50, vapor was observed at the exterior face of the deck at the repaired area.
- The weld is identified as OBW12A-001.
- The Weld is Complete Joint Penetration (CJP) butt joint repair.
- The Y distance for the exposed area was 13150 mm to 13620mm as measured from edge plate (on the counterweight side).
- The segments are located at the trial assembly area.

-AWS D1.5 2002 Section 3.1.3: "Welding shall not be done when the ambient temperature is lower than -20°C [0°F](see 4.2), when surfaces are wet or exposed to rain, snow, or high wind velocities, nor when welders are exposed to inclement conditions."

-AWS D1.5 2002 Section 3.2.1: "Surfaces to be welded and surfaces adjacent to a weld shall also be free from loose or thick scale, slag, rust, moisture, grease, and other foreign material that would prevent proper welding or produce objectionable fumes."

The welds in question were repaired with subsequent NDT documentation.

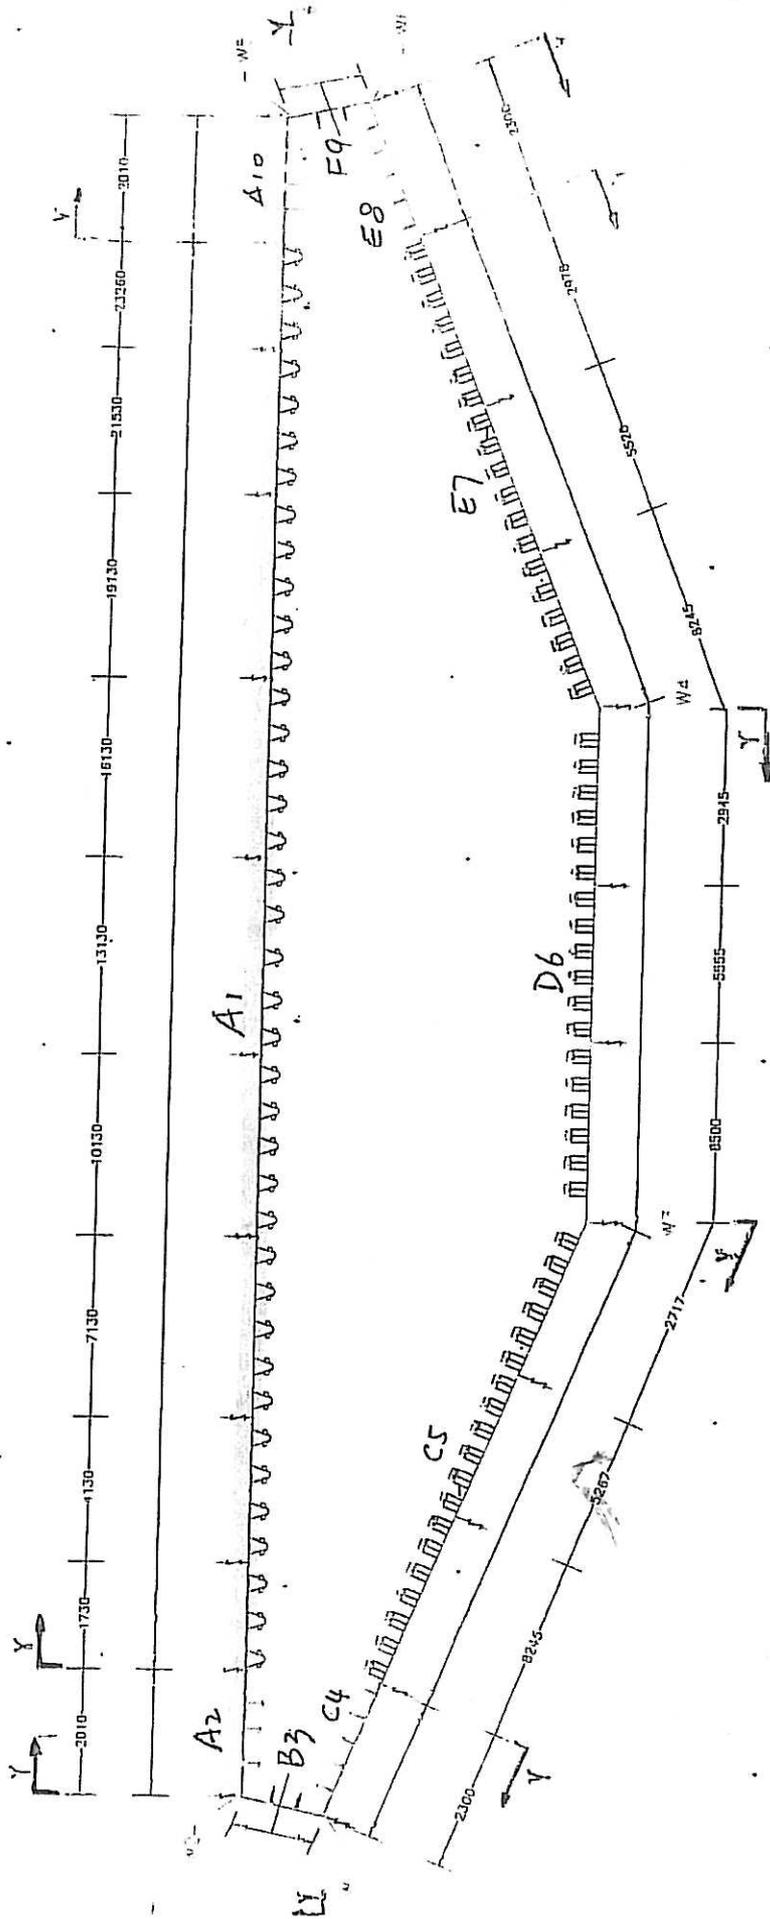
UT-12W-035R2 12/21

Weld Number.	Indication No.	Scan Face	Leg	Decibels				Discontinuity Dimensions (mm)			Evaluation	Inspector	Inspection %		
				Indication Level	Reference Level	Attenuation Factor	Indication Rating	Length	Sound Path	Depth				Distance	
														From "X"	From "Y"
a	b	c	d												
OBW12A-001 (A1)	/	outside	/	/	/	/	/	/	/	/	/	ACC. S022 S020	100%		
OBW12A-002 (A10)	/	outside	/	/	/	/	/	/	/	/	/	ACC. S002	100%		
CA3012-012 (A2)	/	outside	/	/	/	/	/	/	/	/	/	ACC. S034	100%
