Contract #: 04-0120F4Cty: SF/ALA Rte: 80 PM: 13.2/13.9File #: 69.25B**QUALITY ASSURANCE -- NON-CONFORMANCE REPORT****Location:** Changxing Island, Shanghai, P.R. China**Report No:** NCR-000980**Prime Contractor:** American Bridge/Fluor Enterprises, a JV**Date:** 21-Feb-2011**Submitting Contractor:** Zhenhua Port Machinery Company, Ltd (ZPMC), Changxing Island**NCR #:** ZPMC-0938**Type of problem:**

**Reference Description:** ZPMC performed joint change to CJP without following proper welding procedures**Description of Non-Conformance:**

**Job Name:** SAS Superstructure

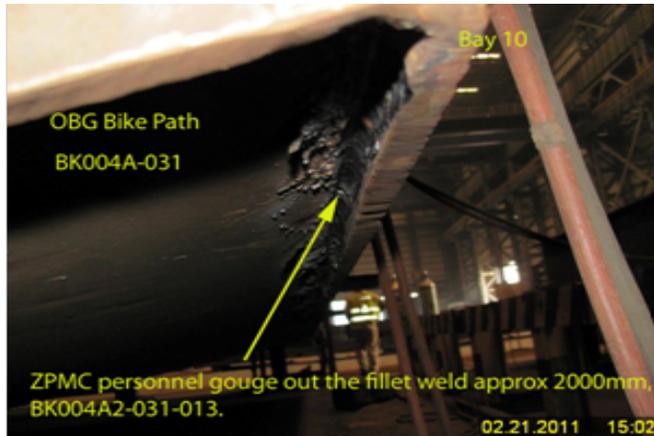
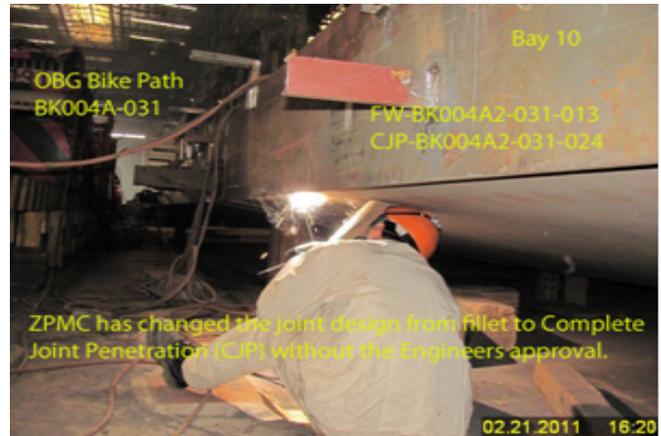
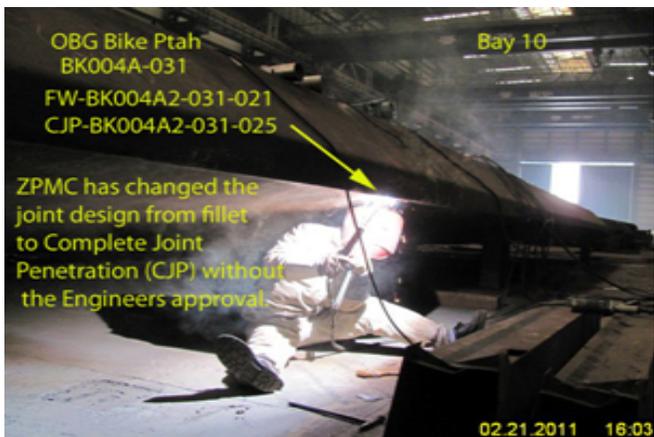
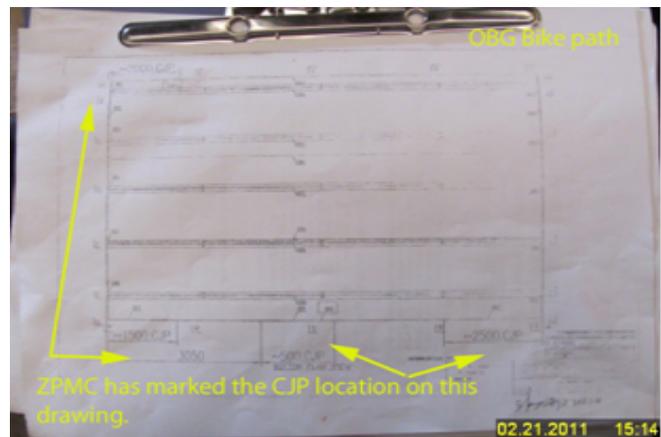
During the fabrication of the Orthotropic Box Girder (OBG) Bikepath (BK) BK004A-031, this Quality Assurance (QA) Inspector discovered the following:

- ZPMC has changed a weld joint detail from fillet to Complete Joint Penetration (CJP) because the fit-up of the root exceeded 5mm.
- ZPMC indicated that the work is performed per Submittal 200R2.
- QA observed that Submittal 200R2 was not followed.
- ZPMC welded single bevel welds without backing bar and with no access to perform backgouging.
- ZPMC used "WPS-345-SMAW-4G(4F)-Repair" for the work which is not appropriate for these new CJP joint.

- Without Engineer's approval, ZPMC is changing these welds from fillet to CJP only in certain sections of the welds, thus they are not continuous CJP with continuous backing.
- The fillet welds observed are BK004A2-031-013 and 021.
- The Y locations for the changed CJP welds on BKPL6A are:
  - 0mm-1500mm, 3050mm-3550mm and 6520mm-9020mm for BK004A2-031-013.
  - 0mm-2000mm for BK004A2-031-021.
- ZPMC identified the new CJP weld IDs as BK004A2-031-024, and BK004A2-031-022, 023, 025.
- The material is A709 Grade 345 Non Seismic Performance Critical Member (Non SPCM).
- The approved drawings, BK004A, specified fillet welds at these locations.
- The OBG Bikepath is located in Bay 10.

**Reference Resolution:** Per the RFI, ZPMC and ABFJV has confirmed that reinforcing fillet on both welds exceeds 6mm.

Per the RFI, ZPMC and ABFJV has confirmed that reinforcing fillet on both welds exceeds 6mm. Per the RFI ZPMC is providing MT of the root pass of this weld and MT of the cover pass as well. Based on this ZPMC requests closure of this NCR.

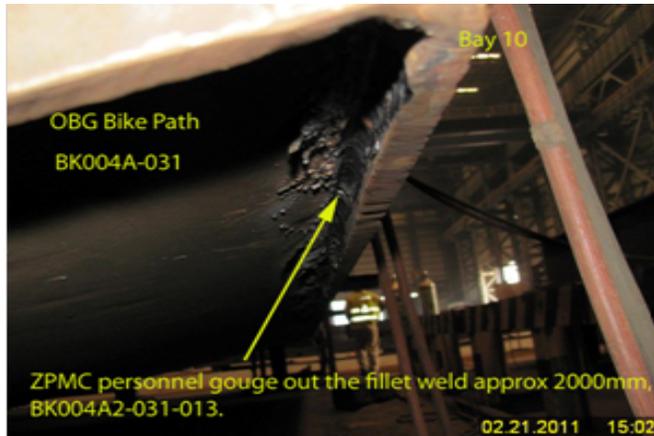
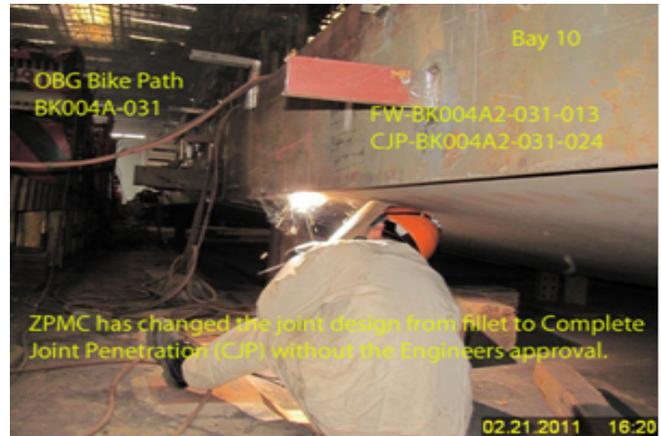
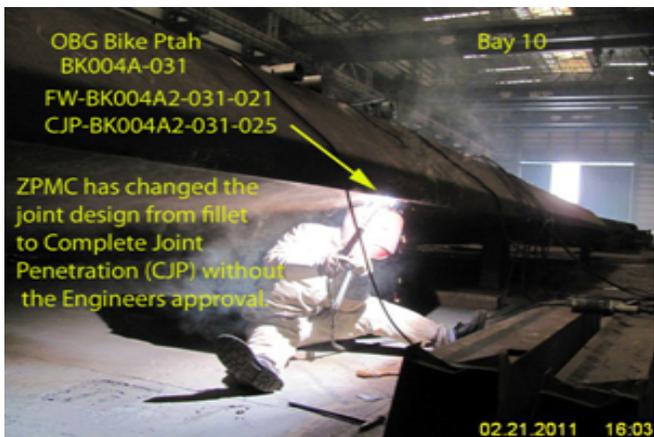
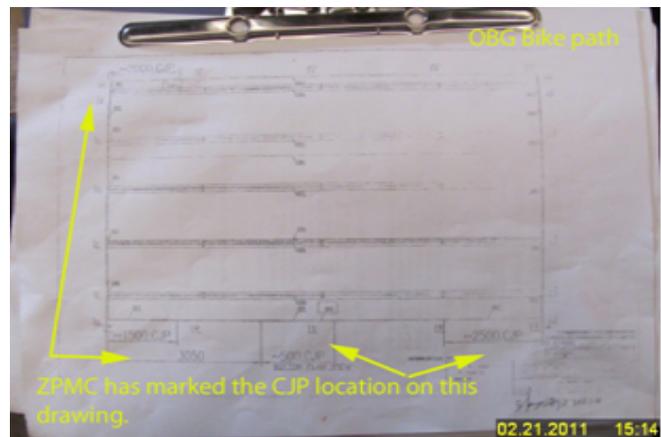
During the fabrication of the Orthotropic Box Girder (OBG) Bikepath (BK) BK004A-031, this Quality Assurance (QA) Inspector discovered the following:

- ZPMC has changed a weld joint detail from fillet to Complete Joint Penetration (CJP) because the fit-up of the root exceeded 5mm.
- ZPMC indicated that the work is performed per Submittal 200R2.
- QA observed that Submittal 200R2 was not followed.
- ZPMC welded single bevel welds without backing bar and with no access to perform backgouging.
- ZPMC used "WPS-345-SMAW-4G(4F)-Repair" for the work which is not appropriate for these new CJP joint.

- Without Engineer's approval, ZPMC is changing these welds from fillet to CJP only in certain sections of the welds, thus they are not continuous CJP with continuous backing.
- The fillet welds observed are BK004A2-031-013 and 021.
- The Y locations for the changed CJP welds on BKPL6A are:
  - 0mm-1500mm, 3050mm-3550mm and 6520mm-9020mm for BK004A2-031-013.
  - 0mm-2000mm for BK004A2-031-021.
- ZPMC identified the new CJP weld IDs as BK004A2-031-024, and BK004A2-031-022, 023, 025.
- The material is A709 Grade 345 Non Seismic Performance Critical Member (Non SPCM).
- The approved drawings, BK004A, specified fillet welds at these locations.
- The OBG Bikepath is located in Bay 10.

Contractor to submit TC-RFI proposing to leave the weld as is as any repairs will cause more damages. To prevent future occurrence, the Production department and the QA/QC personnel involved will be talked to on the non-conformance, reminded that correct procedure must be followed

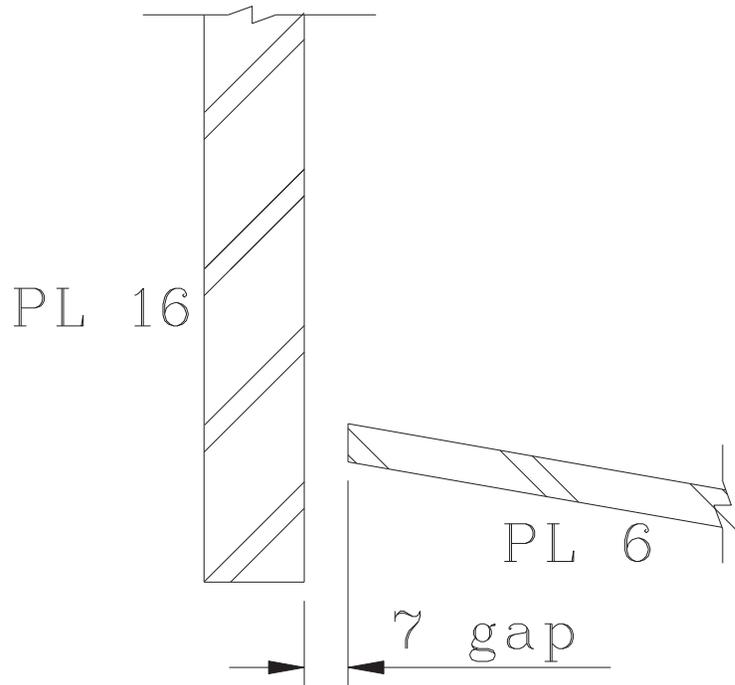
In response to NCR #: ZPMC-0938, ZPMC did receive previous approval to change fillet welds BK004A2-031-013 and -021 into CJP welds BK004A2-031-024 and BK004A2-031-022, -023, -025 under AFC-CAL-TRN-007772. However BK004A2-031-024 and BK004A2-031-022, -023, -025 were not performed according to an approved WPS. As a repair could be more detrimental to the component than the current condition, ZPMC proposes to leave the weld joints as-is. Results of 100% MT of root pass and 100% MT of cover pass were both found to be acceptable. Please confirm if this proposal is acceptable.

As-Built Gap  
(Pre-Weld condition)

To facilitate fabrication, the Contractor's proposal to leave the weld as-is is acceptable on a fit-for-purpose basis, provided that the reinforcing fillet of the as built weld is 6mm minimum. See attached sketch.  
Thanks.

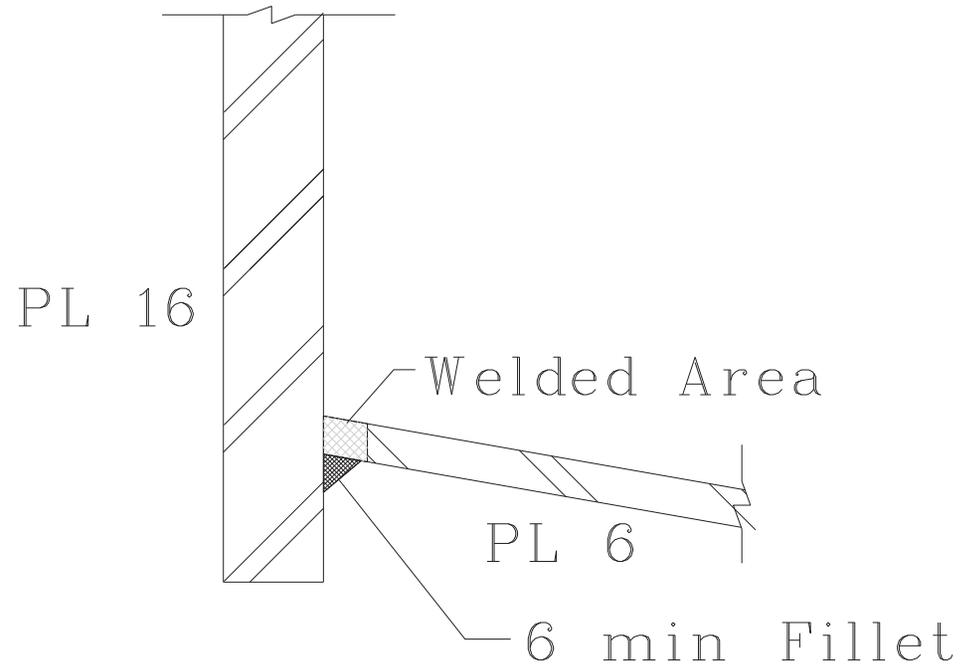
Acceptable Condition
