Contract #: 04-0120F4Cty: SF/ALA Rte: 80 PM: 13.2/13.9File #: 69.25B**QUALITY ASSURANCE -- NON-CONFORMANCE REPORT****Location:** Changxing Island, Shanghai, P.R. China**Report No:** NCR-000989**Prime Contractor:** American Bridge/Fluor Enterprises, a JV**Date:** 12-Mar-2011**Submitting Contractor:** Zhenhua Port Machinery Company, Ltd (ZPMC), Changxing Island**NCR #:** ZPMC-0947**Type of problem:**

Reference Description: QA found a missed UT indication after ZPMC had tested and accepted the weld at Traveler Rail 20TR2-030

Job Name: SAS Superstructure
Document No: 05.03.06-000946

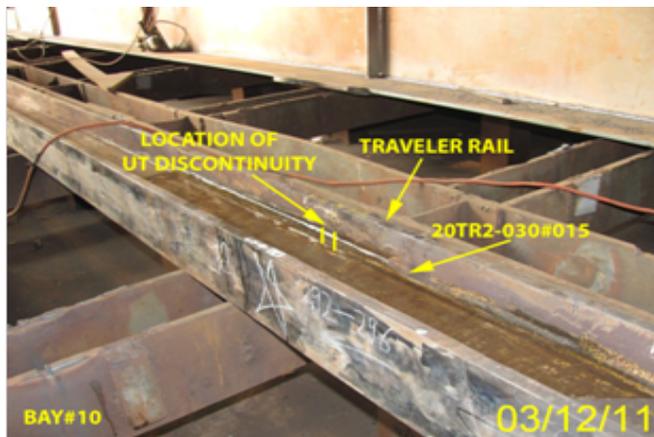
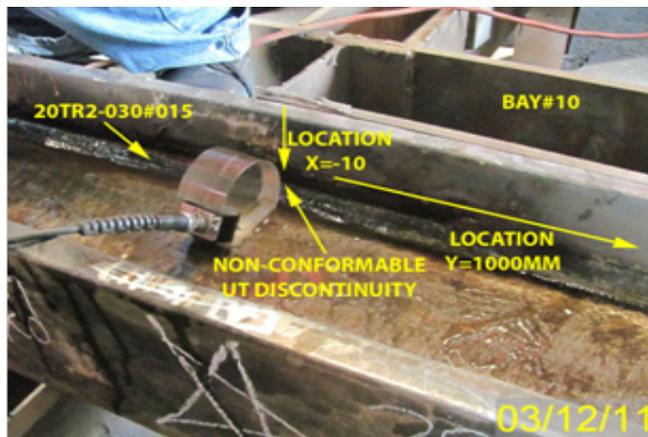
During the Quality Assurance (QA) Ultrasonic Testing (UT) verification of weld located on traveler rail 20TR2-030-015, this QA Inspector discovered the following issue:

- One (1) Class "A" non-conforming longitudinal indication in a weld.
- UT discontinuity rating was +9 dB.
- Depth of the discontinuity from face "A" is approximately 14 mm.
- Length of the discontinuity is approximately 10 mm in length.
- Y location is approximately 220 mm from left side of the joint.
- The weld is a complete joint penetration (CJP) T- joint, joining the web to flange.
- The weld is identified as 20TR2-030-015.
- The nominal thickness of the material is 20 mm.
- Component located at fabrication Bay#10.

The Notice of Witness Inspection Number (NWIT) is 08527. The indication is located inside the area that has been previously tested and accepted by ZPMC Quality Control (QC) personnel. ZPMC's QC personnel performed 100% UT inspection of this weld.

Reference Resolution: ZPMC has repaired the indication noted in the NCR and is providing NDT documentation after the repair to show the indication has been removed.

ZPMC has repaired the indication noted in the NCR and is providing NDT documentation after the repair to show the indication has been removed.

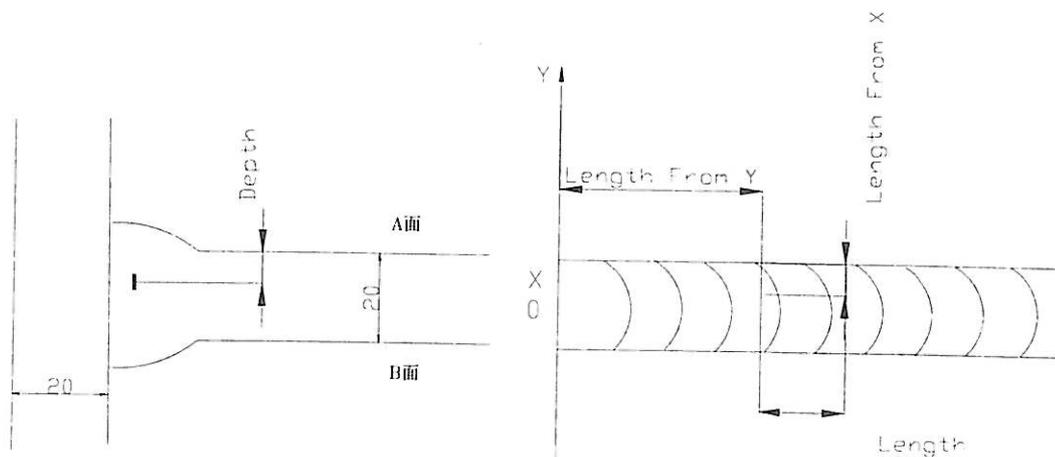
焊缝编号为： 20TR2-030-015,20TR2-039-015

(Description of welding discontinuity): Rejected indication found by ultrasonic inspection is less than the maximum allowance aggregate length.

Please see the detail data from UT report!

1、焊道未及时处理干净。

1. Did not clear the weld pass completely in time.

1. 从缺陷距离端面较近一侧 ($D \leq 0.65T$, D为缺陷深度, T为板厚) 采用碳刨或打磨的方法去除焊缝缺陷;
2. 参照返修焊接工艺规程 (WPS) 准备正确的接头型式, 预热和焊接;
3. 将修补区域打磨到与母材或邻近焊缝平齐;
4. 根据批准的车间图纸检查焊缝.

1. Gouge or grind from nearer side from metal edge ($D \leq 0.65T$, "D" is depth of defects, "T" is thickness of metal) to remove all defects;
2. Follow repair WPS for joint preparation, preheat, and weld deposit;
3. Grind the repaired area flush with base metal or the adjacent weld;
4. Check the welds according to the working drawings.
