Contract #: 04-0120F4Cty: SF/ALA Rte: 80 PM: 13.2/13.9File #: 69.25B**QUALITY ASSURANCE -- NON-CONFORMANCE REPORT****Location:** Changxing Island, Shanghai, China**Report No:** NCR-000992**Prime Contractor:** American Bridge/Fluor Enterprises, a JV**Date:** 18-Mar-2011**Submitting Contractor:** Zhenhua Port Machinery Company, Ltd (ZPMC), Changxing Island**NCR #:** ZPMC-0950**Type of problem:**

Reference Description: Missed UT Indication Discovered by QA on Segment 13CE RS Stiffener Weld at SP3075A

Job Name: SAS Superstructure

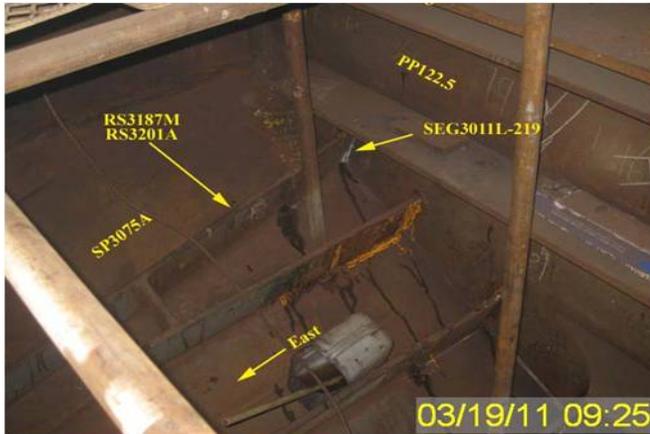
- A total of one (1) Class 'A' longitudinal indication measuring approximately 10 mm in length in the side panel rib stiffener (RS3187M) attachment to the floor beam web, east of panel point 122.5.
- The indication dB rating is -1db.
- Material thickness is 22 mm and depth of the indication is approximately 16.74 mm.
- The 'Y' location of the indication is 40 mm.
- The weld is identified as SEG3011L-219.
- The indication is clearly marked near the weld.
- Segment 13CE is located in Bay 14.

The notice of witness inspection (NWIT) no. is 08574. The indication is located within the area which was previously tested and accepted by ZPMC Quality Control (QC) personnel. As per contract documents, ZPMC's QC personnel are required to perform hundred (100%) percent UT inspection of this weld.

AWS D1.5-02 Section 6; Table 6.3 specifies a class “A” indication as having a rating of 8dbs and under for material thicknesses 20mm through 38mm.

ZPMC acknowledged this problem and has issued an internal NCR. ZPMC has repaired the indications noted in the NCR and is providing WR & NDT documentation after the repair to show the indication has been removed. Based on these actions, ZPMC requests closure of this NCR.

This proposed resolution is acceptable. The documentation received is sufficient and the Department concurs that Non-Conformance ZPMC-0950 is closed.

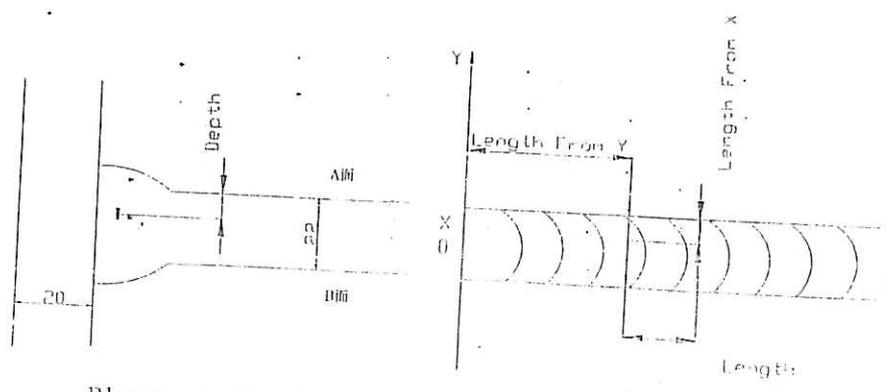
焊缝返修位置示意图:
 Draft of welding discontinuity:

焊缝缺陷描述: (普通UT探伤发现的缺陷长度小于最大允许长度)
 (Description of welding discontinuity): Rejected indication found by ultrasonic inspection is less than the maximum allowance aggregate length.
 焊缝编号为: SEG3011L-219

Please see the detail data from UT report!

1. 焊道未及时处理干净。
1. Did not clear the weld pass completely in time.

1. 从缺陷距离端面较近一侧 ($D \leq 0.65T$, D 为缺陷深度, T 为板厚) 采用碳刨或打磨的方法去除焊缝缺陷;
 2. 参照返修焊接工艺规程 (WPS) 准备正确的接头型式, 预热和焊接;
 3. 将修补区域打磨到与母材或邻近焊缝平齐;
 4. 根据批准的车间图纸检查焊缝.
-
1. Gouge or grind from nearer side from metal edge ($D \leq 0.65T$, "D" is depth of defects, "T" is thickness of metal) to remove all defects;
 2. Follow repair WPS for joint preparation, preheat, and weld deposit;
 3. Grind the repaired area flush with base metal or the adjacent weld;
 4. Check the welds according to the working drawings.

1. Improve monitoring of welding and interpass cleaning.
