LETTER OF SUBMITTAL
KFM Skyway Project # 04-012024

Subject: Kie-Con NCR for fender module FP-1-30

NCR-302-001 FIX PROPOSAL

Subject: KFM SUB# 6036 Kie-Con NCR-302-001 for Fender Module FP-1-30

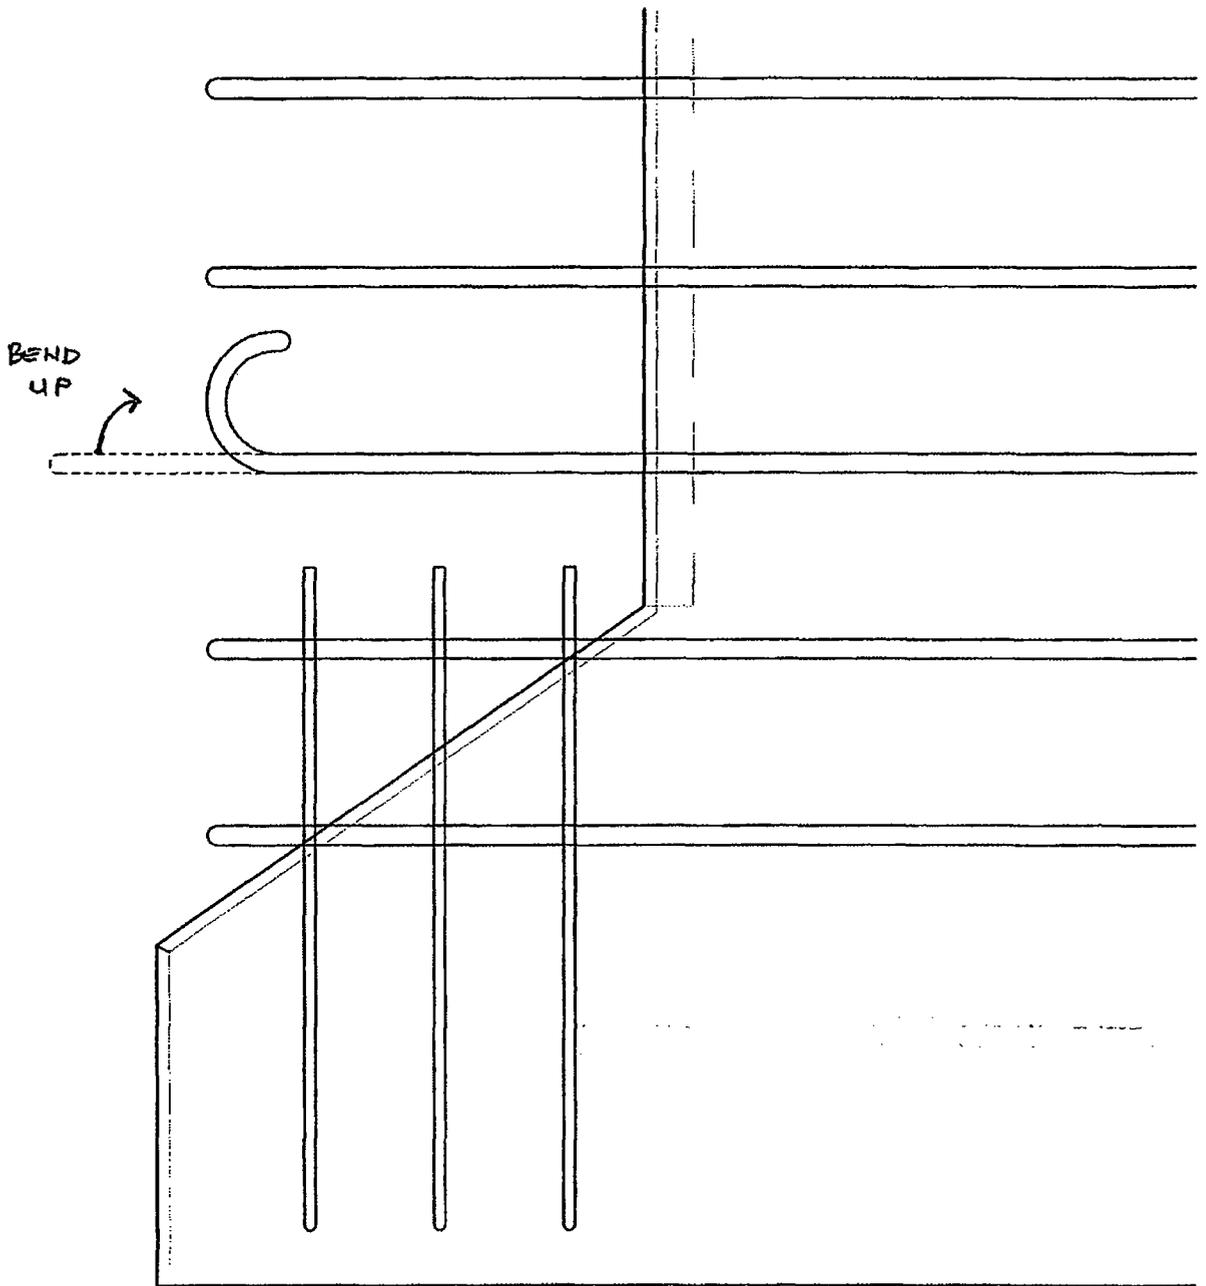
OPTION 1

KFM's subcontractor Kie-Con has submitted several alternative proposals for their internal NCR-302-001. One of the rebar "MK25PT01" has moved out approximately 9-1/2" toward Fender's Nose during form closure or concrete pour without being noticed. They have submitted four different alternatives to rectify the problem and bring the member in compliance. The approved fix would be done by Kie-Con at no charge to KFM or Caltrans.

Option 1: The U-Bar will be bent (upward or downward and back) 180 degrees without cutting the rebar. This way the bar is still developed per plans and specification. Any damaged epoxy shall be patched.

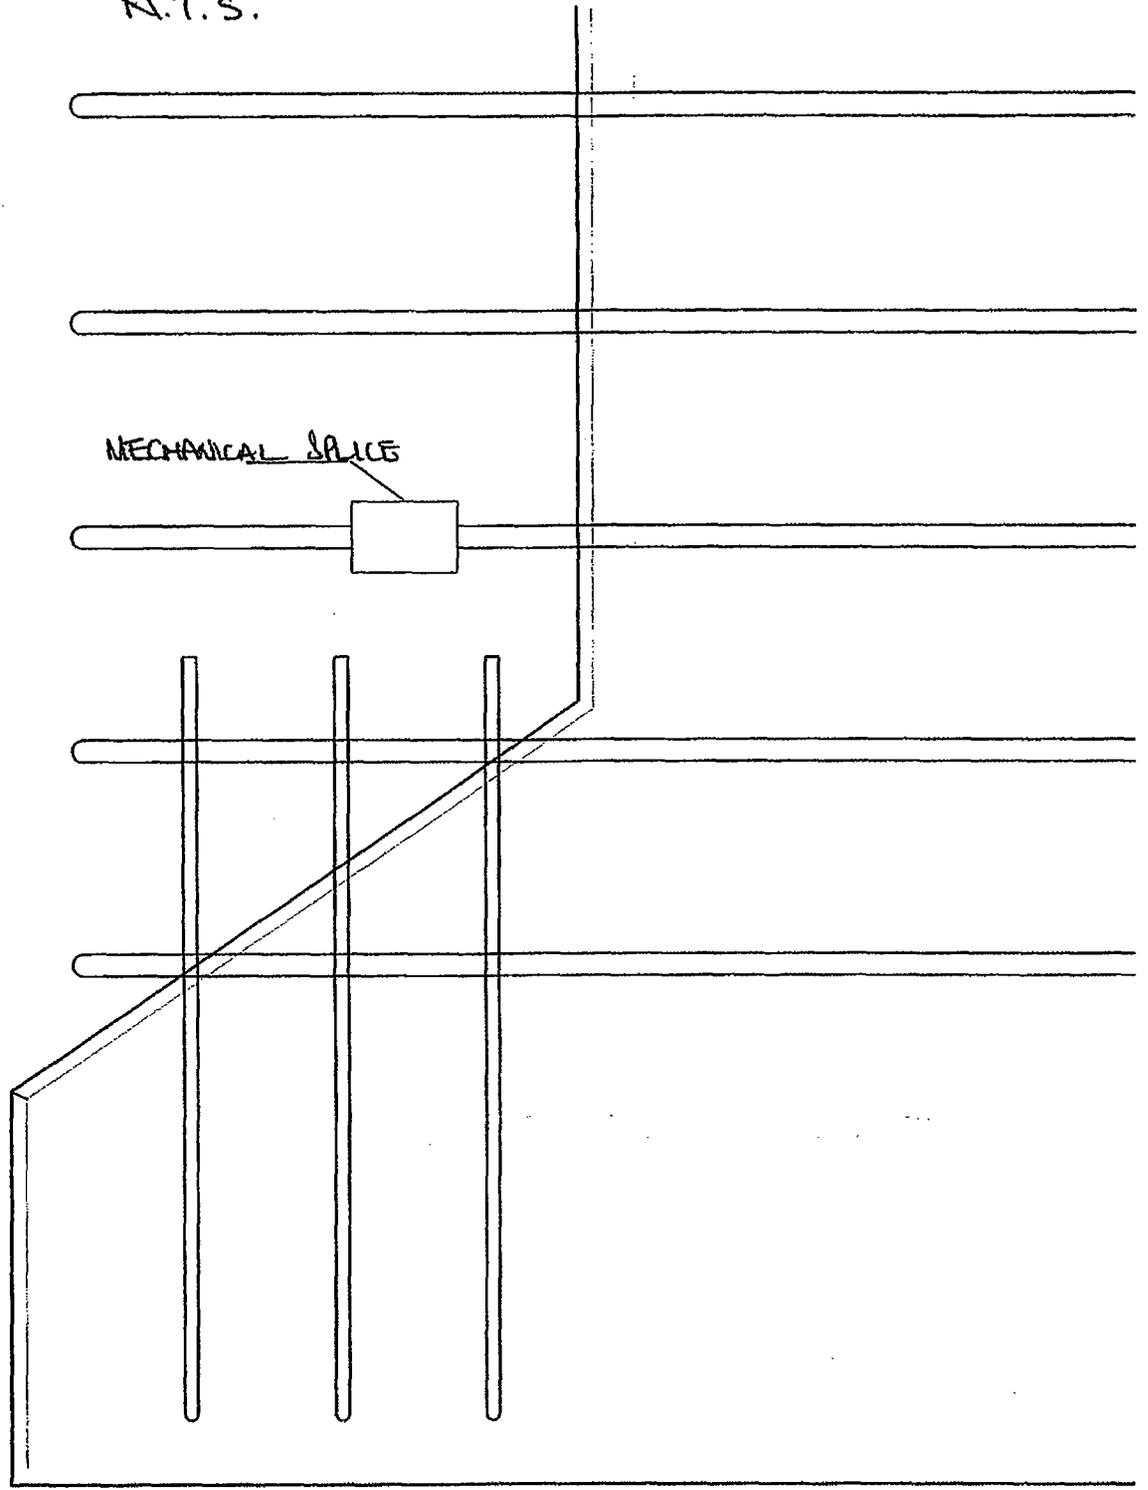
OPTION 3

Based on potential constructability issues at the job site, either option 3 or 4 seems the best suited option for the rebar shortening. However, in regard to loss of reinforcement, associated with this rebar movement within the Fender and its consequences relating to the capacity of the fender, OSM defers to the Design.

Option 3: The U-Bar will be cut in a specified location provided by KFM due to the job site conditions. It will be then spliced with a new fabricated U-Bar using a mechanical splice. The mechanical splice shall be epoxy coated or it shall be shrink wrapped per project specifications.
