Contract #: 04-0120R4
 Cty: SF Rte: 80 PM: 12.6,13.2
 File #: 81.25B

QUALITY ASSURANCE -- NON-CONFORMANCE REPORT

Welding	Concrete	Other	
Welding	Curing	Procedural	Bridge No: 34-0006
Joint fit-up	Coating	Other	Component: East Tie In
Procedural	Procedural	Descriptor: FCM Gusset Plate at South Truss Vertical A112A

Reference Description: Damaged/gouged gusset plate during heat straightening.

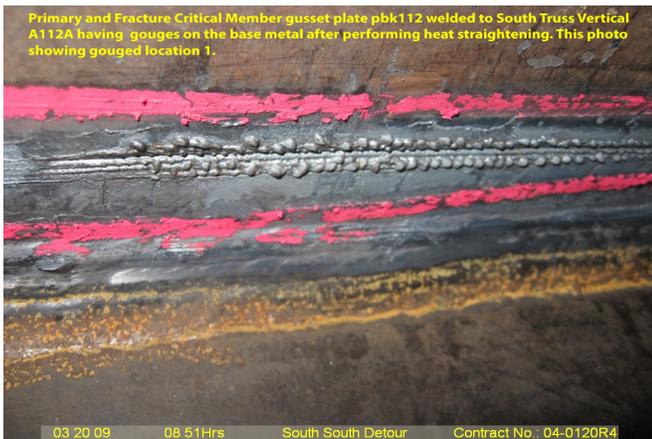
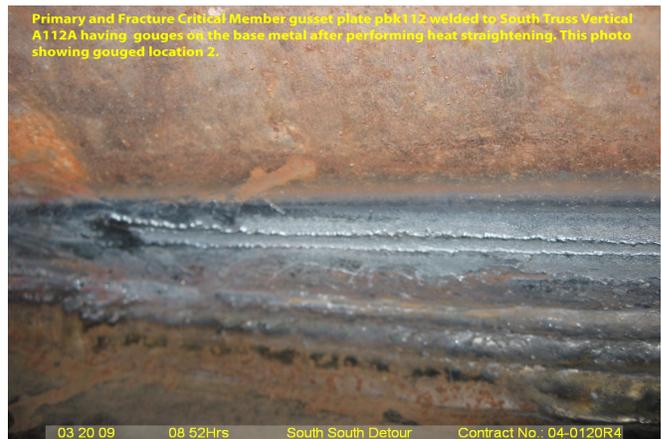
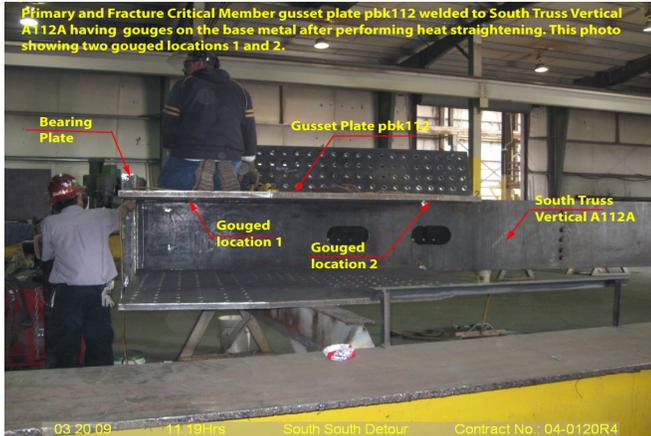
Welding distortion was noted on welded FCM gusset plate to the South Truss Vertical A112A. Stinger Welding attempted heat straightening to correct the distortion. During heat straightening of this gusset plate pbk112 from the underside, the plate was overheated gouging/damaging the plate. Stinger QC Mark Bauers was monitoring the application of localized heat. Four applications of localized heat were conducted on the same location on the gusset plate. On the fourth pass, there was burning/gouging and discoloration of the plate occurred per QC record. The applied heat exceeded the maximum temperature that is specified in the approved HSR procedure as evidenced by the burning/gouging and discoloration of the plate. It is noted that their approved procedure requires each application of heat to be 13mm from the previously heated area and this apparently did not occur.

AWS D1.5 Section 3.7.3 and 12.12. and Stinger Heat Straightening Request 1055 Portal Gussets -1 Rev. 0

They requested to use the material as is. Reference submittal 215-SUB.00292-110 for additional information.

Stinger Welding, Inc had made an evaluation by performing hardness test on the affected gusset plate pbk112A and compared it to the non-affected gusset plate pbh112A. The average hardness taken from the affected area was 152.55 HBLD whereas the non-affected area was 159.2 HBLD. Comparing both hardness readings, there were minor differences between the two areas. Although blisters, slight gouging and discoloration of the plate were observed, these appear to be superficial. Stinger Welding, Inc suggested not to do any further repair to the burned gusset plate and they request to use as it is.
