Contract # : 04-0120S4
 Cty SF Rte 80 PM 12.7/13.2
 File # 1.25 B

QUALITY ASSURANCE - NONCONFORMANCE REPORT

Location: C-Trans, Oakland, CA**JOBSITE NCR** **Date:** 12/19/11**Prime Contractor:** MCM Construction Inc.**NCR #4****Submitting Contractor:** Schwager Davis Incorporated (SDI)**Type of problem:****Welding** **Concrete** **Other** **Welding:** **Curing:** **Procedural:** **Bridge No.** 34-0006**Joint fit-up:** **Coating:** **Other:** **Component:** Post Tensioning Tendon**Procedural:** **Procedural:** _____

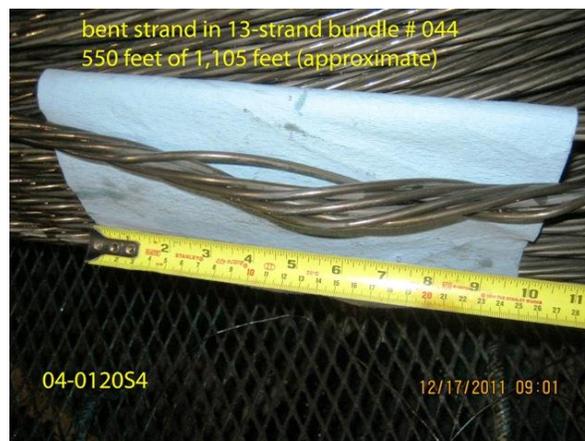
Description of Non-Conformance: It was observed during the coiling of post tensioning tendon bundle # 044 that one of the 13 strands had been physically damaged (bent). See photo below. The bent strand was not removed and is currently in the bundle.

Applicable reference: Contract Special Provisions 50-1.05 "Prestressing steel that has sustained physical damage at any time shall be rejected."

Corrective action taken: The bent strand, noted as a 7 inch "bird cage", was removed from the bundle before release on January 6th of 2012. The QA Inspector, Craig Hager, orange tagged the "bundle of Post Tensioning (PT) strand identified as 044 (12-strand bundle)." The material was inspected in accordance with Section 6 of the Standard Specifications and found to substantially comply with contract plans and specifications.

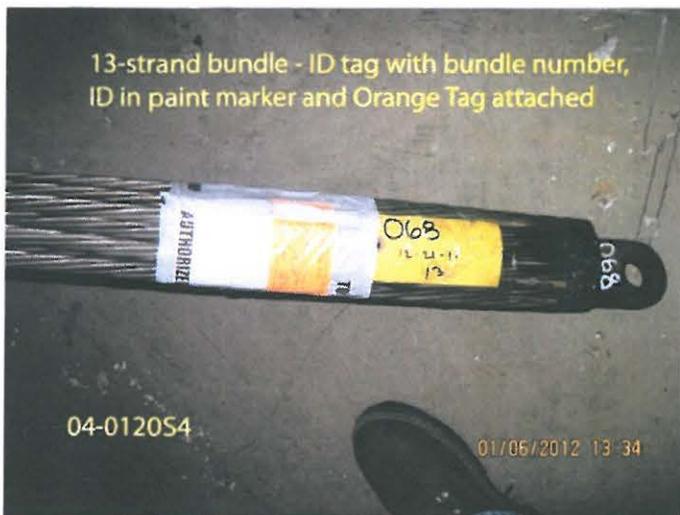
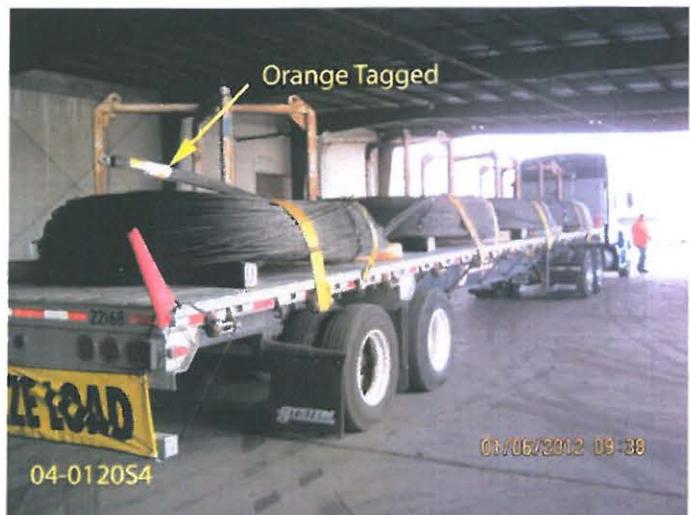
This QA Inspector proceeded with the release of the remaining 114 bundles of strand. See above for the specific bundles and below for typical photos.
