Contract #: 04-0120F4  
 Cty: SF/ALA Rte: 80 PM: 13.9/14.3,0.0/1.6  
 File #: 69.28

**WELDING INSPECTION REPORT**

**Report No:** WIR-000823  
**Date Inspected:** 05-Nov-2007

**Project Name:** SAS Superstructure **OSM Arrival Time:** 630  
**Prime Contractor:** American Bridge/Fluor Enterprises, a JV **OSM Departure Time:** 1530  
**Contractor:** Zhenhua Port Machinery Company, Ltd (ZPMC), Changxing Island **Location:** Shanghai, China

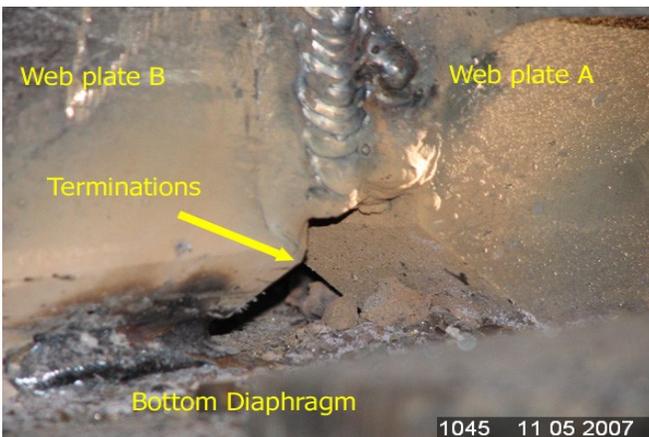
Item Description	WBS	Dwg No.	Status
1 89 Mock-up Assembly- MUB1			
The QA inspector performed random visual inspection to the weld terminations at the mock-up areas. QA inspector observed that welds joint web plate to web plate was being terminated as shown on the photograph below.

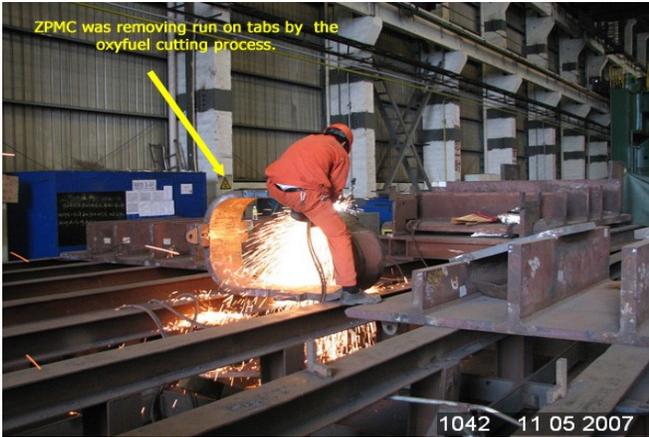
2 Cutting operations at the Flange Reinforcement ring SA-273 Tower Mock-up 77 M

The QA inspector observed ZPMC performing oxyfuel cutting operations to the run on tabs located at end of the weld joint 1 thru 5 for the flange reinforcement ring SA-273.

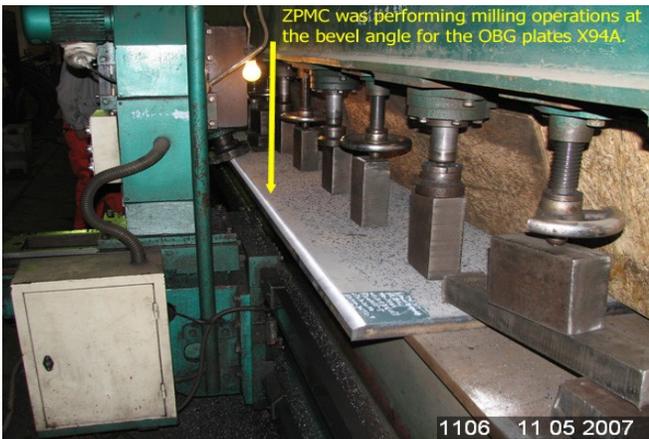
4 OBG Milling operations plate X94-A

The QA inspector observed ZPMC milling operations on the bevel preparation for the plate for the OBG X94-A.

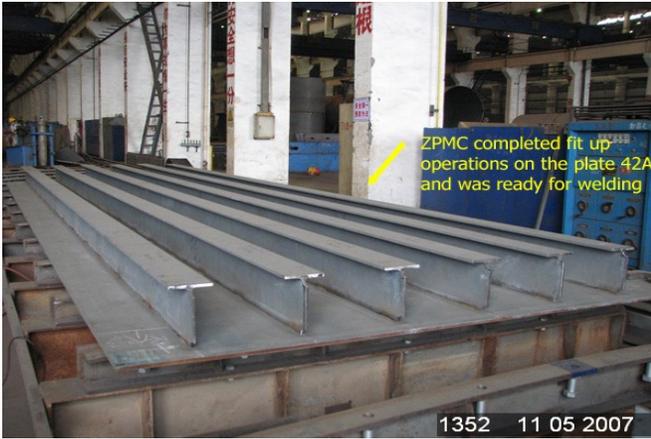
5 OBG Bottom deck Tees open ribs for the panel PL42A

The QA inspector observed ZPMC moving the bottom deck panel PL42A, to the Gantry welding table on shop # 3 and making set-ups of the welding machine before being welded.
