DEPARTMENT OF TRANSPORTATION

Quality Assurance and Source Inspection

Contract #: 04-0120F4Cty: SF/ALA Rte: 80 PM: 13.2/13.9File #: 69.28**WELDING INSPECTION REPORT****Resident Engineer:** Pursell, Gary**Address:** 333 Burma Road**City:** Oakland, CA 94607**Report No:** WIR-000874**Date Inspected:** 16-Nov-2007**Project Name:** SAS Superstructure**OSM Arrival Time:** 600**Prime Contractor:** American Bridge/Fluor Enterprises, a JV**OSM Departure Time:** 1530**Contractor:** Zhenhua Port Machinery Company, Ltd (ZPMC), Changxing Island **Location:** Shanghai, China

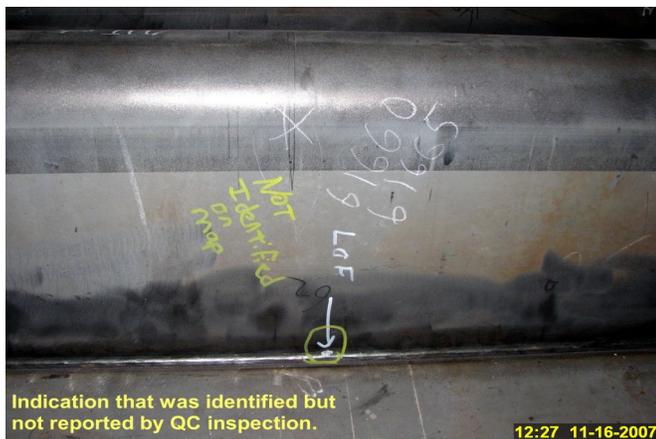
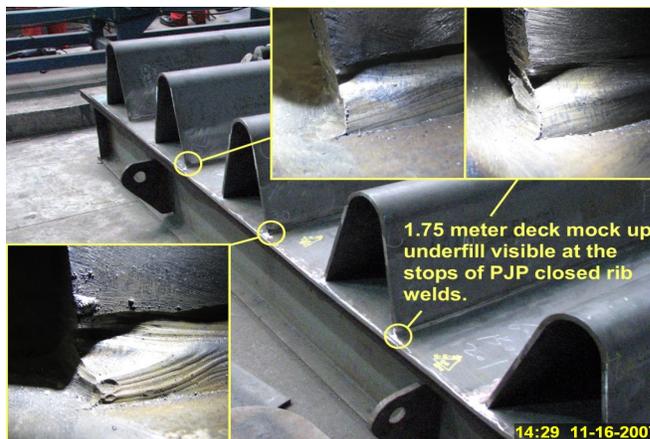
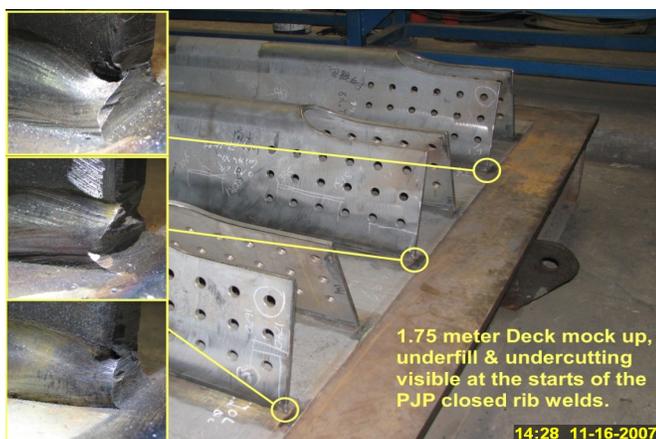
The QA inspector Scott Croff observed completed partial joint penetration welds (PJP) between the closed ribs and deck plate on the 13 meter and 1.75 meter deck mock up sections. The PJP welds are completed and have been inspected by Quality Control (QC) inspectors for American Bridge/Fluor (ABF) and ZPMC. The QA inspector was informed that light leak tests and visual inspections should be conducted on the accepted PJP welds. The QA inspector was provided with a weld map of discontinuities that have been identified by the QC inspection. The QA inspector Larry Viars was also present during the examinations of the PJP welds. The QA inspector Scott Croff identified areas along the PJP welds where overlap and light is visible using the "light leak test" that has been authorized by the QA inspector Robert Cuellar and agreed upon by ABF QC. During the examination and testing, the QA inspector noted the appearance of undercut that was measured at 0.5mm deep for a length of 20mm on weld 1 of the 13 meter section. The QA inspector Robert Cuellar was notified of this observation. The QA inspector also noted that an indication of "LOF" was marked out on weld #7, but was not reported on the QC map of discontinuities. The QA inspector observed that welds on the 1.75 meter mock up appear to have undercut and under-fill at the ends. These observations were also reported to the QA inspector Robert Cuellar. See the attached photos of some of these noted observations.

As noted above, the QA inspector Scott Croff and Larry Viars conducted examination of PJP welds on closed ribs to deck mock up sections. There were conversations regarding the observation of the noted overlap and light leaks, undercut and underfill. The QA inspectors would assist each other when there were questionable observations. The QA inspector Robert Cuellar was then informed of all observed discrepancies that were not previously reported on the provided QC inspection report. There were no other notable conversations during this shift.
