Contract #: 04-0120F4Cty: SF/ALA Rte: 80 PM: 13.2/13.9File #: 69.28**WELDING INSPECTION REPORT****Resident Engineer:** Pursell, Gary**Address:** 333 Burma Road**City:** Oakland, CA 94607**Report No:** WIR-000875**Date Inspected:** 14-Nov-2007**Project Name:** SAS Superstructure**OSM Arrival Time:** 600**Prime Contractor:** American Bridge/Fluor Enterprises, a JV**OSM Departure Time:** 1530**Contractor:** Zhenhua Port Machinery Company, Ltd (ZPMC), Changxing Island **Location:** Shanghai, China

# WELDING INSPECTION REPORT

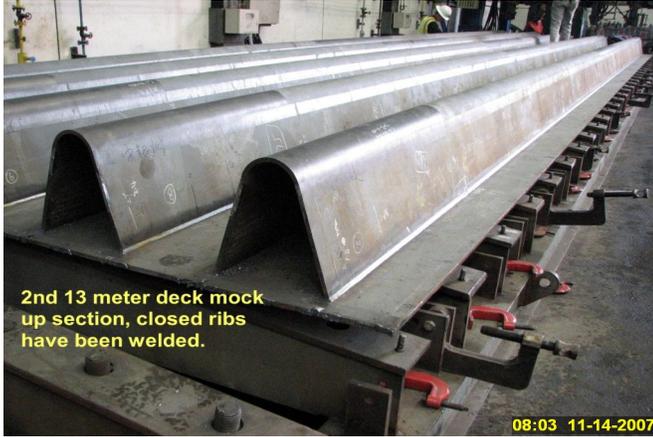
The QA inspector arrived at the fabrication facility and met with the QA inspector Robert Cuellar and Alfredo Acuna. The QA inspector was informed of the locations of work being performed at this time. The QA inspectors Scott Croff and Alfredo Acuna went to Bay 1 and made random observations of the closed rib welds on the deck mock up. The QA inspector Scott Croff was informed of the status of the 1st and 2nd mock up and the partial joint penetration (PJP) welds. See the attached photo.

The QA inspector Scott Croff assisted the QA inspectors Robert Cuellar and Alfredo Acuna in conducting a visual examination of the closed rib PJP welds on the 1st 13 meter deck mock up. The QA inspector noted that Art Peterson, Peter Ferguson and Craig Knops of American Bridge/Fluor (ABF) were present and also conducting the visual examination of the closed rib PJP welds. The QA inspector measured and recorded dimensional observations and measurements of observed weld overlap. The recorded information was reported to the QA inspector Alfredo Acuna.
